SPECIALIST REPORT

A PHASE 1 ARCHAEOLOGICAL AND HERITAGE IMPACT ASSESSMENT OF THE
STONE WALLED SETTLEMENTS ON TAURUS PLANTATION, BARBERTON
DISTRICT, MPUMALANGA PROVINCE

**REPORT PREPARED FOR
YORK TIMBERS**

APRIL 2015

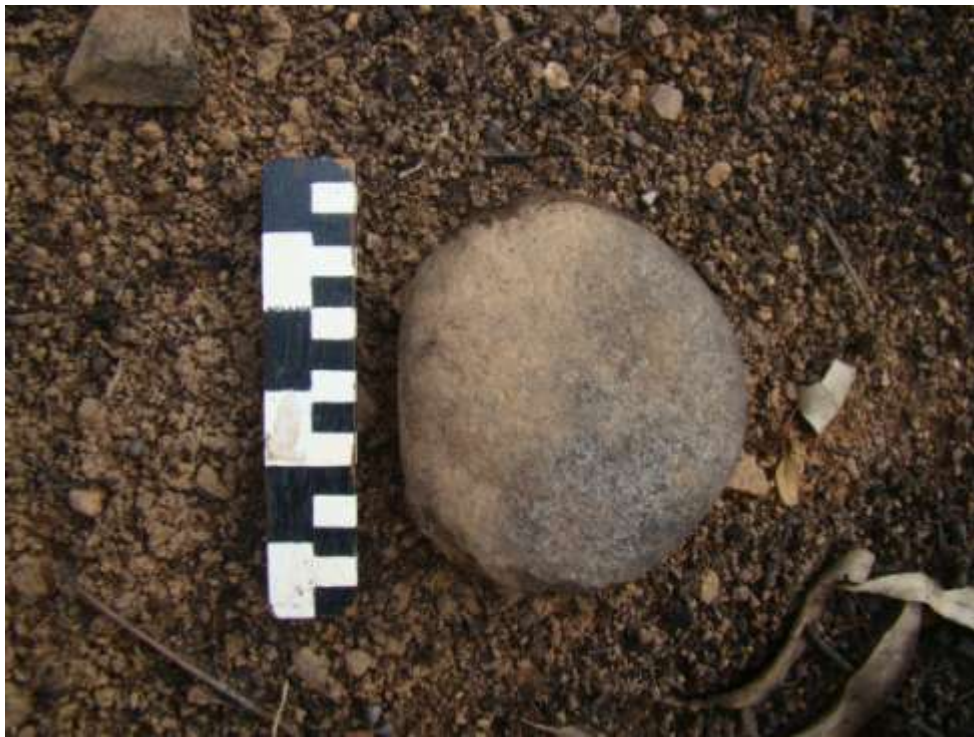
Fig. 157: An upper grinder.

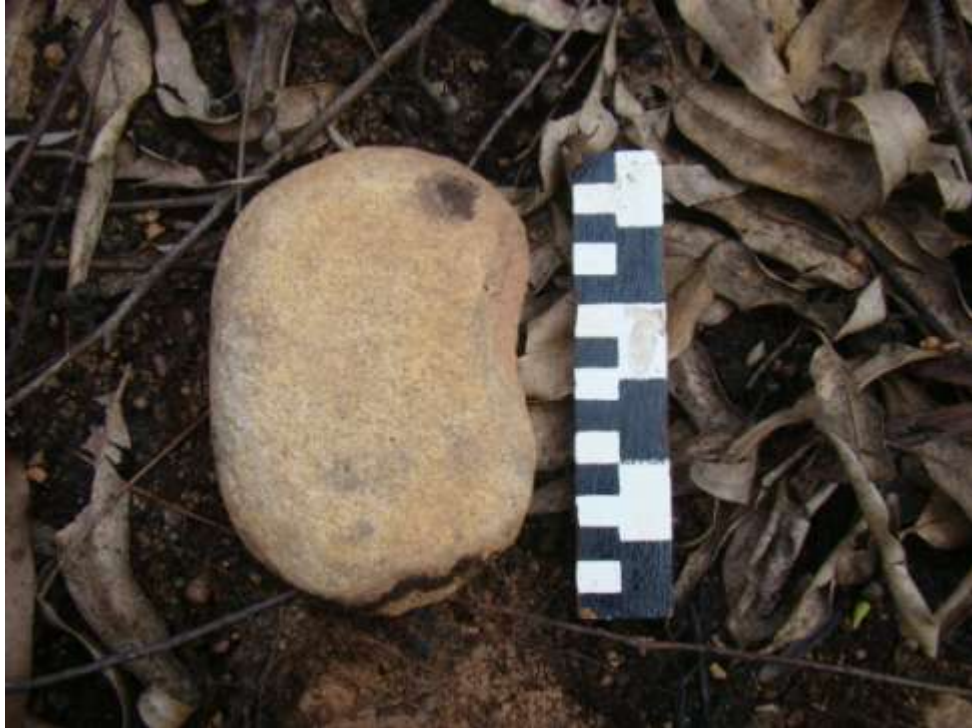
Fig. 160: A broken upper grinder.

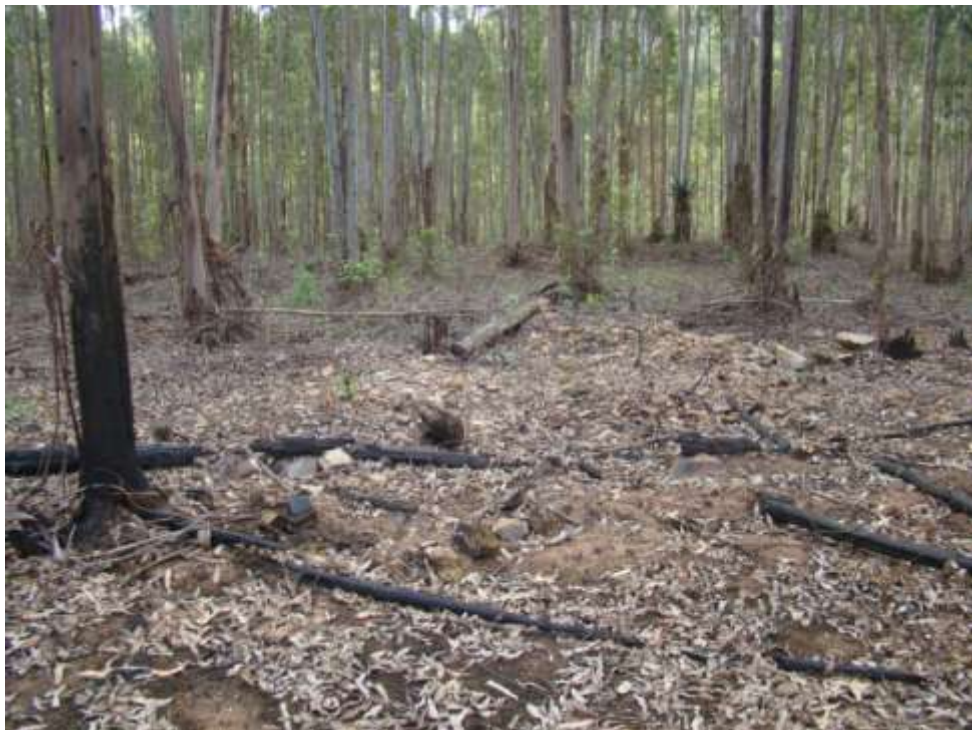
Fig. 161: This unit is very indistinct, and disturbed.

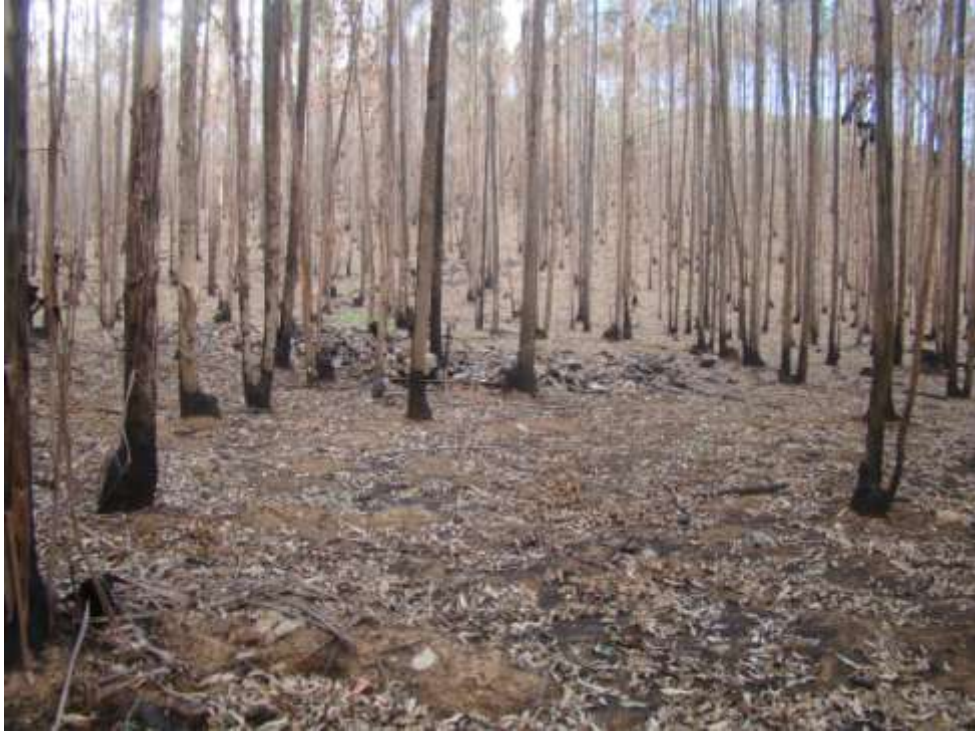
Fig. 162: Another circular unit in this section.

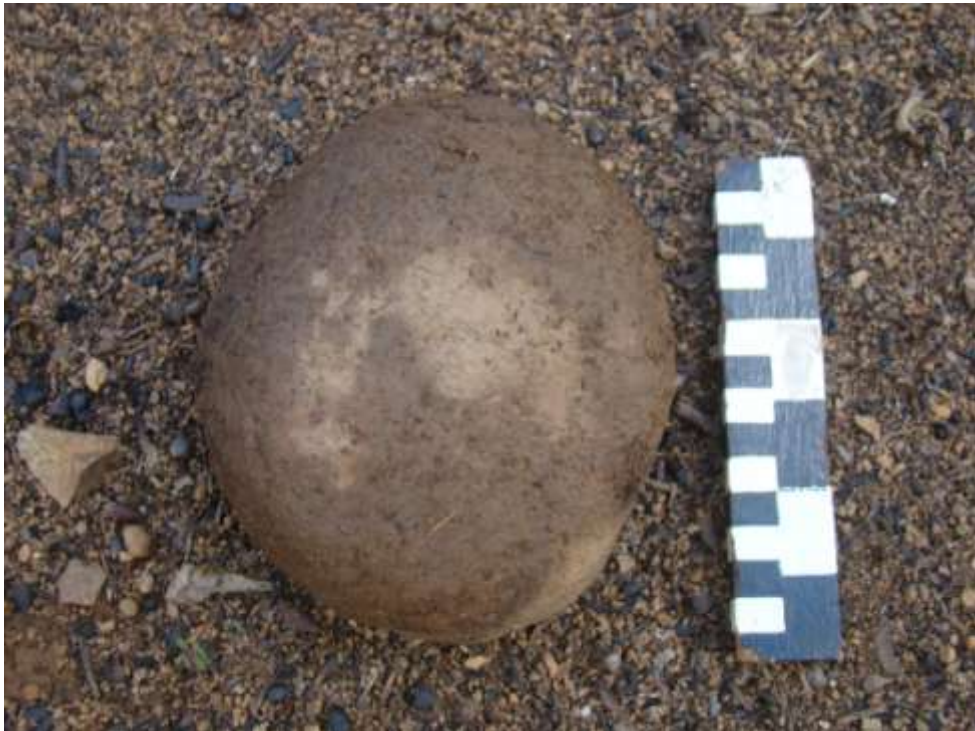
Fig. 163: An upper grinder.

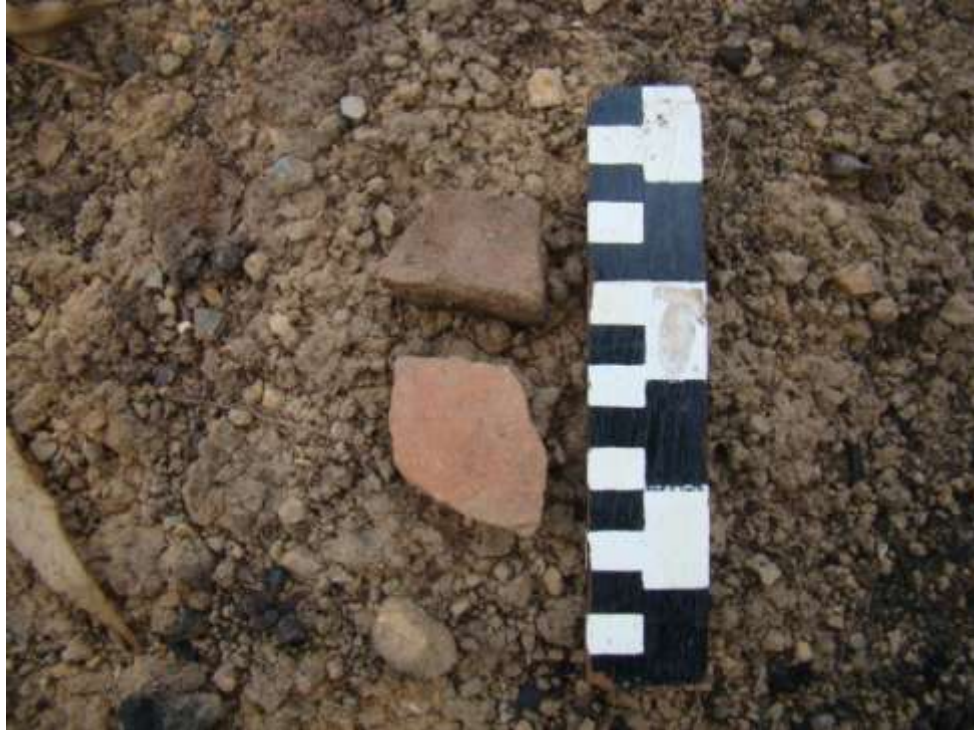
Fig. 167: Fragments of potsherds are also visible at the graves.

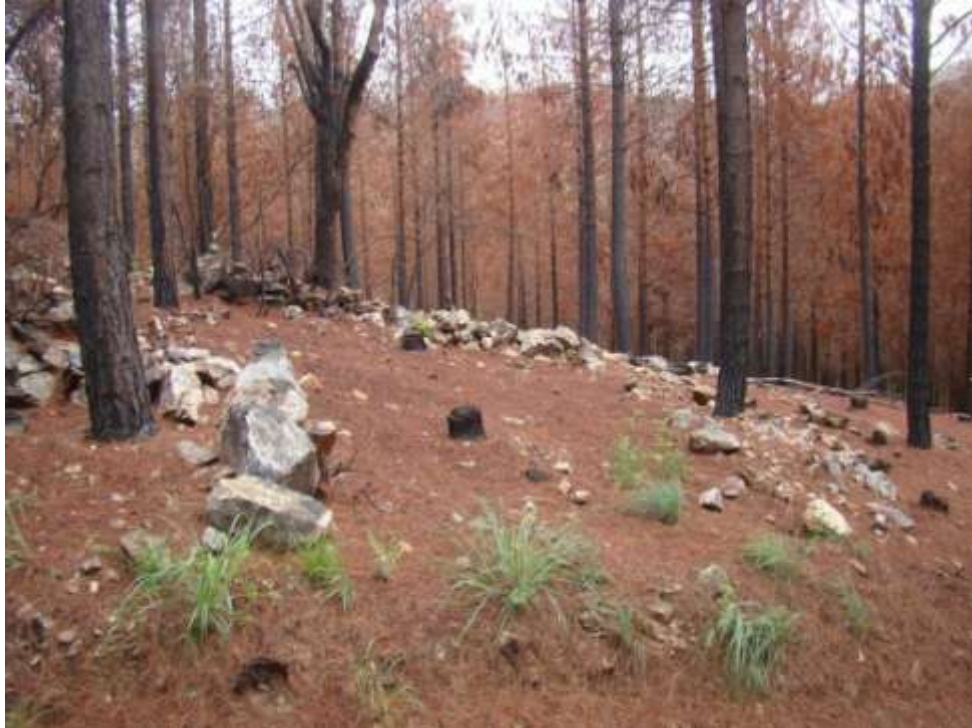
Fig. 171: The cattle track continues across the road (north) towards the settlement.

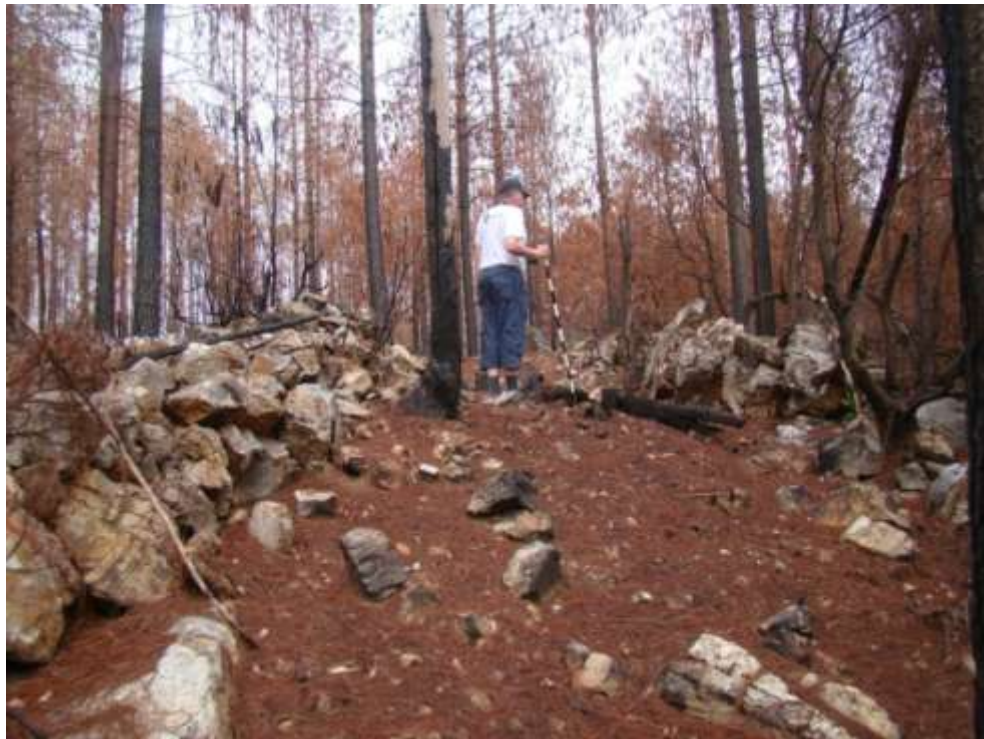
Fig. 174: Most of the walls in this area are still clear.

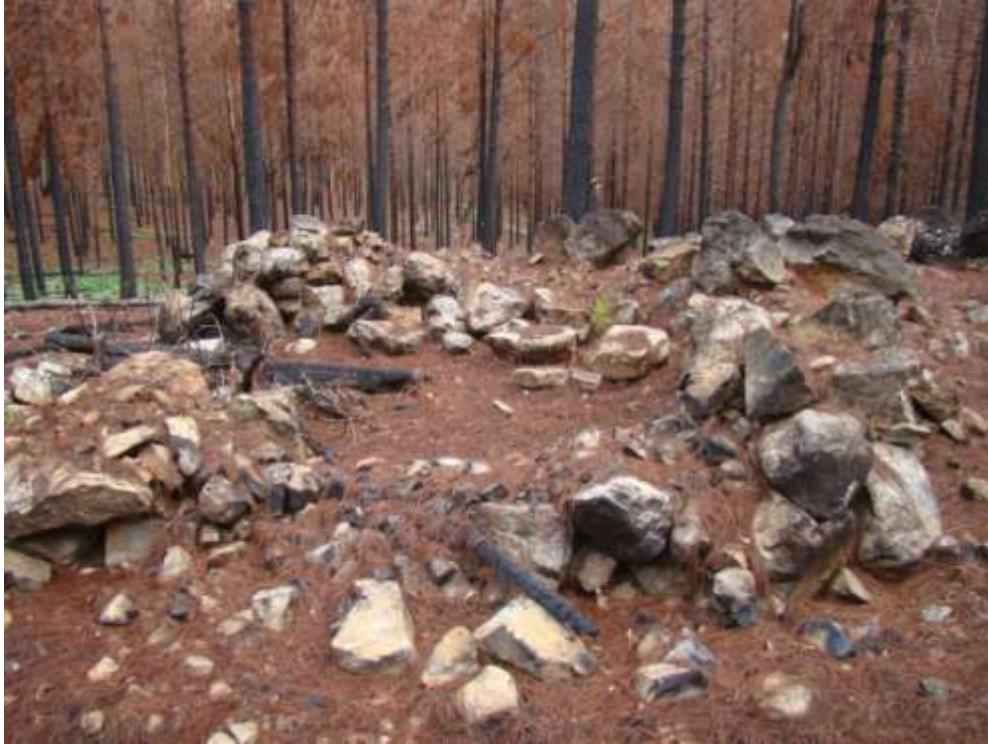
Fig. 175: One of the units which is almost square.

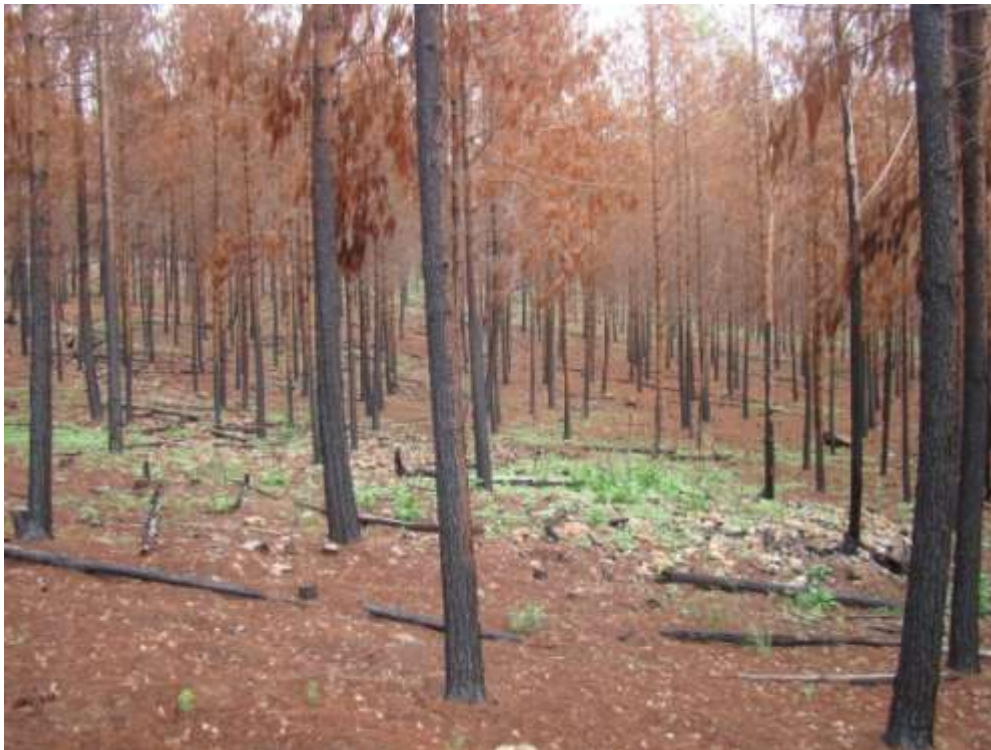
Fig. 176: A circular unit on the northern slope.

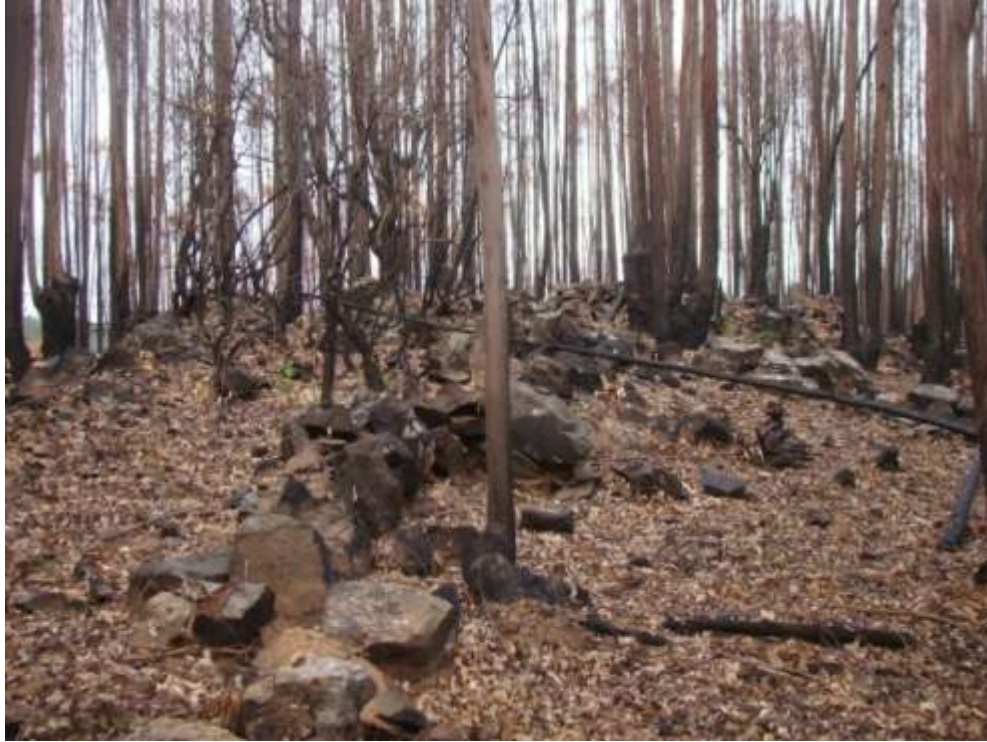
Fig. 177: Traces of the stone walls are visible in this burnt section.

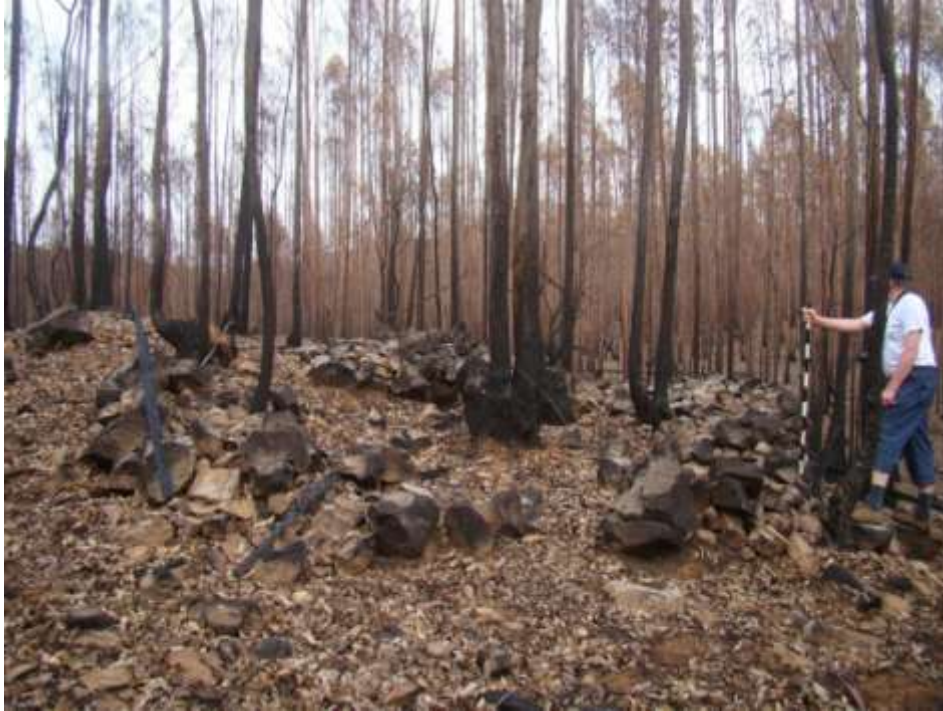
Fig. 179: A circular unit on the northern slope.

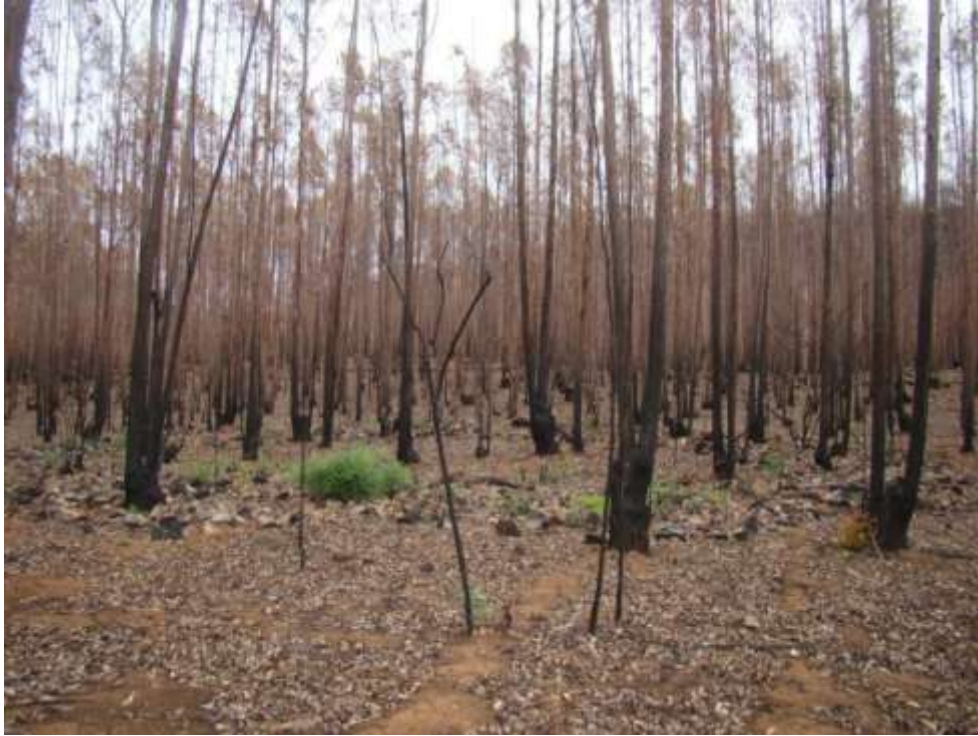
Fig. 181: Another circular unit in this area.

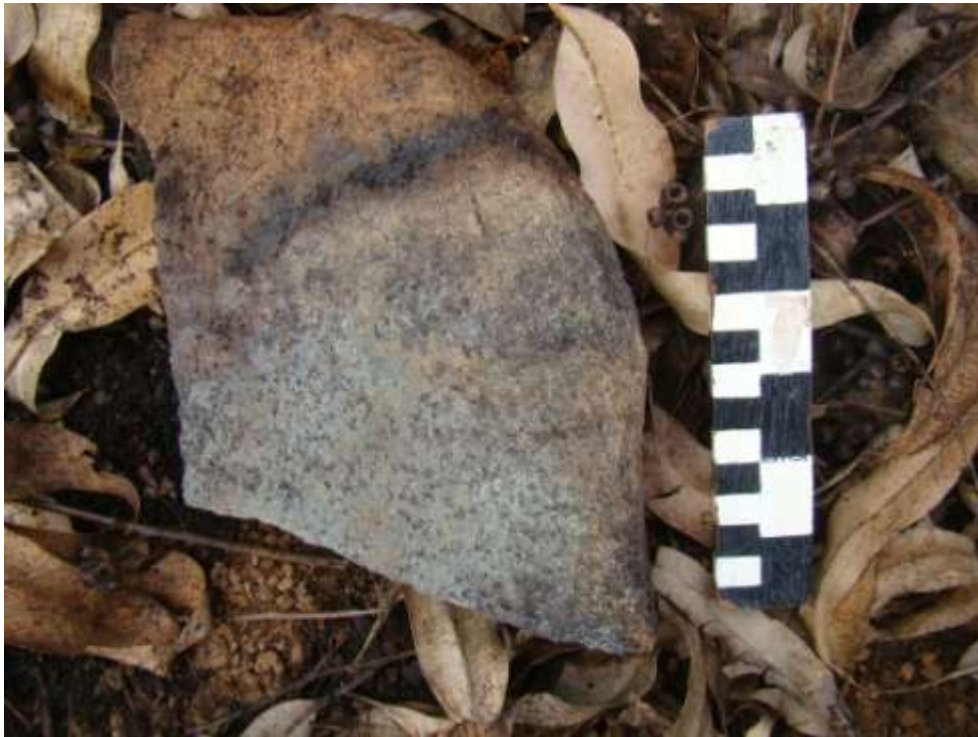
Fig. 182: A broken lower grinder.

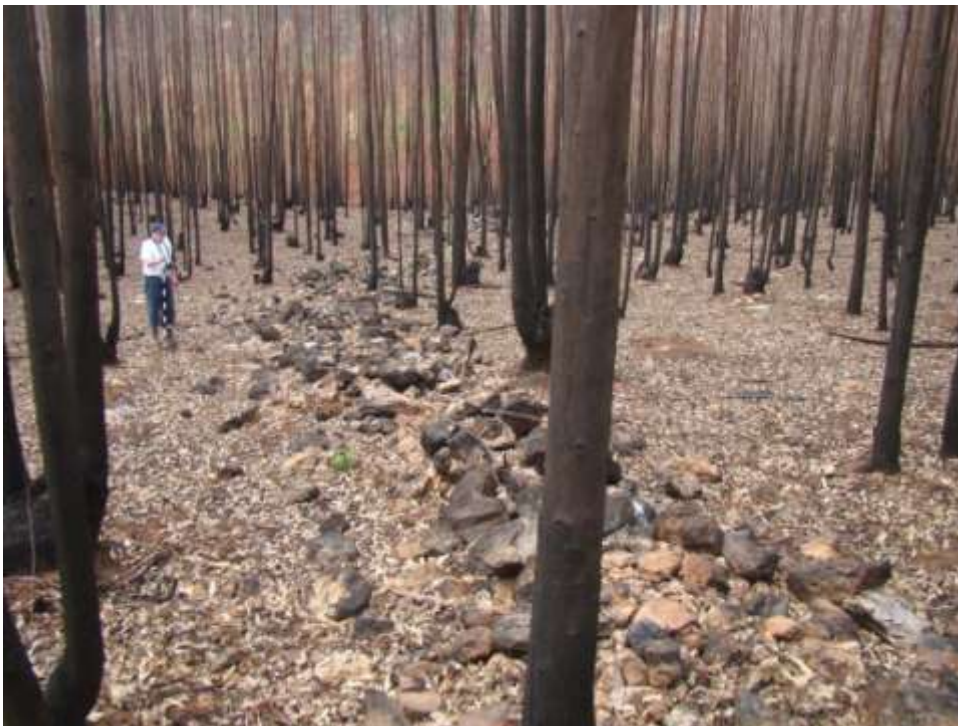
Fig. 184: The walls continue in most of the plantation area.

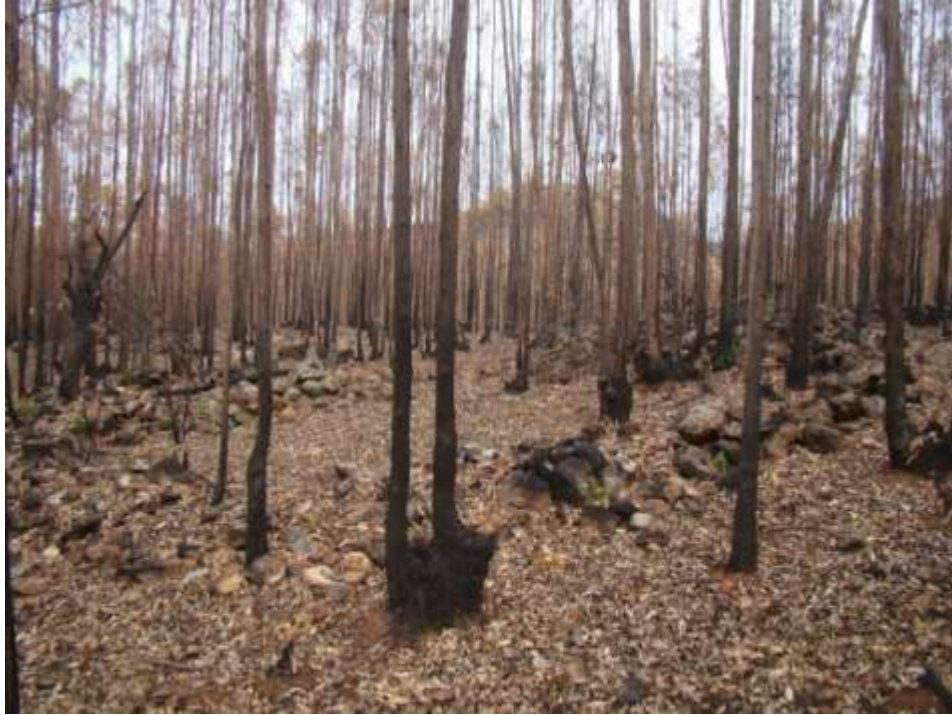
Fig. 185: More stone walls in this section.

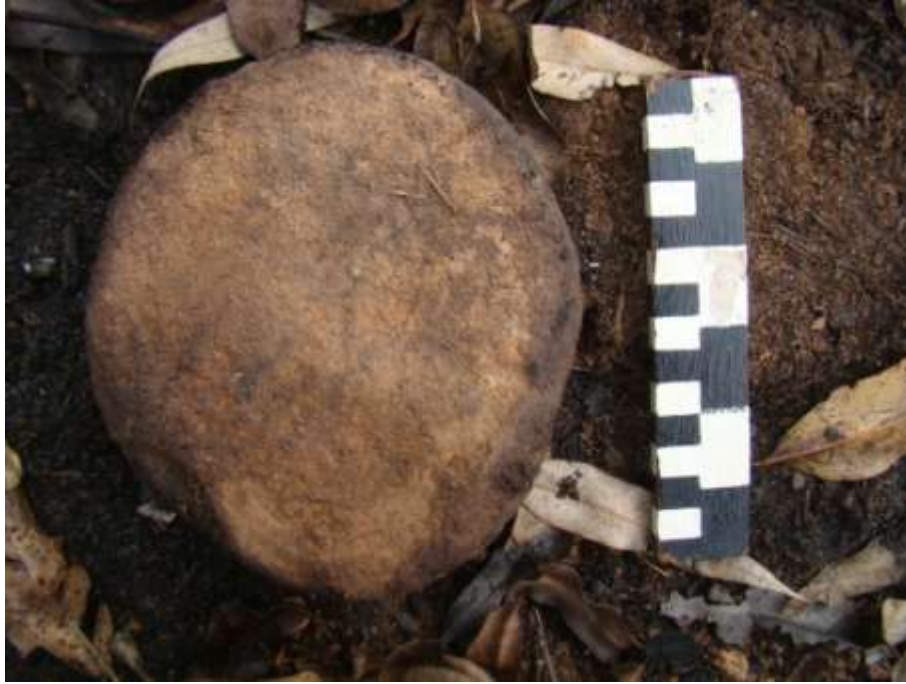
Fig. 187: An upper grinder.

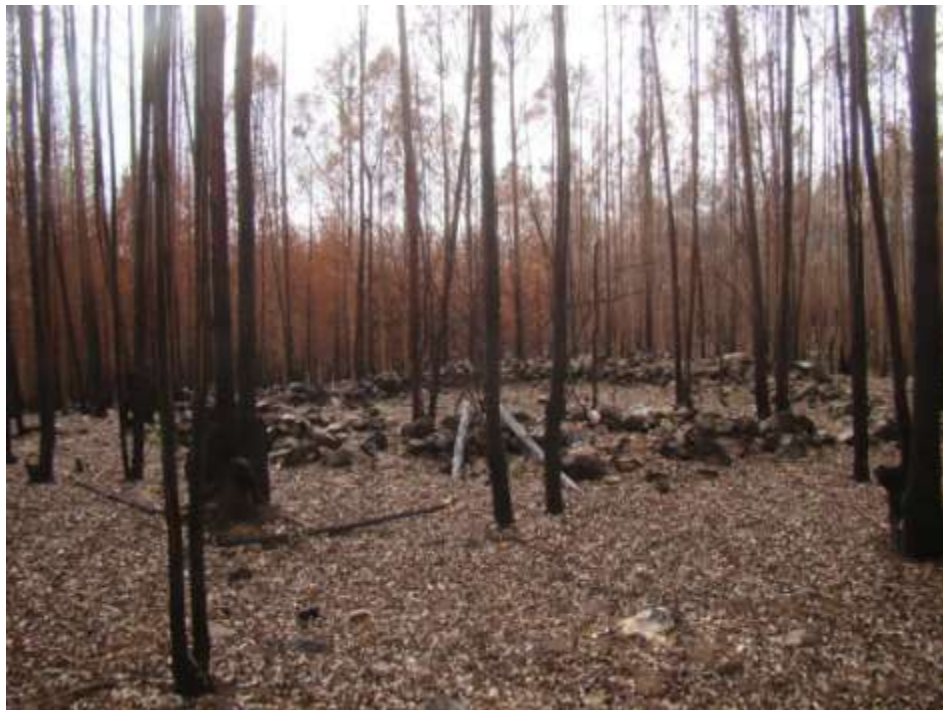
Fig. 190: More circular units in this section.

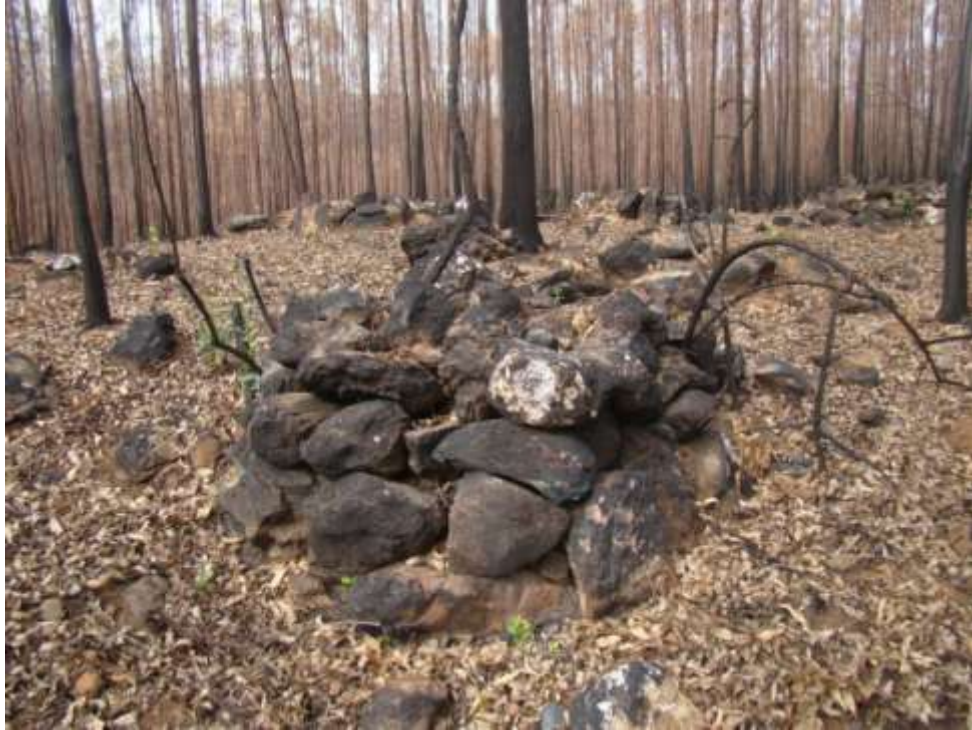
Fig. 191: One of the stone heaps.

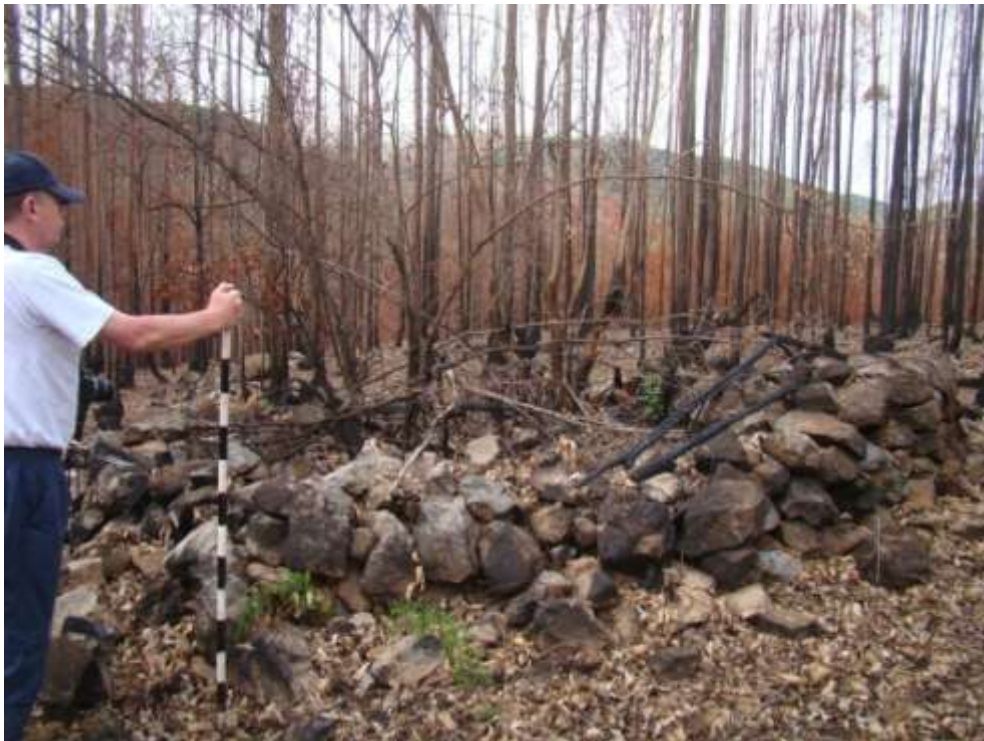
Fig. 194: Circular unit.

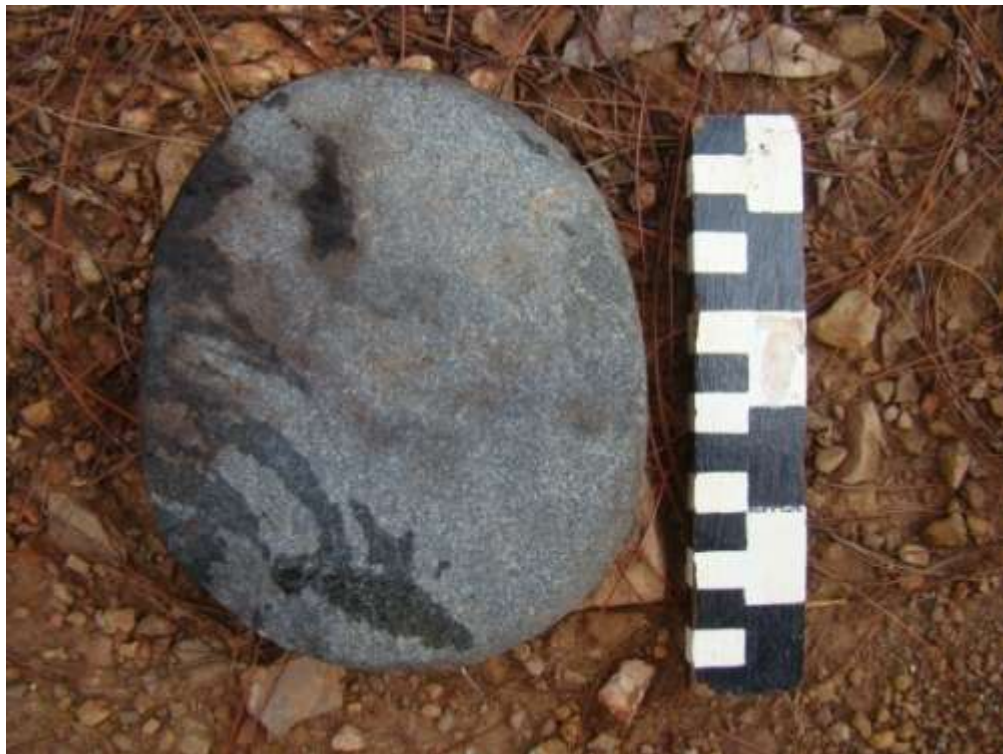
Fig. 196: An upper grinder.

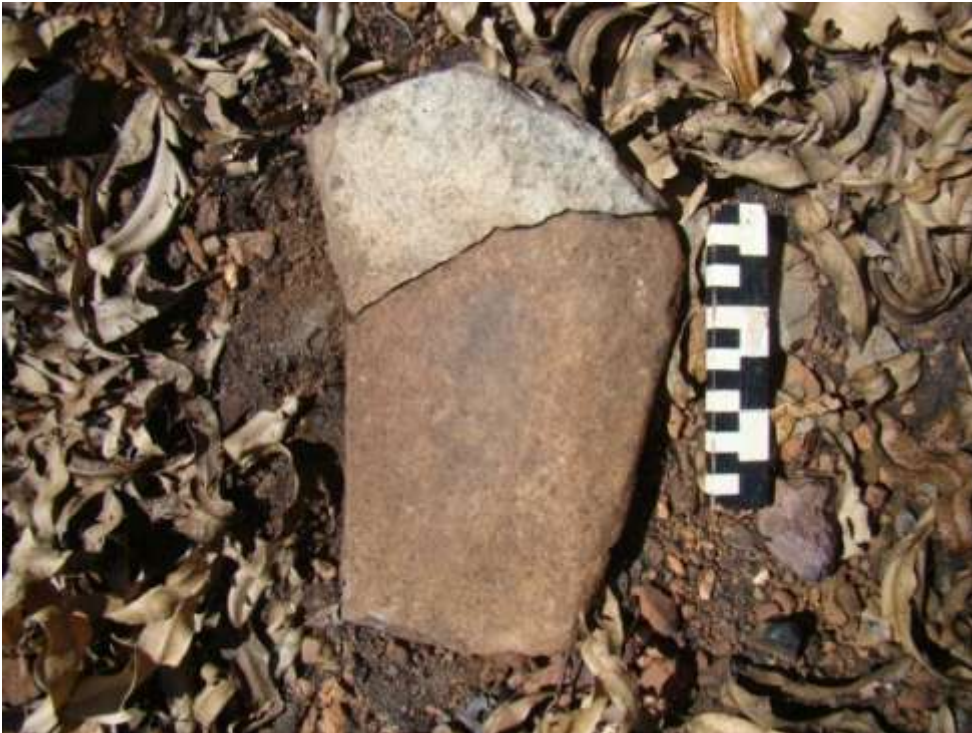
Fig. 202: A broken lower grinder (2 pieces).

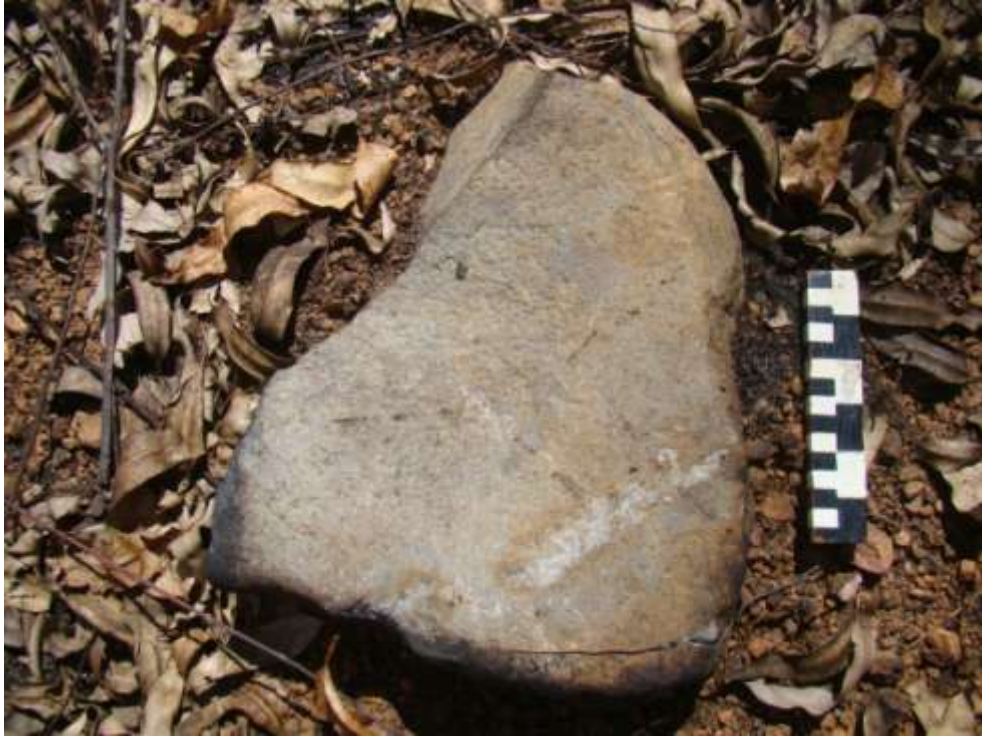
Fig. 203: A broken lower grinder.

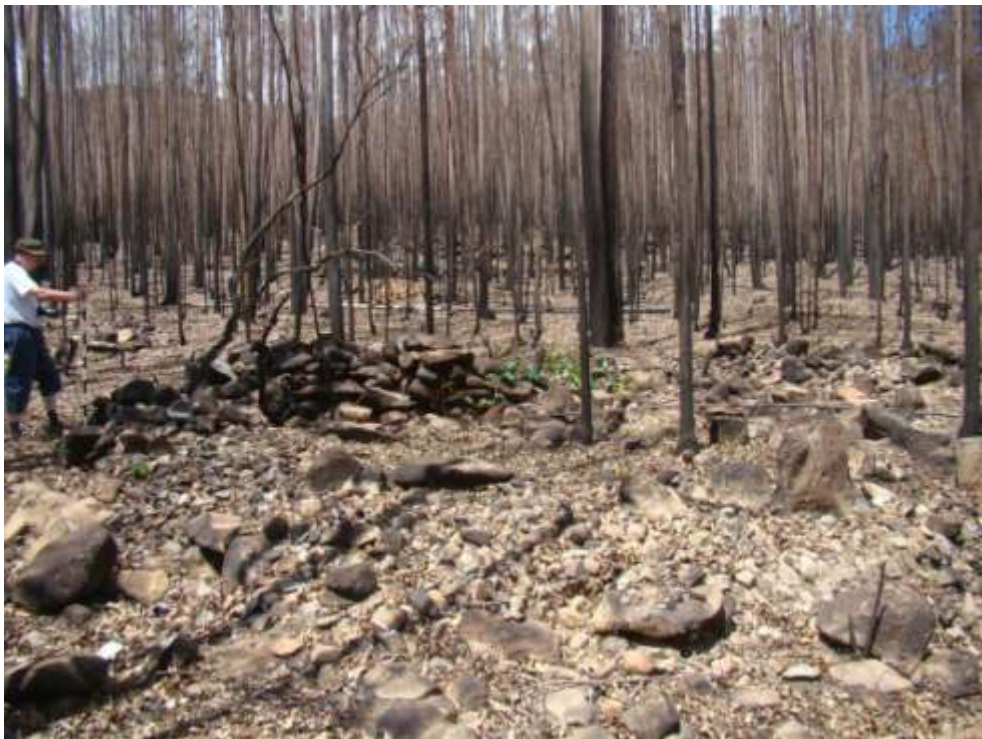
Fig. 212: Detail of the above units.

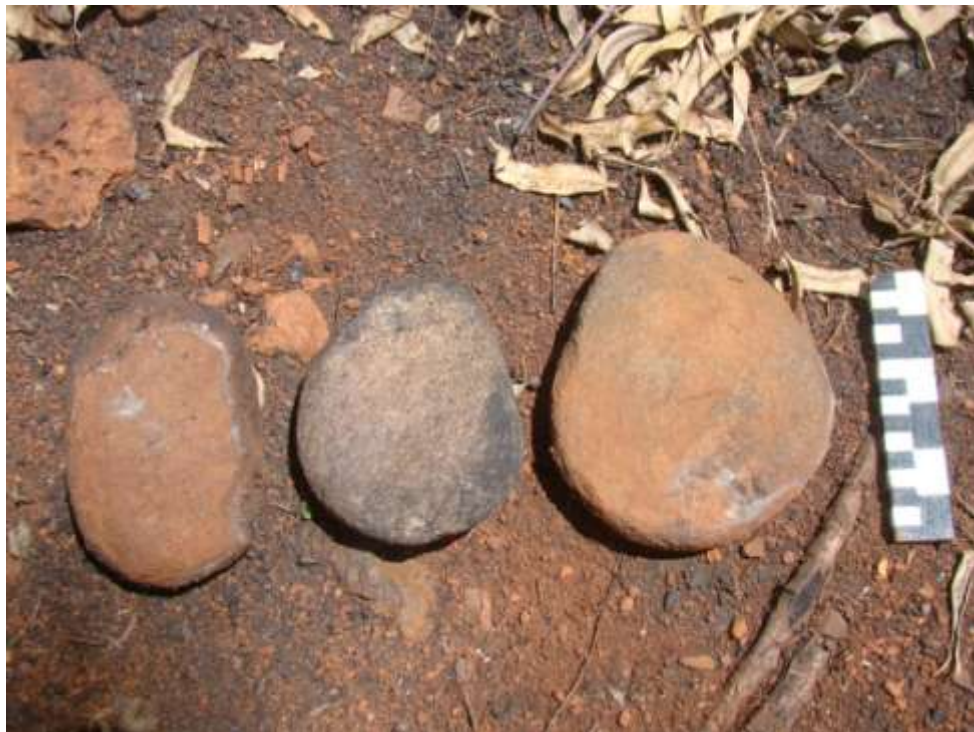
Fig. 215: 3 x upper grinders

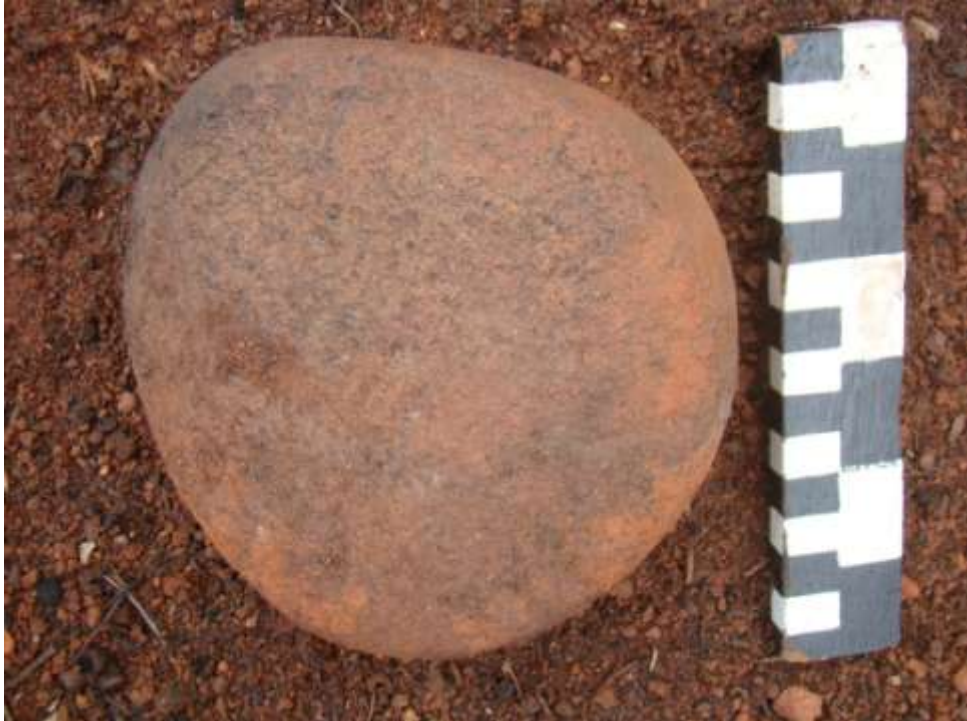
Fig. 216: 1 x upper grinder

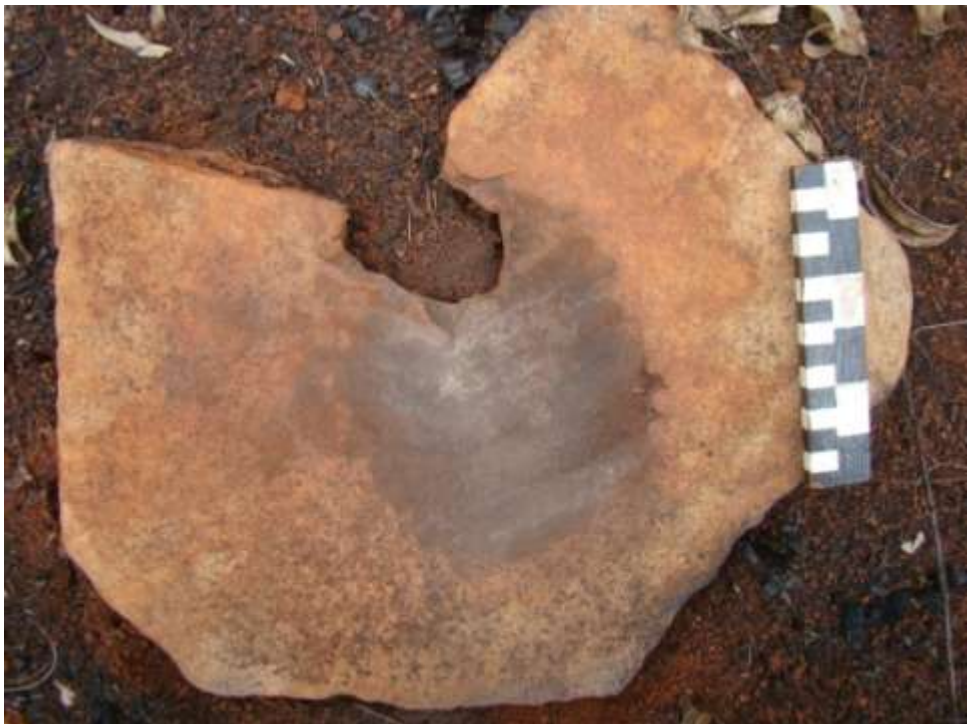
Fig. 217: 1 x lower grinder (broken)

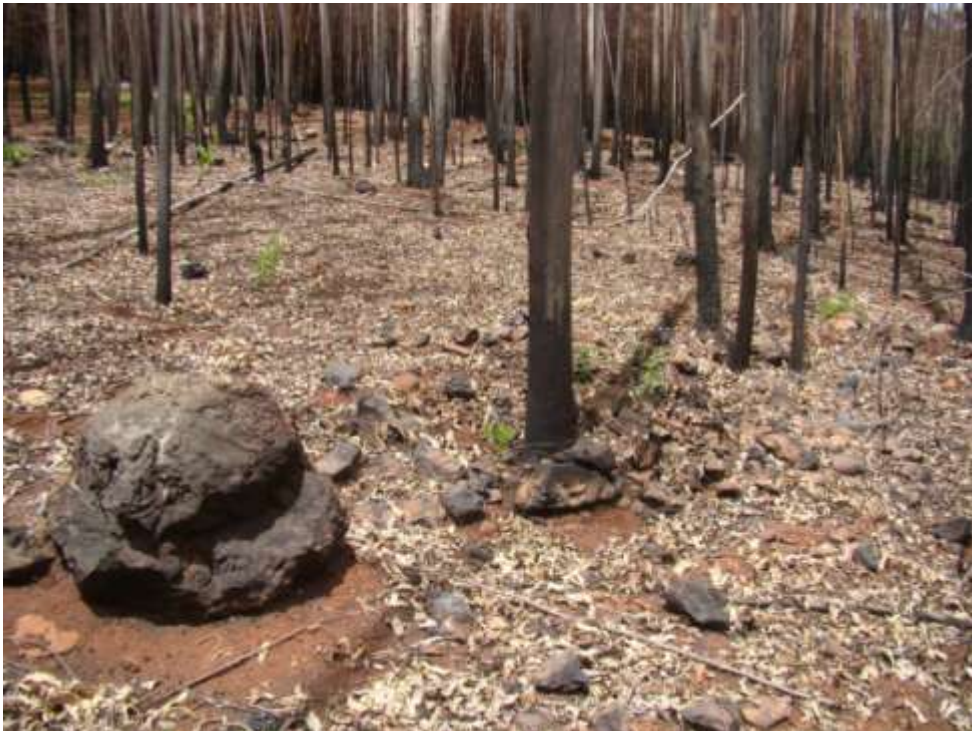
Fig. 219: Terrace walls in the area.

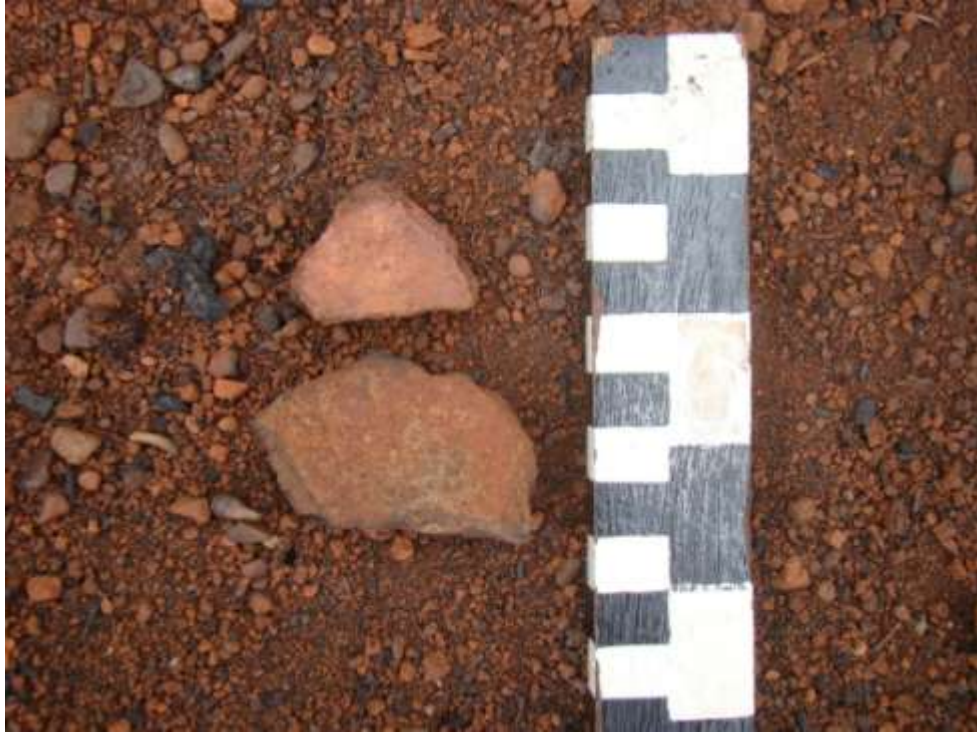
Fig. 220: Fragments of potsherds in this section.

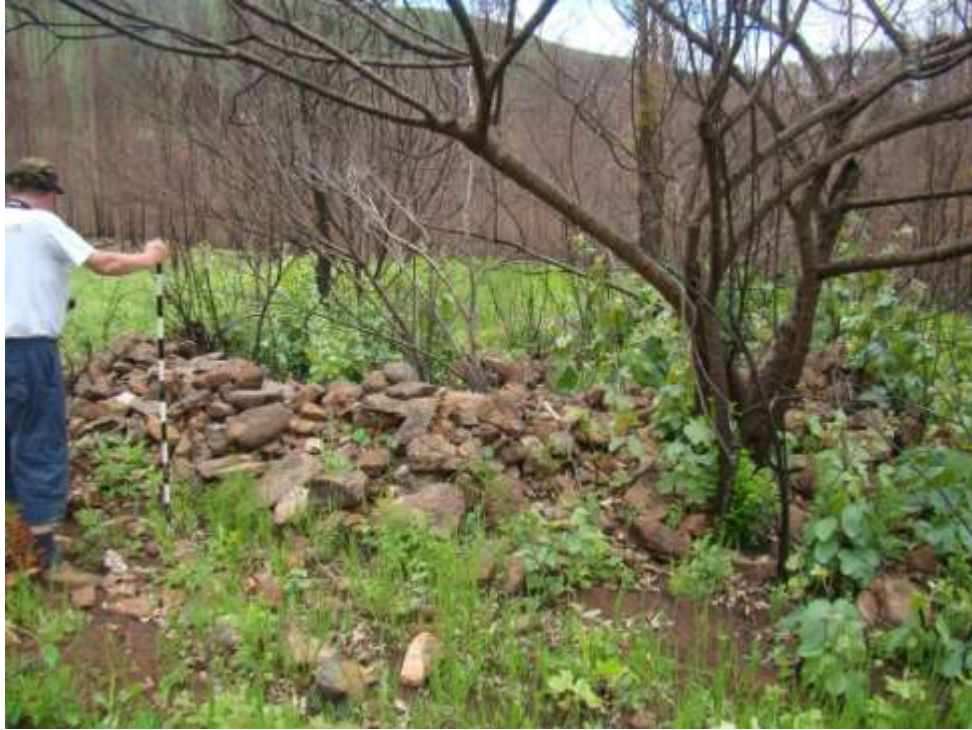
Fig. 224: Detail of the above unit.

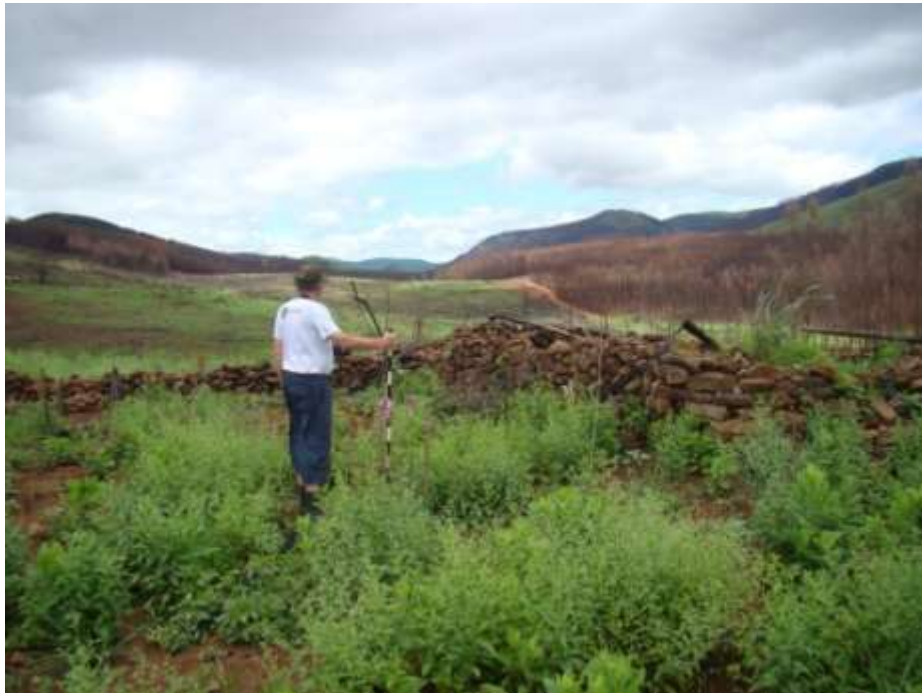
Fig. 228: A historic square sheep enclosure.

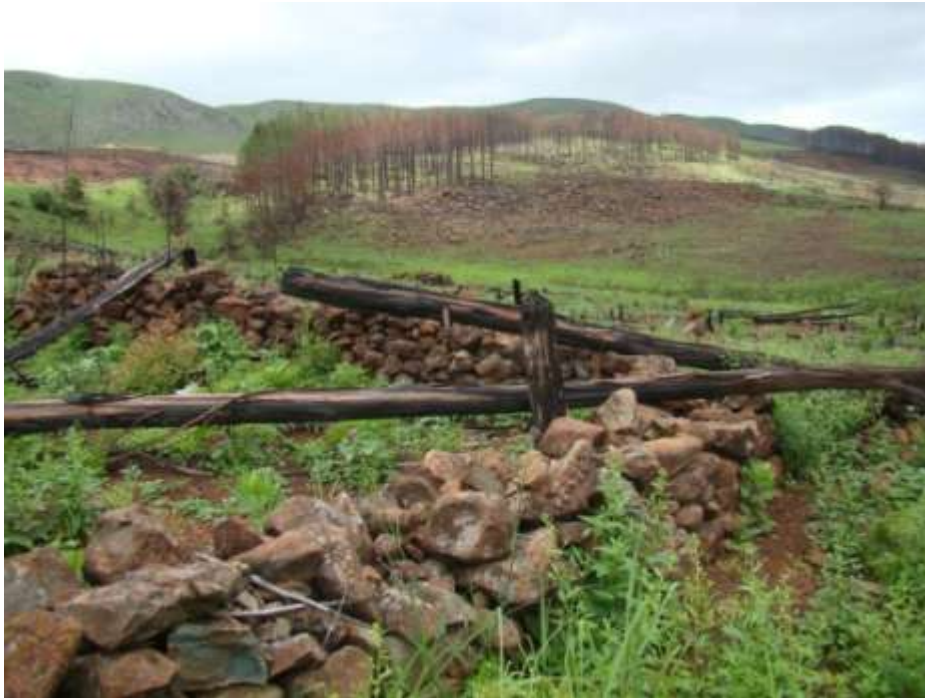
Fig. 230: Detail of the square enclosure.
