SPECIALIST REPORT

A PHASE 1 ARCHAEOLOGICAL AND HERITAGE IMPACT ASSESSMENT OF THE
STONE WALLED SETTLEMENTS ON TAURUS PLANTATION, BARBERTON
DISTRICT, MPUMALANGA PROVINCE

**REPORT PREPARED FOR
YORK TIMBERS**

APRIL 2015

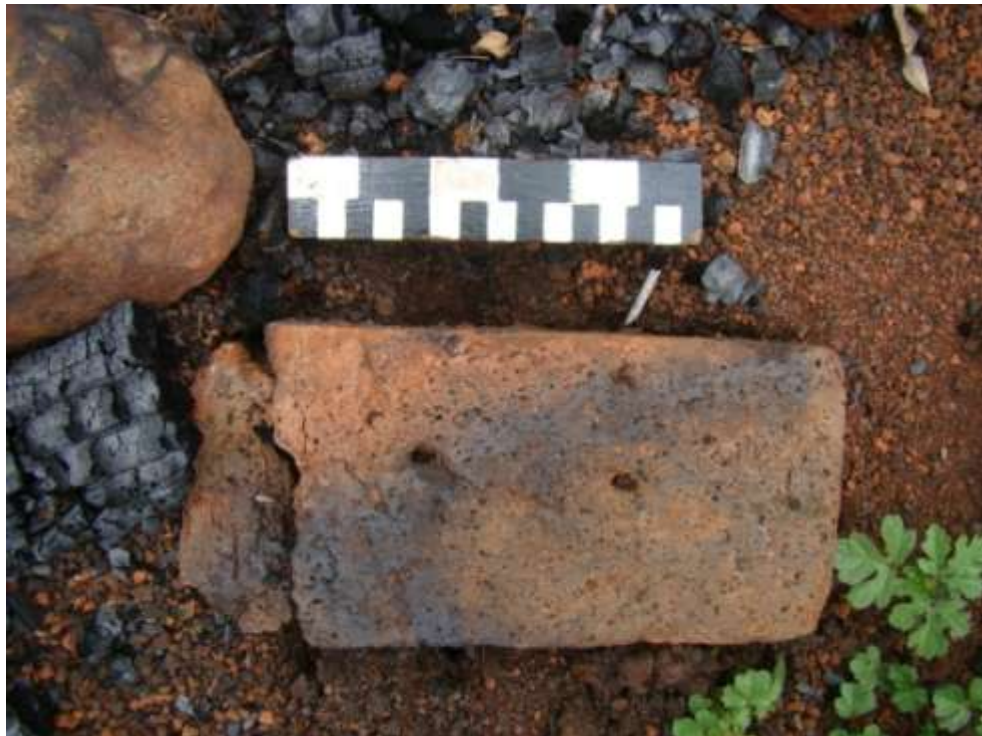
Fig. 232: A baked brick which was found at the enclosure.

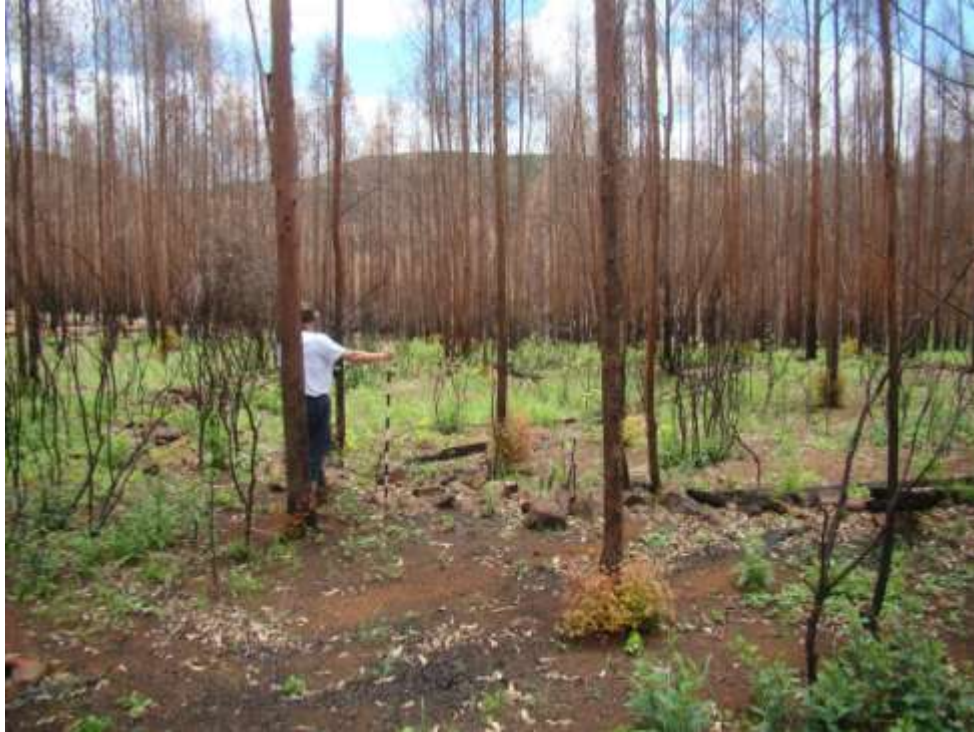
Fig. 236: The unit is indistinct and damaged by plantation and road activities.

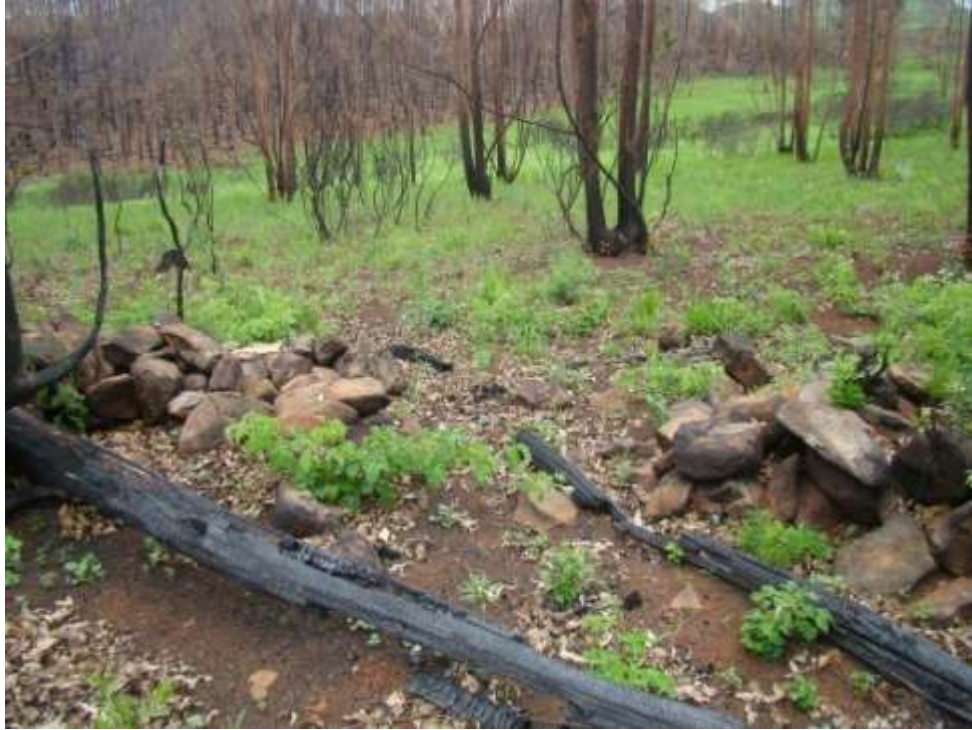
Fig. 238: A clear entrance of the above unit.

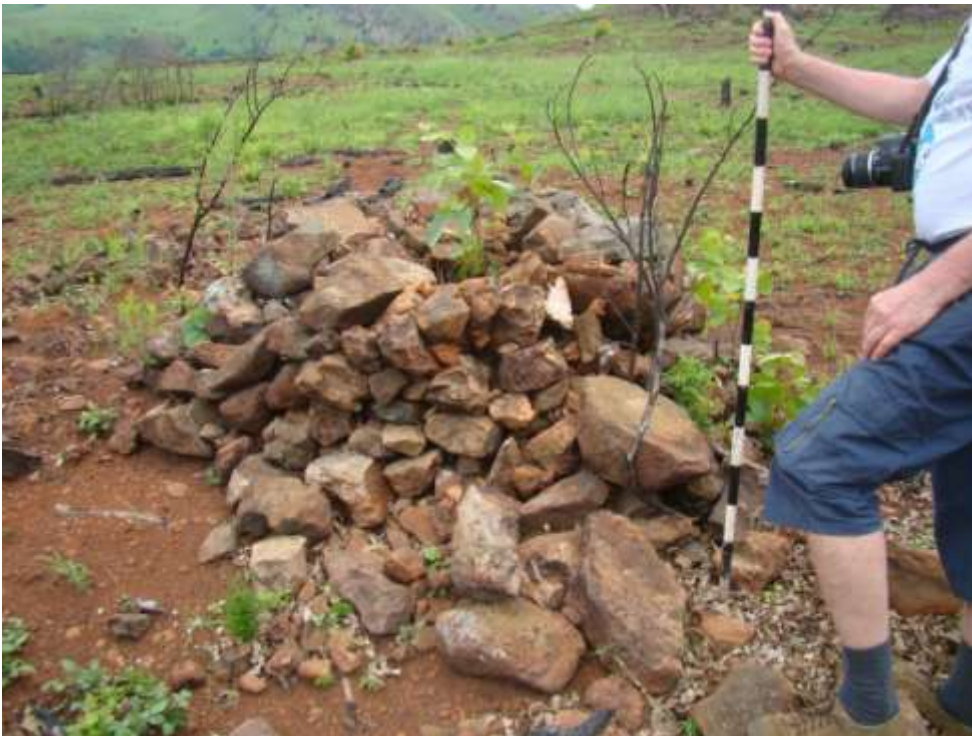
Fig. 239: One of the stone cairns.

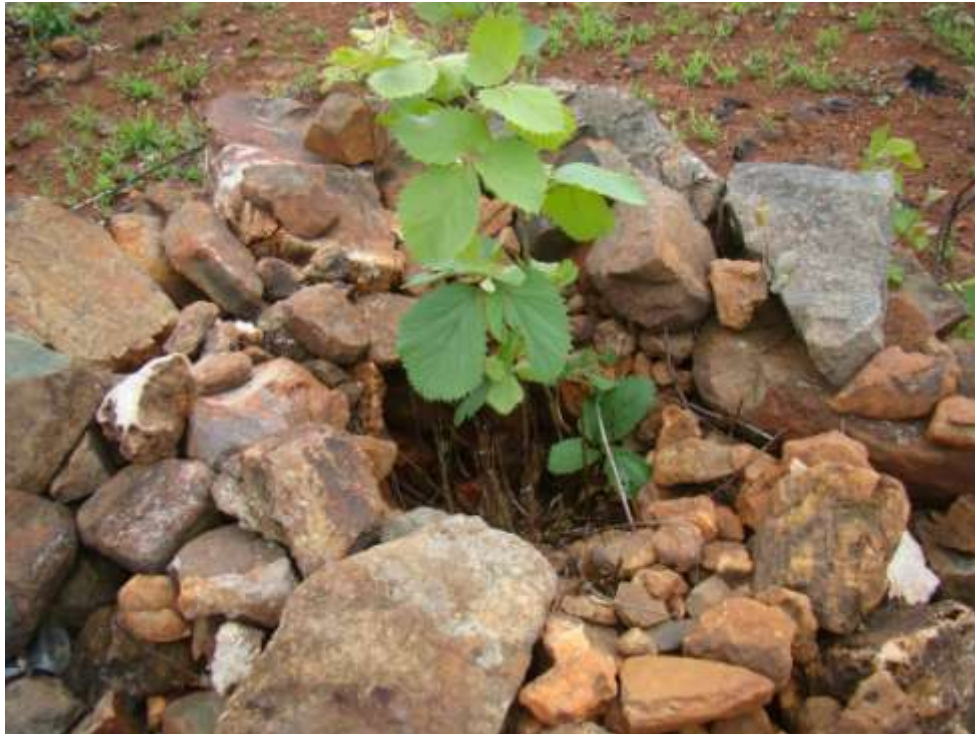
Fig. 240: Detail of the stone cairn.

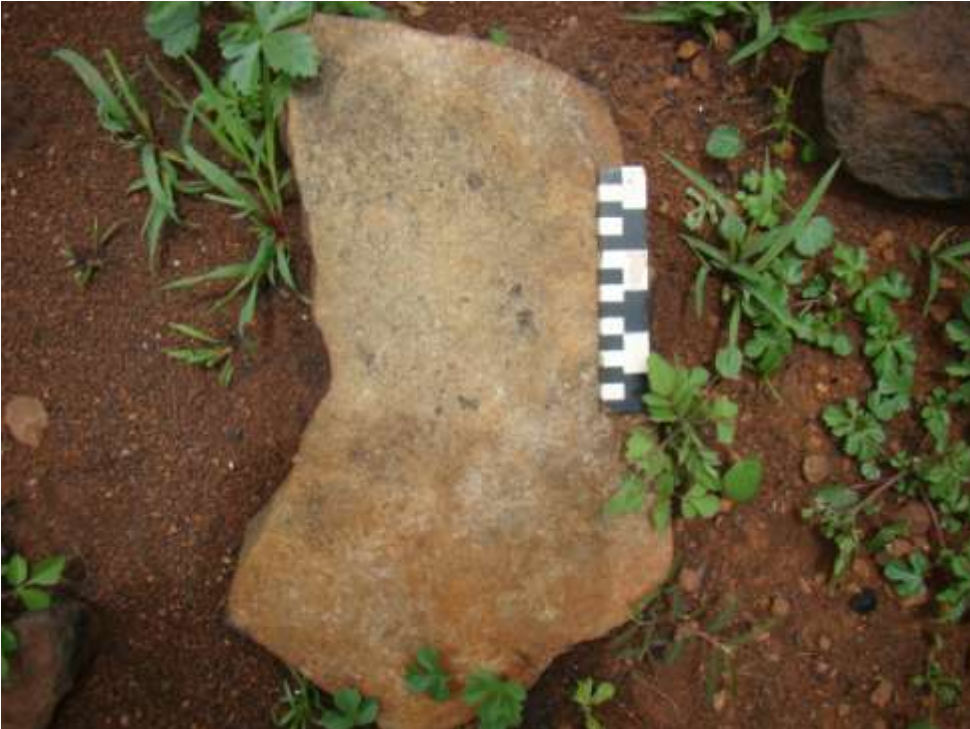
Fig. 245: One of the two broken lower grinders inside C22 – 3.
