## **1st Phase**

**Cultural Heritage Resources Impact Assessment for proposed rapid bus service, Paul Kruger Street, Pretoria, Tshwane.**

**June 2011**

**Report compiled by Sidney Miller and Dr. Udo S. Küsel.**

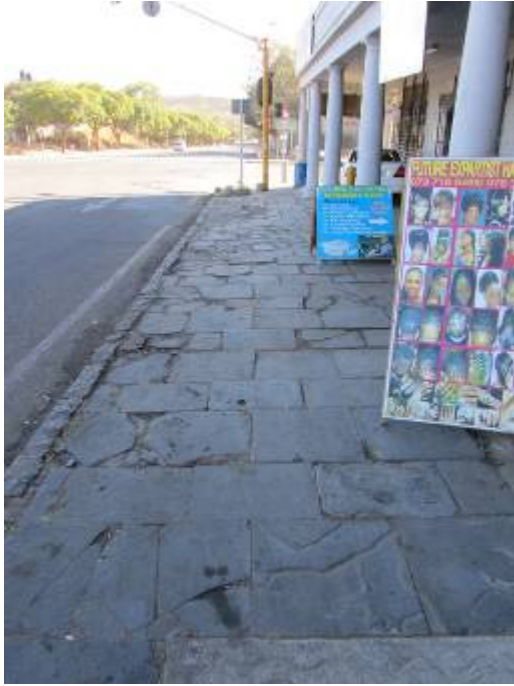
**Figures 27 and 28.** Historical slate sidewalk in front of 'protected building'. Granite curb stone and pillars. (P800, P801)

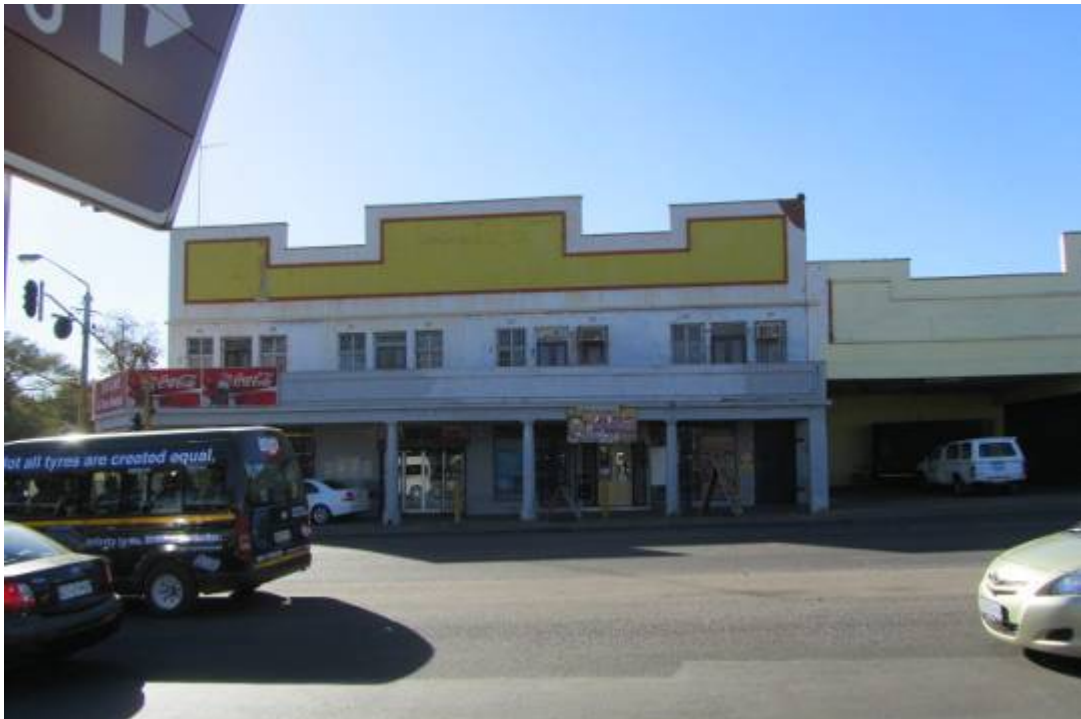
**Figure 32.** ‘Protected building’ (P809). Note absence of greening.

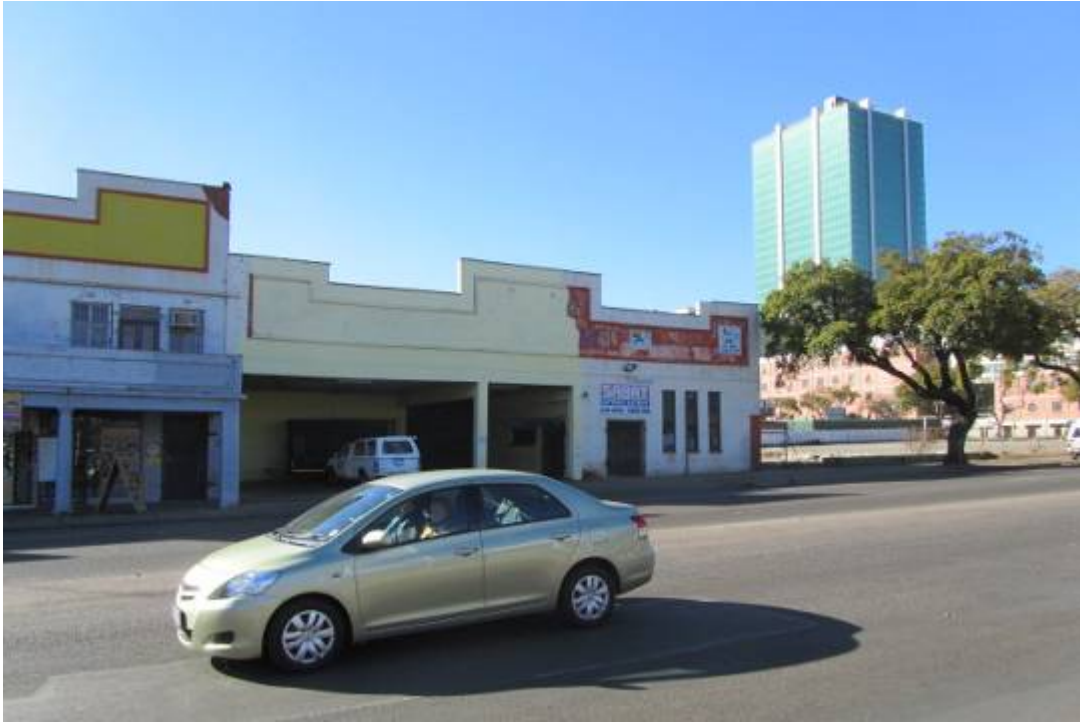
*Figure 33. 'Protected building'. (P810). Note demolition through neglect. Total pressed steel ceiling collapse is imminent. No shop front, windows or doors.*

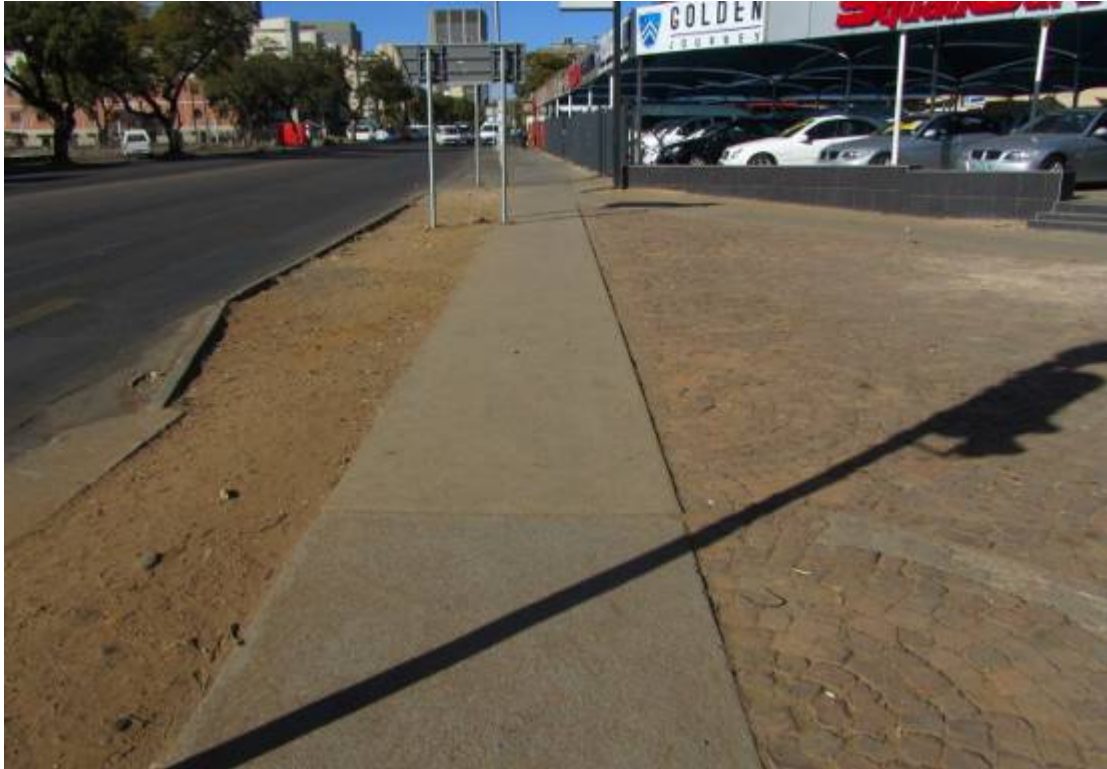
**Figure 35.** Modern sidewalk in front of ‘protected building’. (P807)

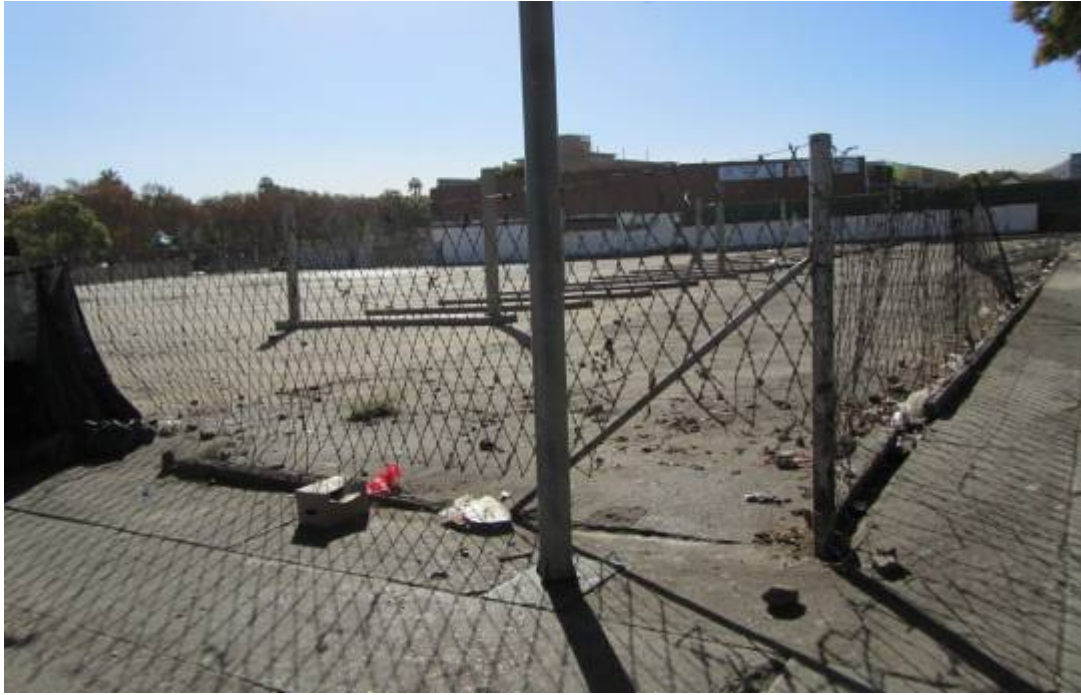
**Figure 40.** *Unused land. Possible Taxi terminus as before. (P817)*

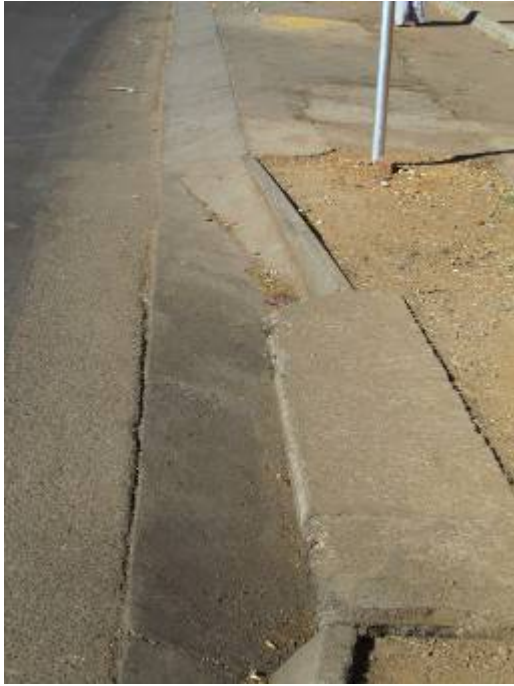
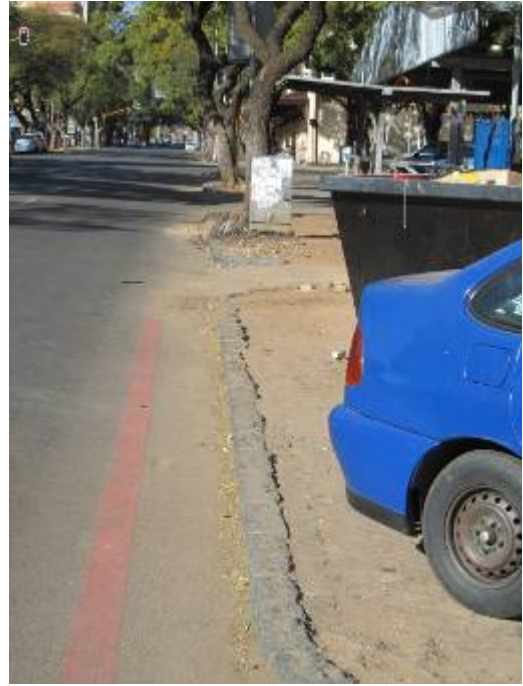
**Figures 51 and 52.** *Curbing along the first, and middle to end section of the western sidewalk in block 2. A section of the sidewalk was sacrificed for parking. (P826 and P 827).*

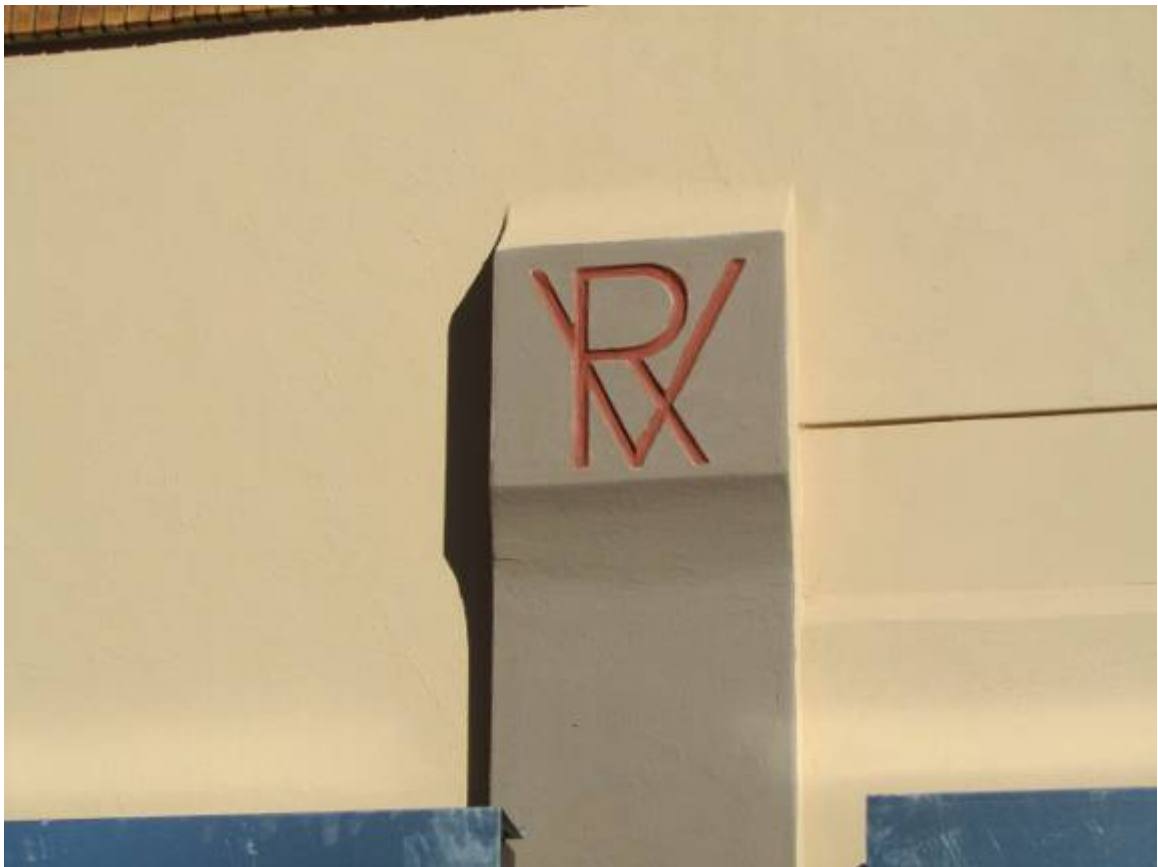
**Figure 53.** *All that remains of the 'face' of this protected building. (P 828)*

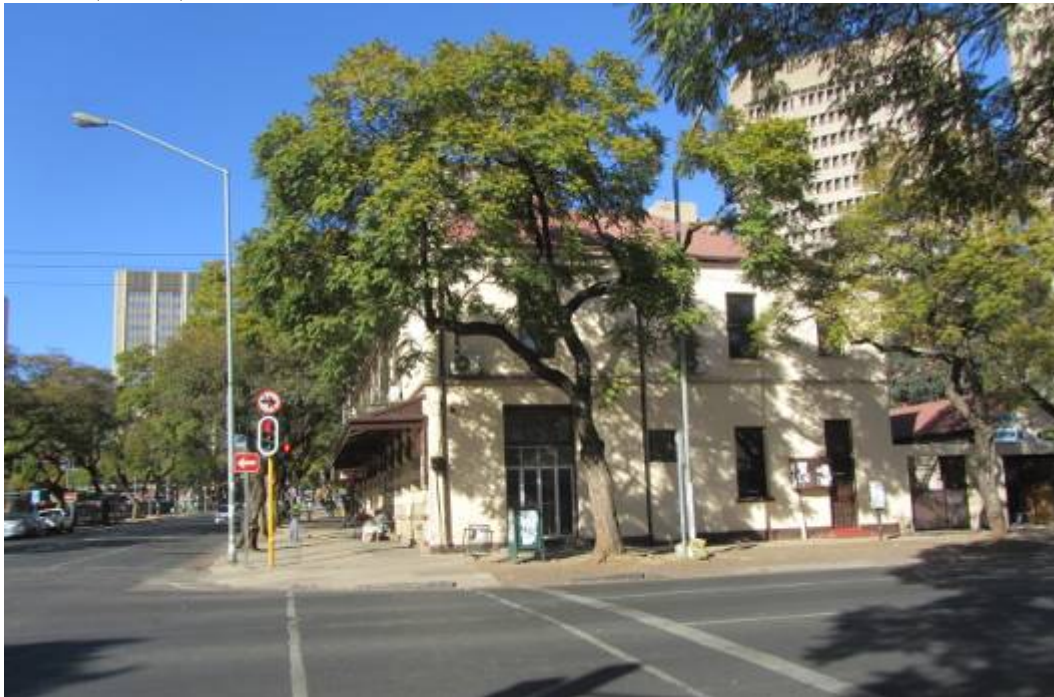
**Figure 57.** *'Protected building', (the Panagos shop) that has been around for one and a quarter century. Sadly the system of demolition through gutting, and neglect of maintenance, is a cancer that is destroying the historical buildings of Pretoria in Tshwane (P 833)*

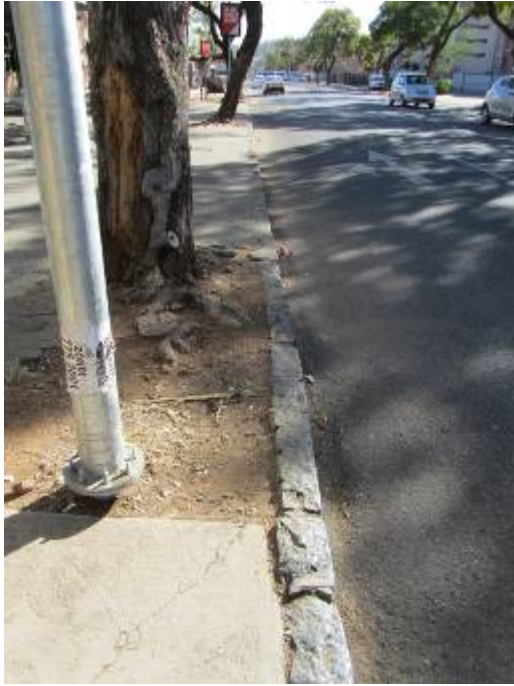
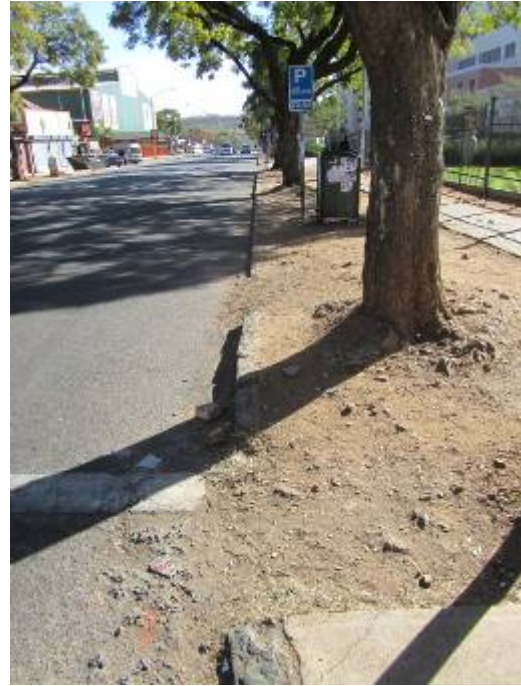
**Figures 58 and 59.** Granite curbing. The exposed and uplifting roots of the Jacaranda trees may pose some design challenges for the paving application. (P834 and P 836).

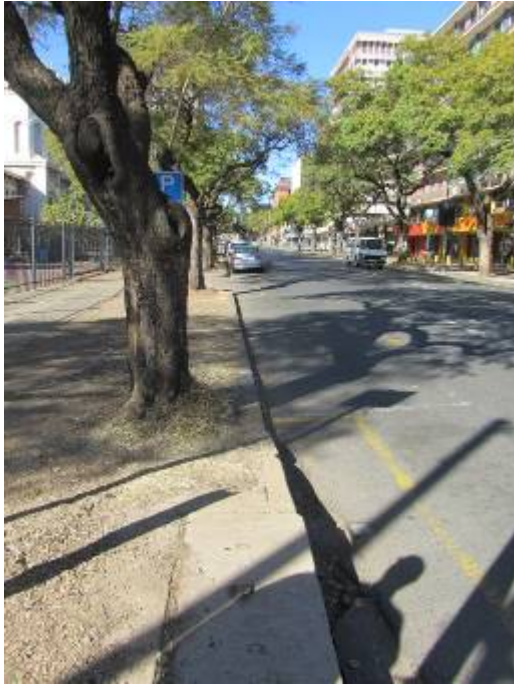
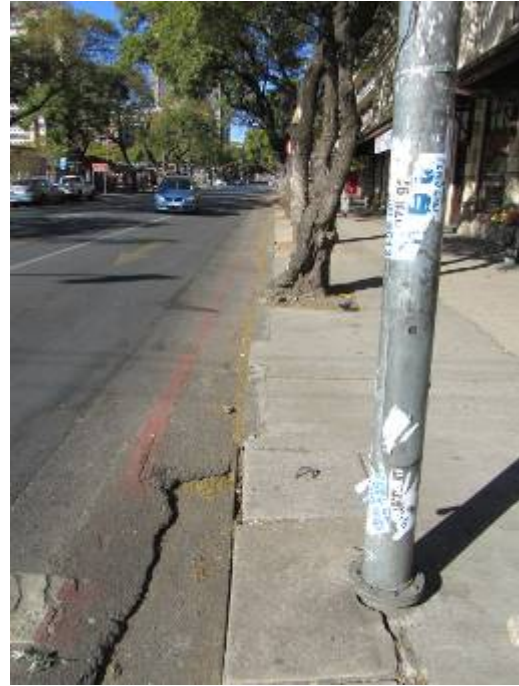
**Figures 69 and 70.** Granite curbing defining old roadway dimensions both on north eastern and north western sidewalks. Concrete strips are the main paving agent but offers little practical access to services. The exposed and uplifting roots of the Jacaranda trees may pose some design challenges for the paving application. (P850 and P 851).

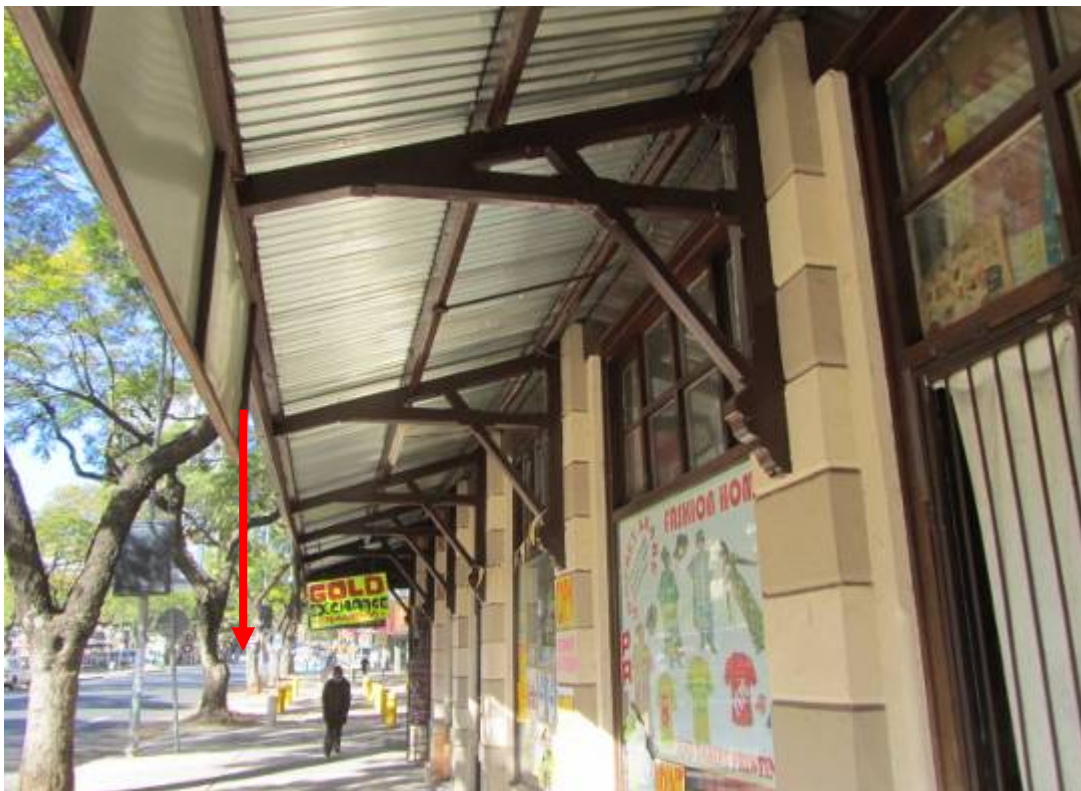
**Figure 71.** 'Protected building'. Note definition of original sidewalk by cantilevered canopy. (P 853)

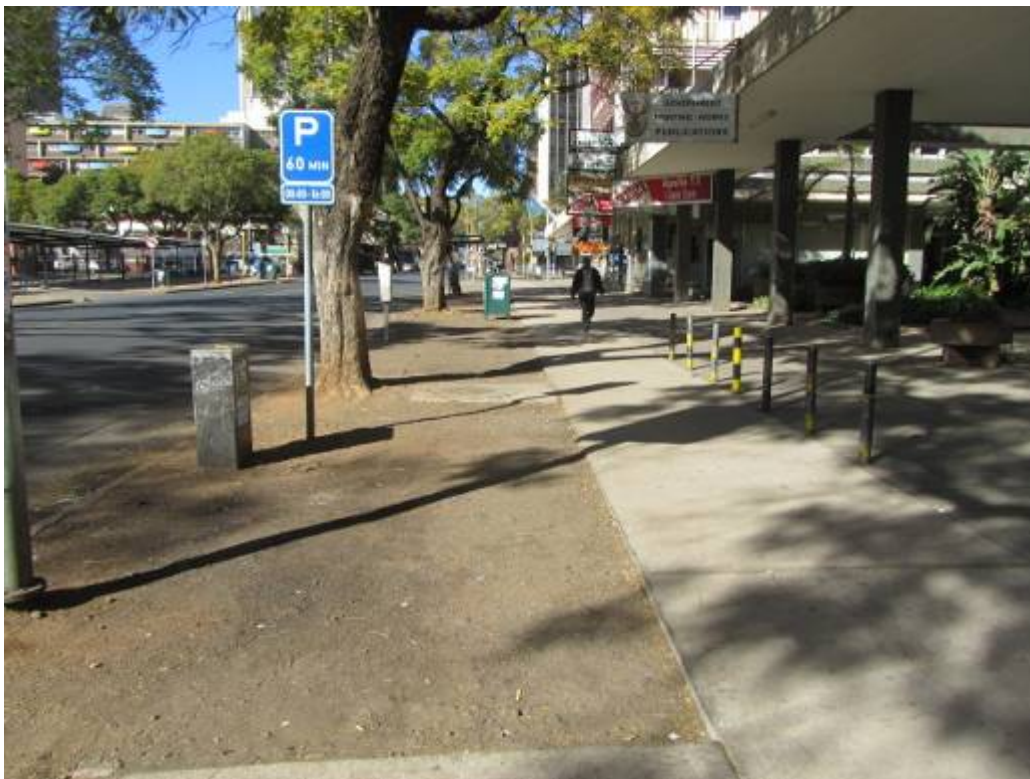
*Figure 75. 'Provisionally protected building'. Strip concrete and bare earth sidewalk. (P 860).*

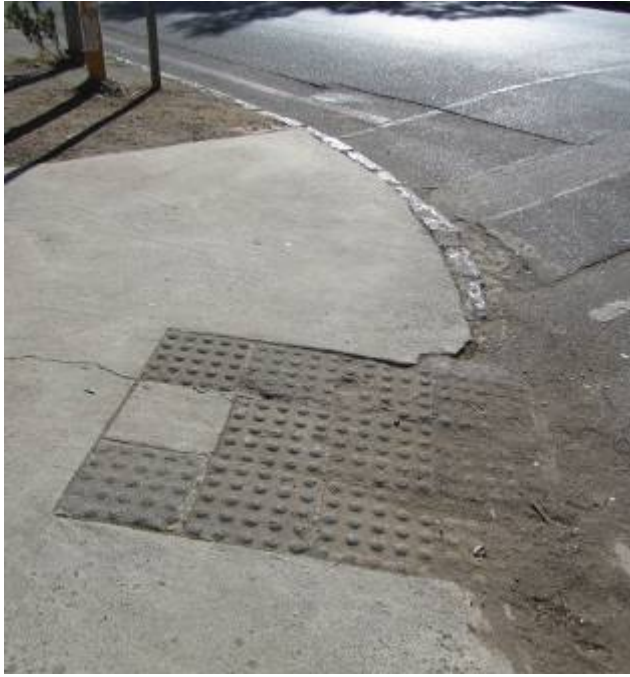
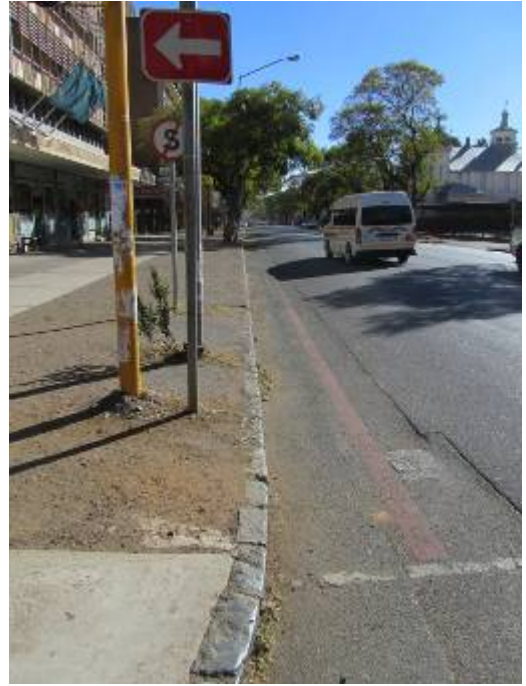
*Figures 80 and 81. Granite curbing defining old roadway. This access for disabled people shows that this practice will have to be continued throughout the design. (P867and P 868)*

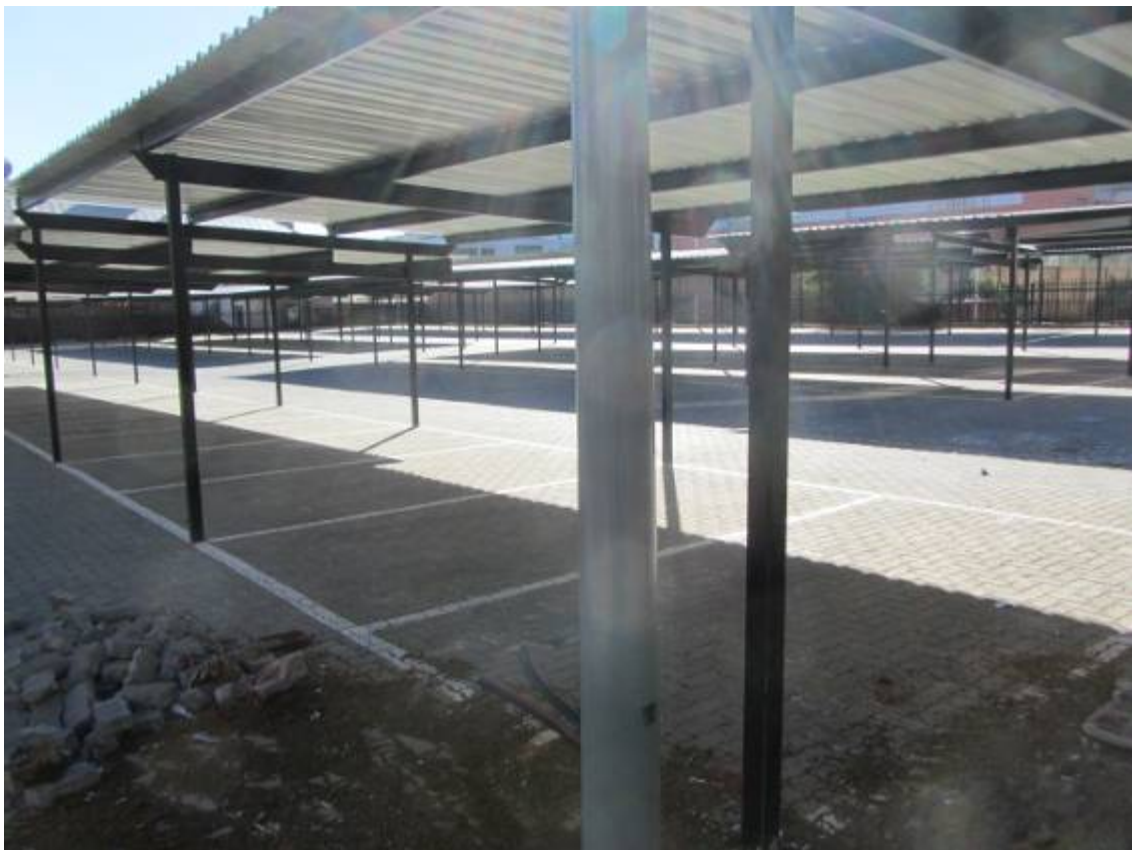
*Figure 86. 'Parking?'. (P 876).*

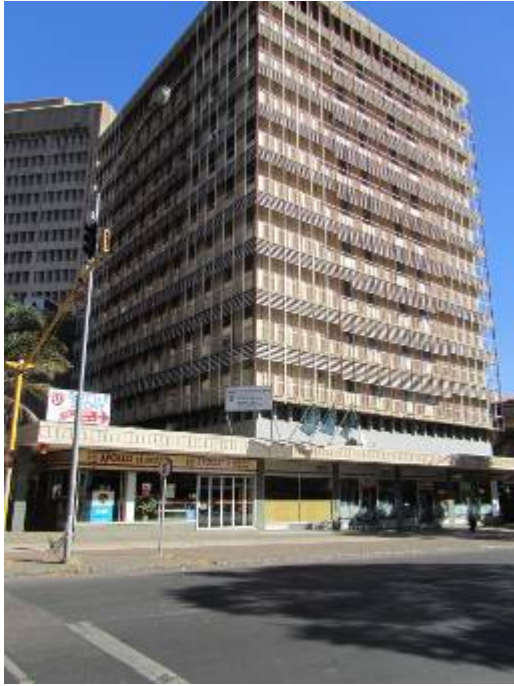
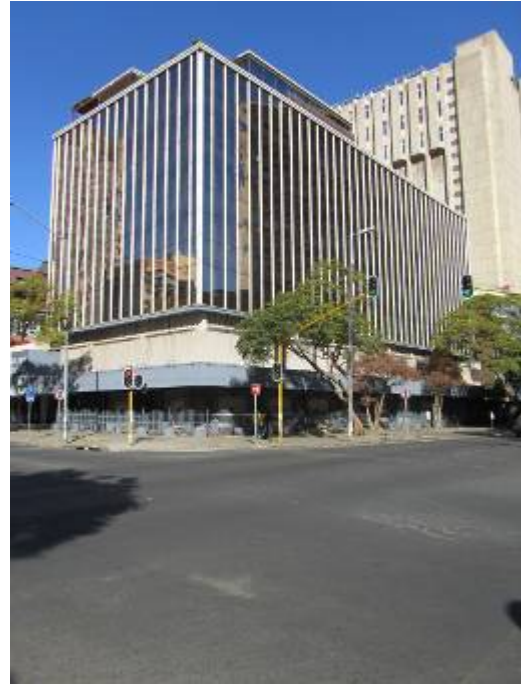
*Figures 87 and 88. 'Provisionally protected buildings'. Note loss of greening in first figure. (P872 and P 873).*

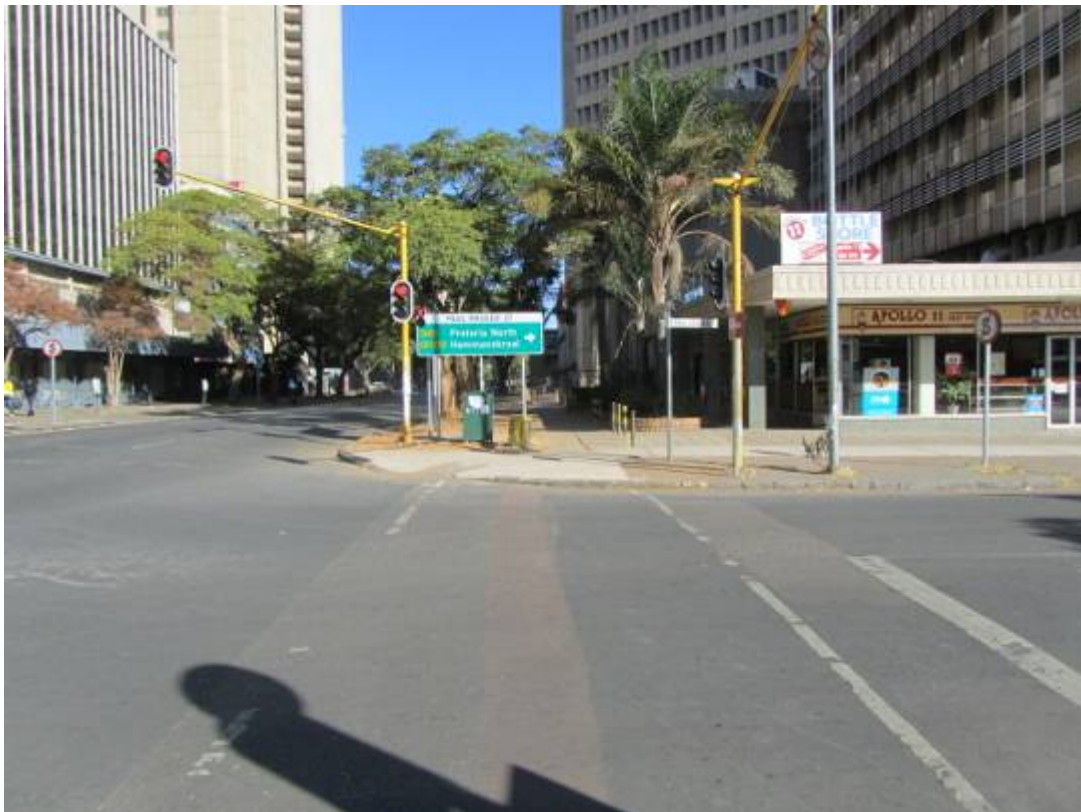
*Figure 89. Typical intersection, showing complex format of levels for road continuity and water drainage. (P 865).*

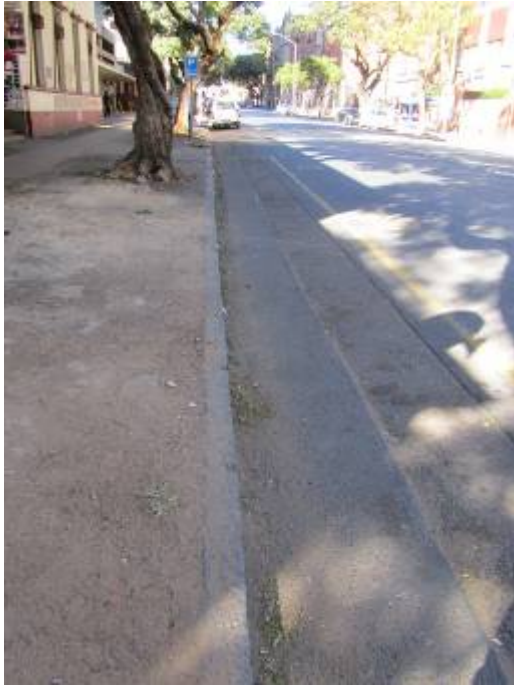
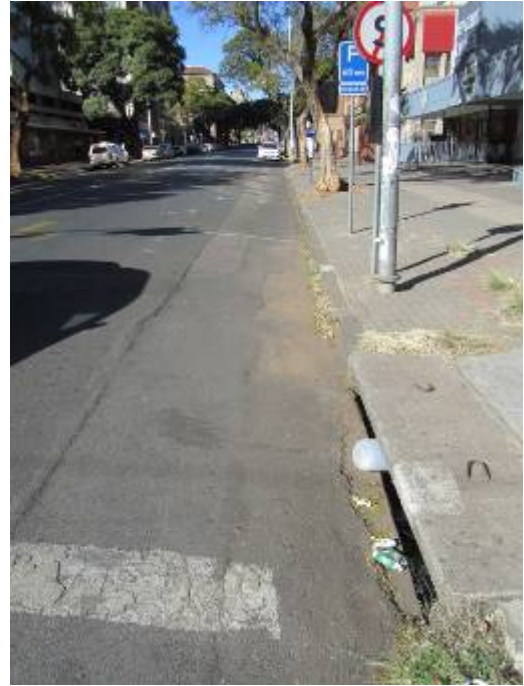
*Figures 97 and 98. Granite curbing defining old roadway. (P883 and P 887).*

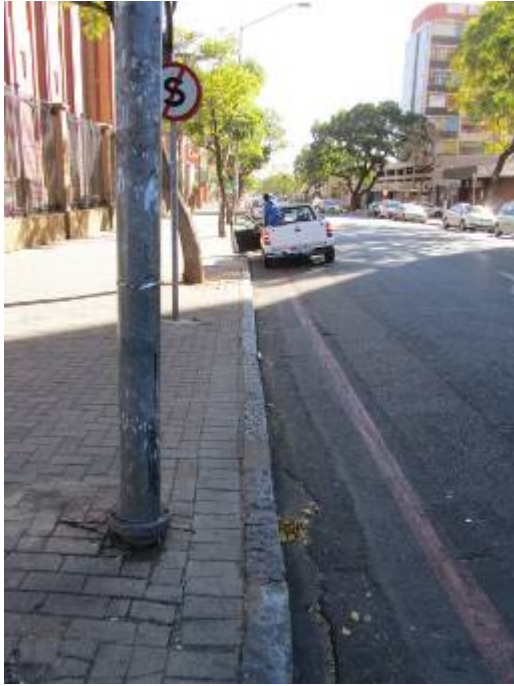
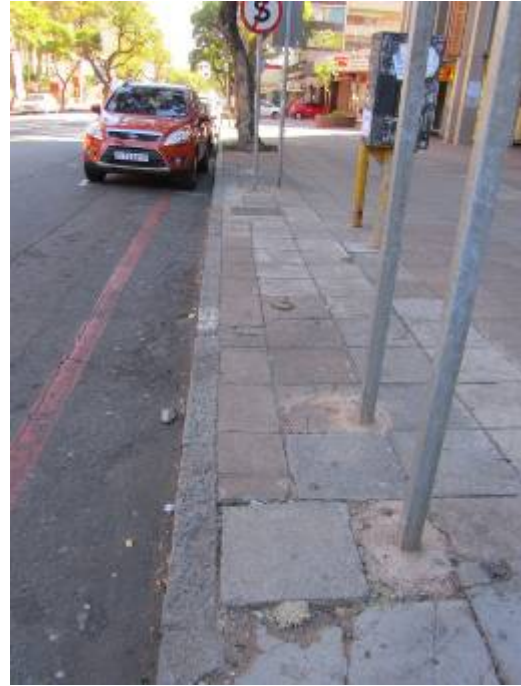
*Figures 109 and 110. Granite curbing defining old roadway. (P907 and P 909).*

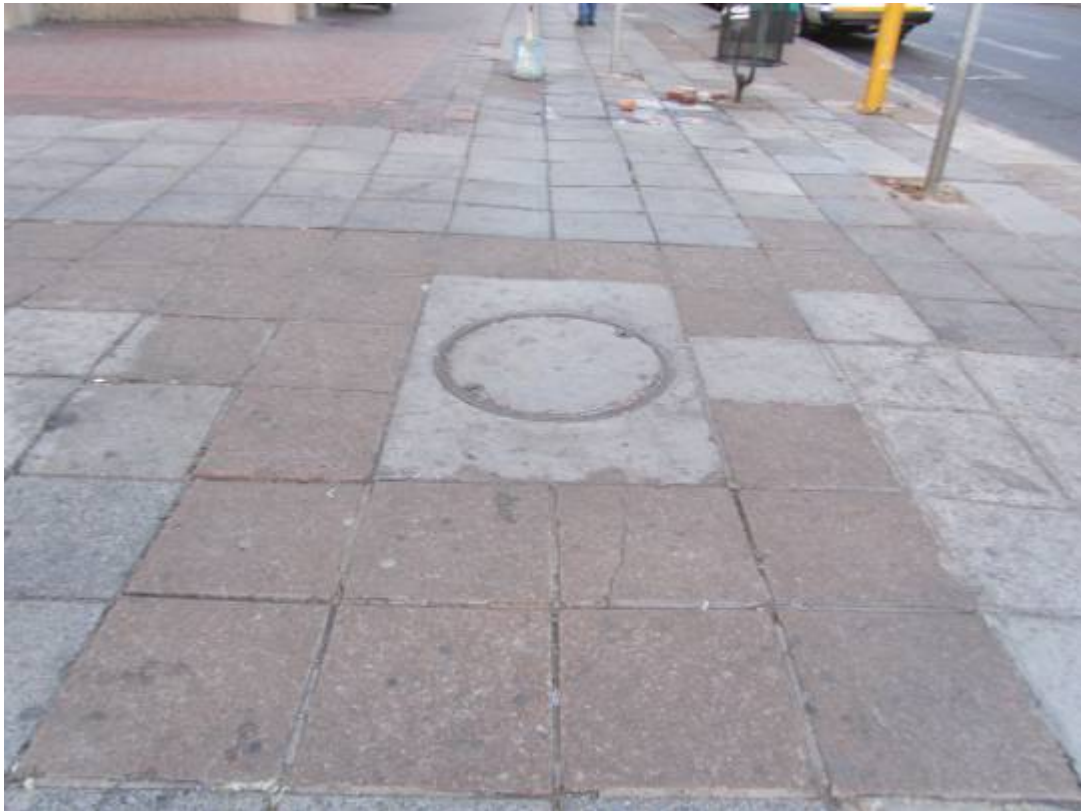
*Figure 111. 'Services and access to services will determine much about the character of new paving. (P 908).*

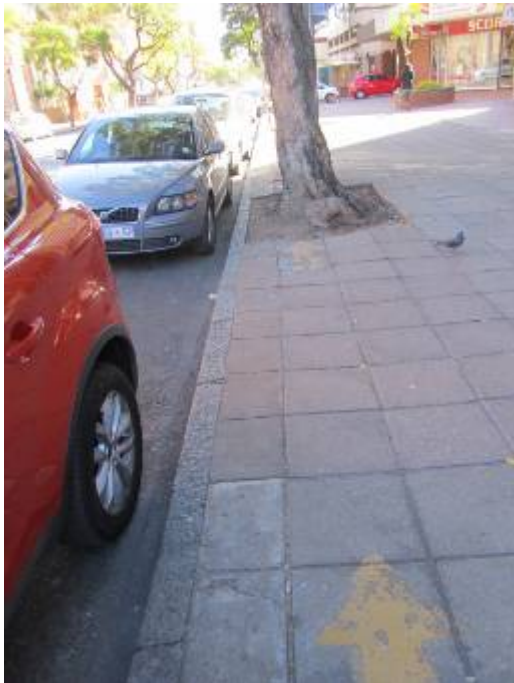
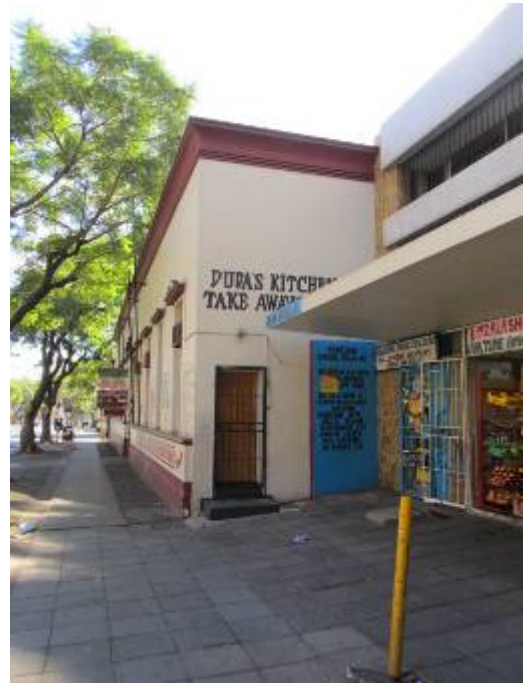
*Figures 115 and 116. Granite curbing defining old roadway and cement block paving. . (P914 and P 919).*

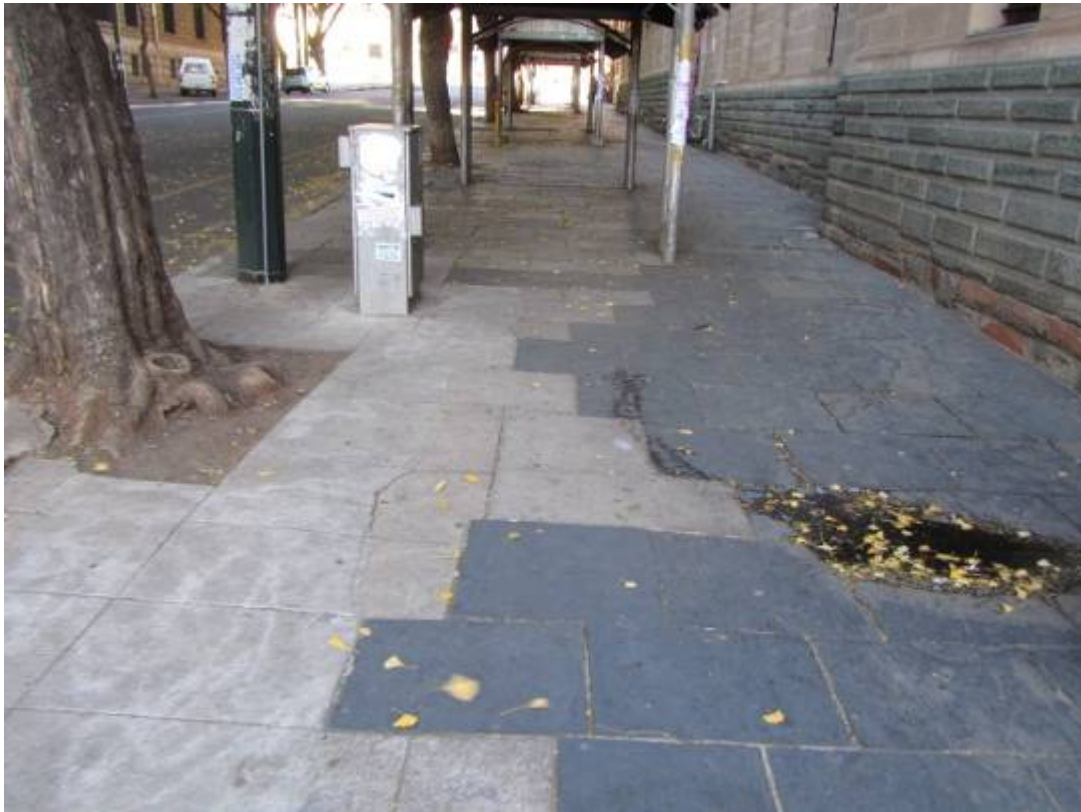
**Figure 129.** Concrete interruption in historic slate paving. (P 929).

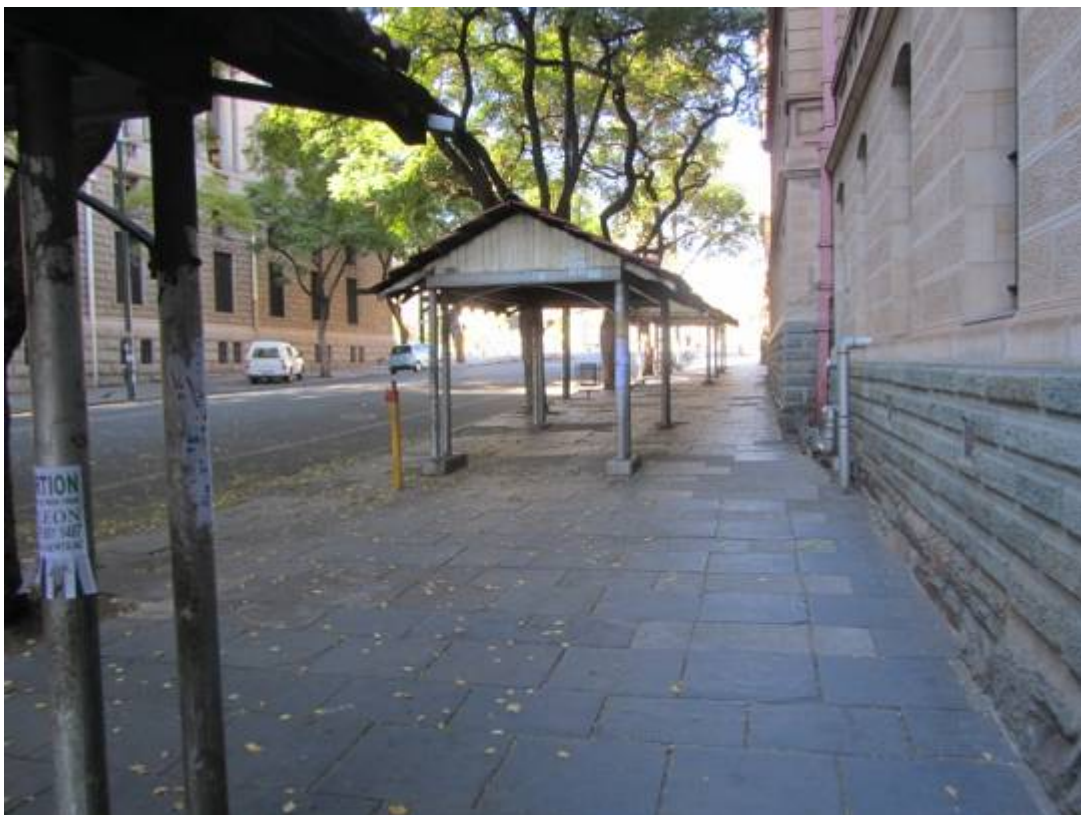
**Figure 130.** Concrete interruption in historic slate paving. (P 932).

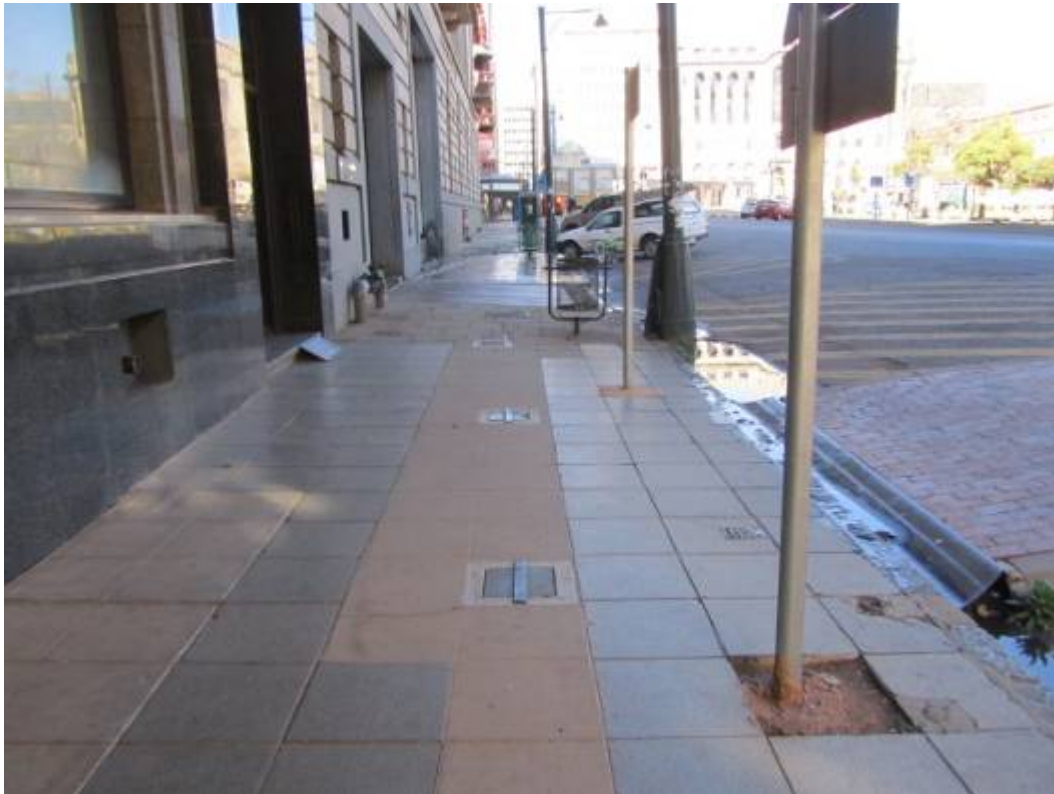
***Figure 151. Cement block paving adjacent to historical building. (P 954).***

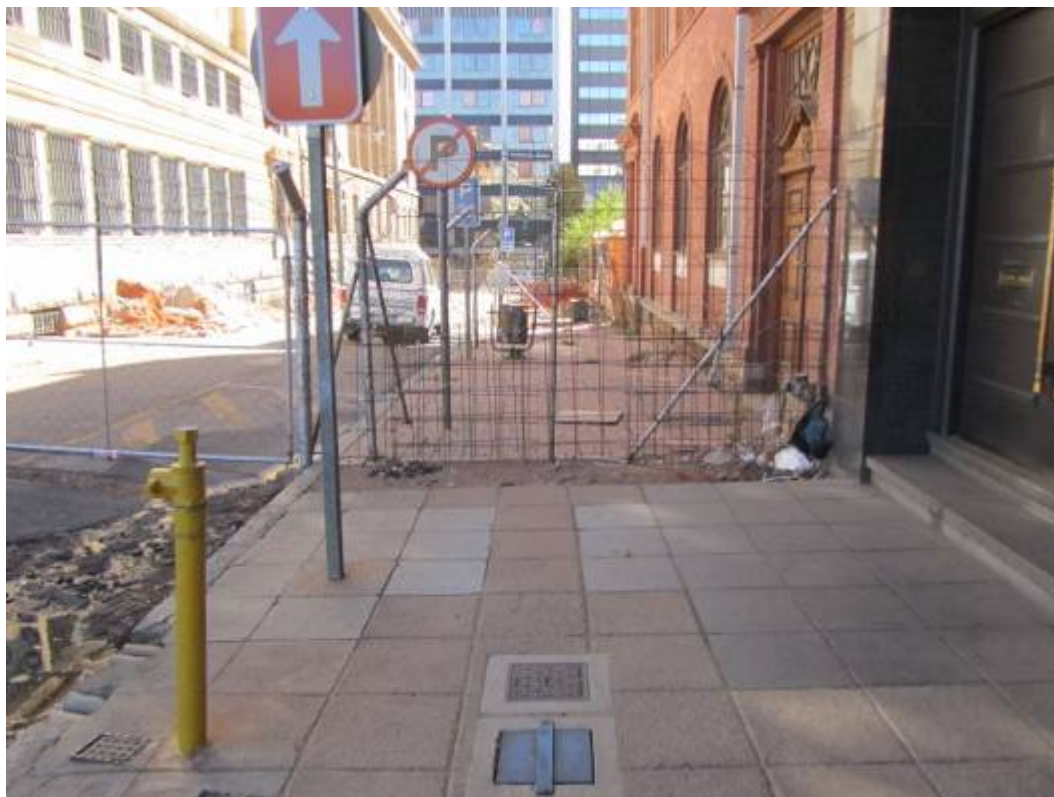
***Figure 152. Construction work in historical street . (P 955).***

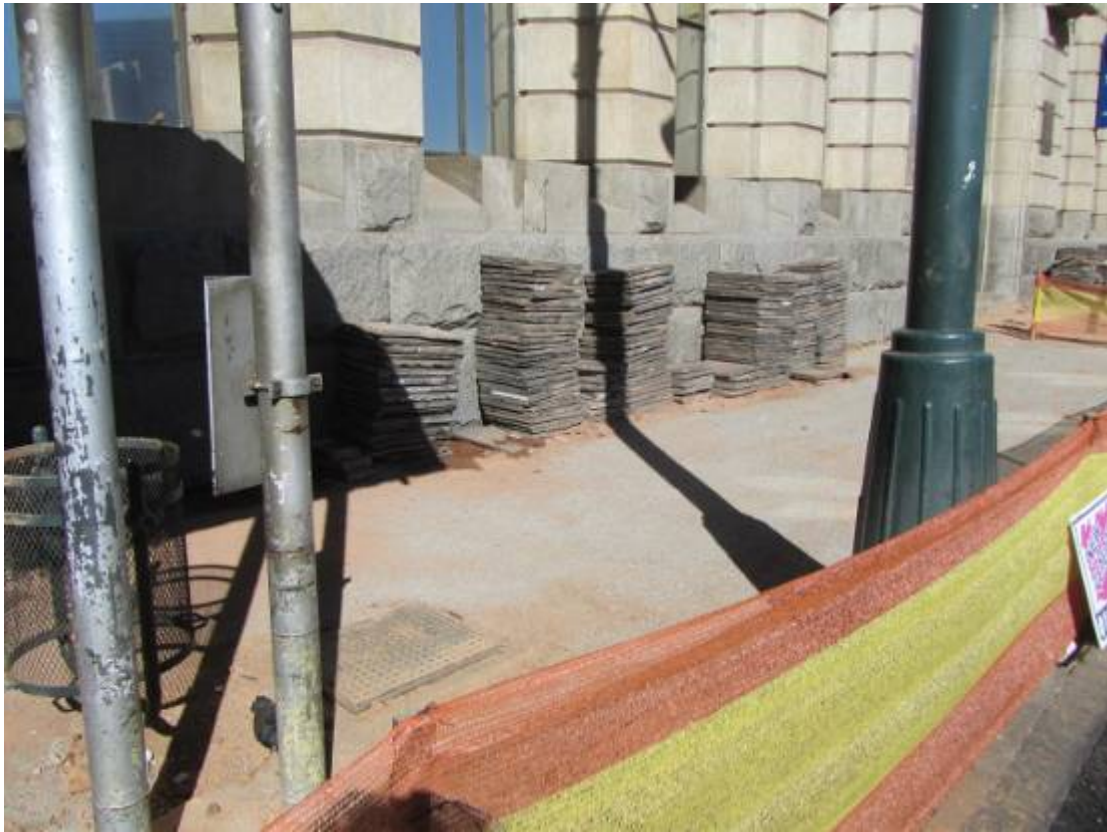
*Figure 174. Slate paving in front of historical building being lifted. (P 977).*

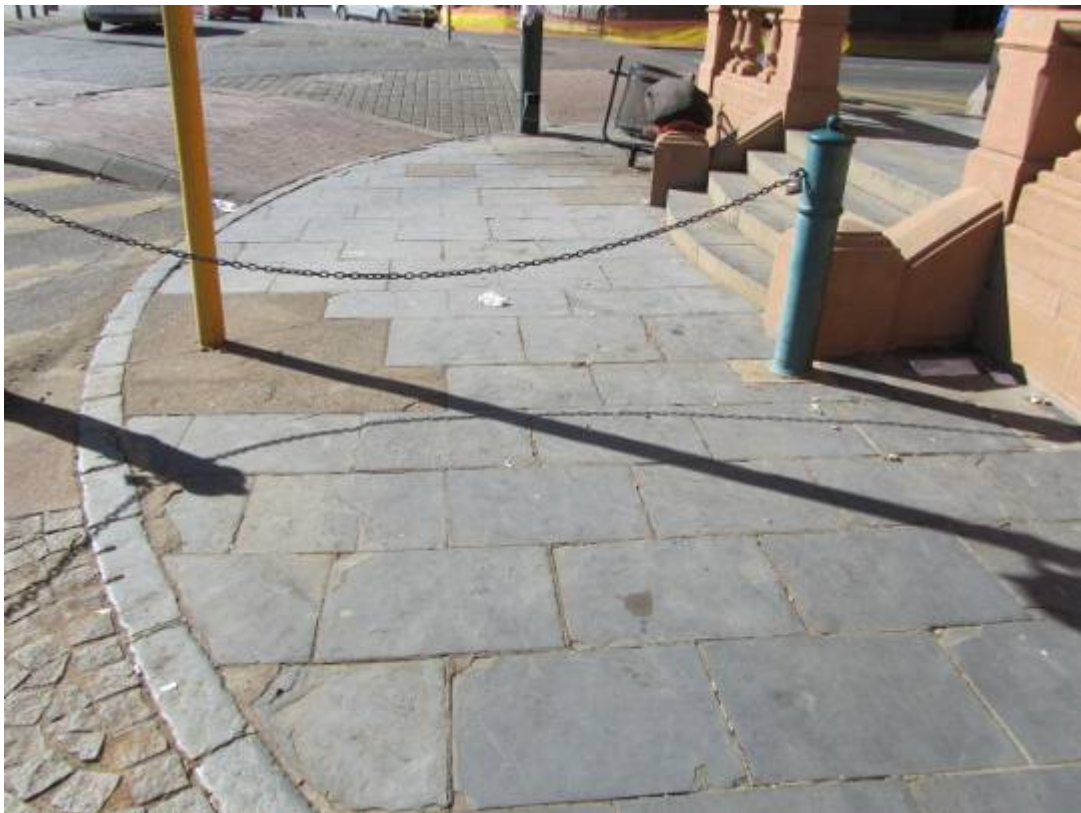
**Figure 181.** An array of paving materials in front of a historical building. (P 984).

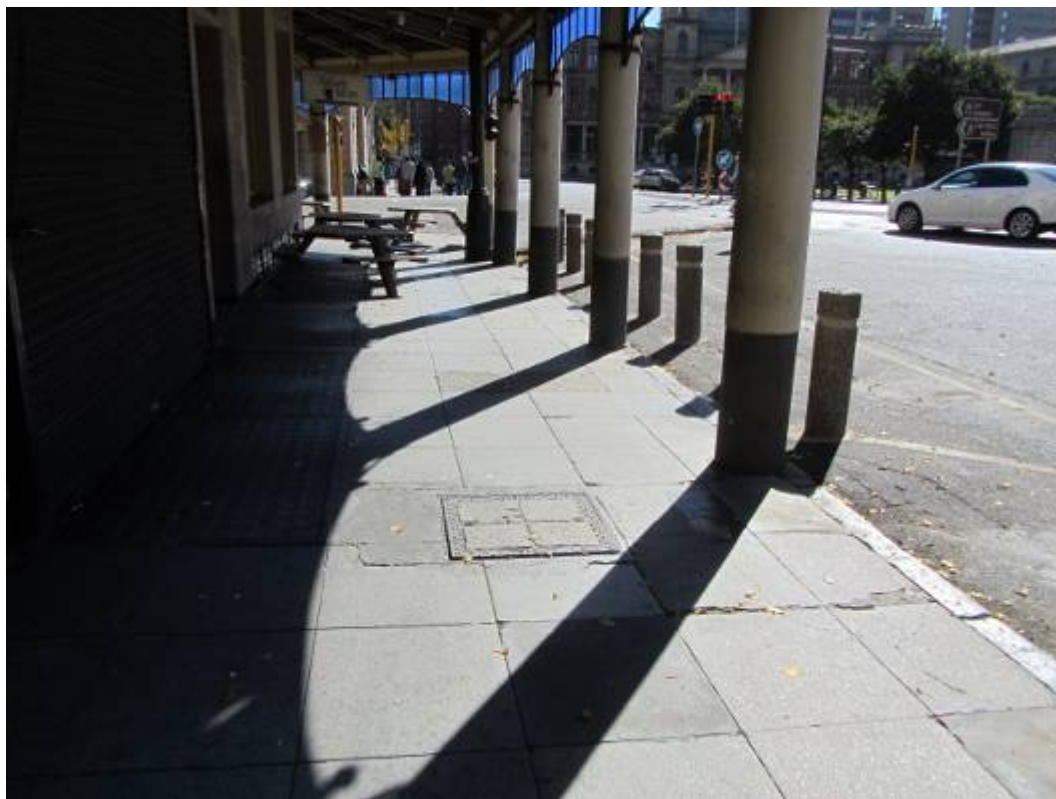
*Figure 192. Large cement blocks as paving adjacent to historical building. (P 995).*

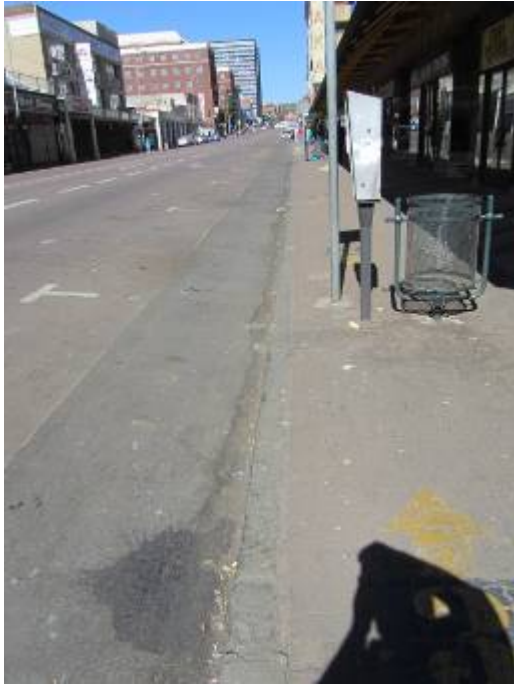
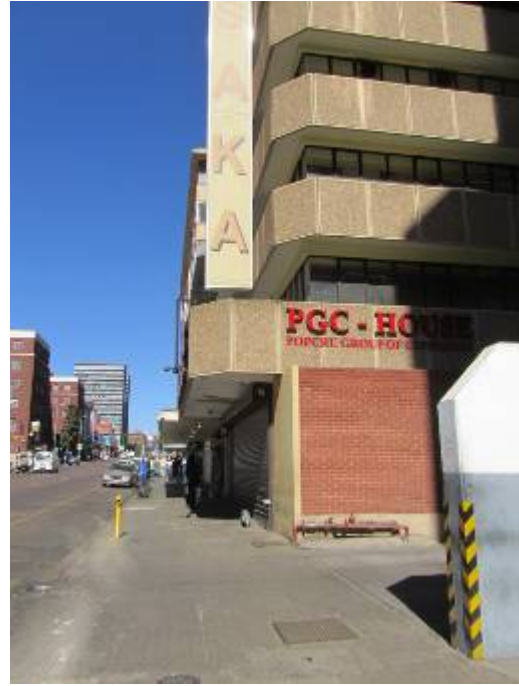
*Figures 216 and 217. Cement block paving and granite curbing defining old roadway. (P 1016 and P 1020).*
