## **1st Phase**

**Cultural Heritage Resources Impact Assessment for proposed rapid bus service, Paul Kruger Street, Pretoria, Tshwane.**

**June 2011**

**Report compiled by Sidney Miller and Dr. Udo S. Küsel.**

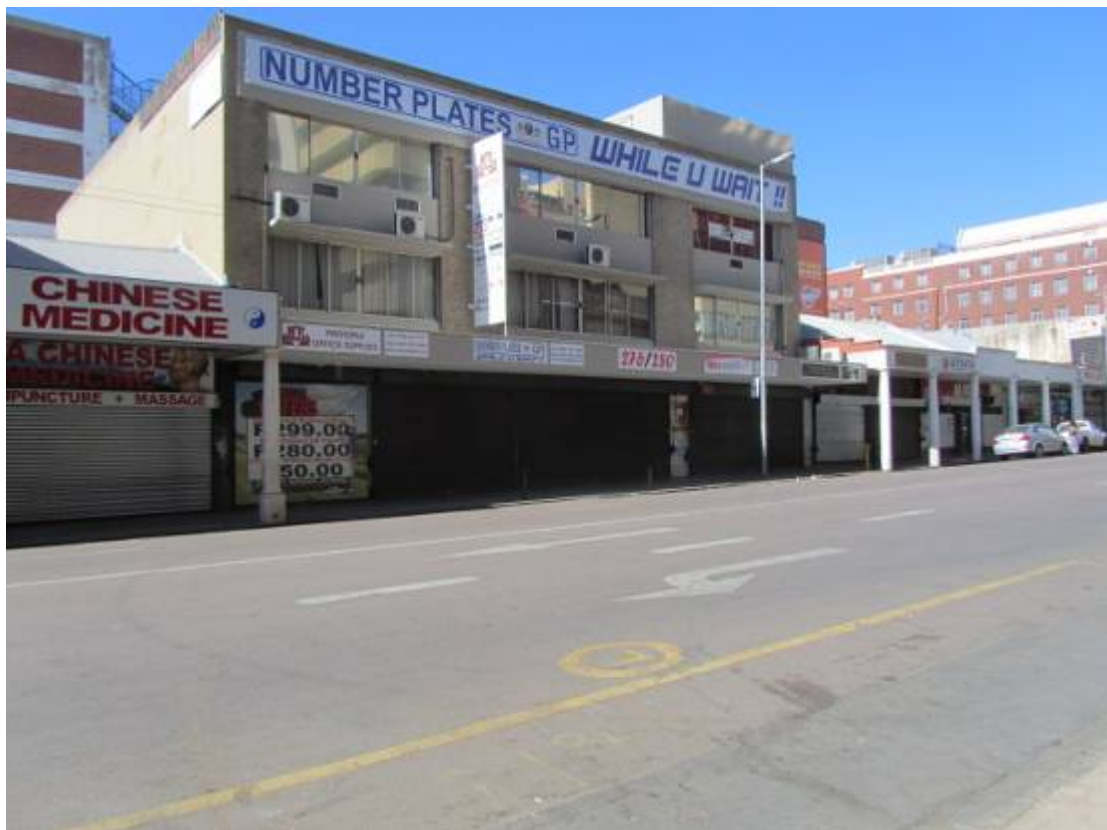
*Figure 219. Protected buildings. (P 1018)*

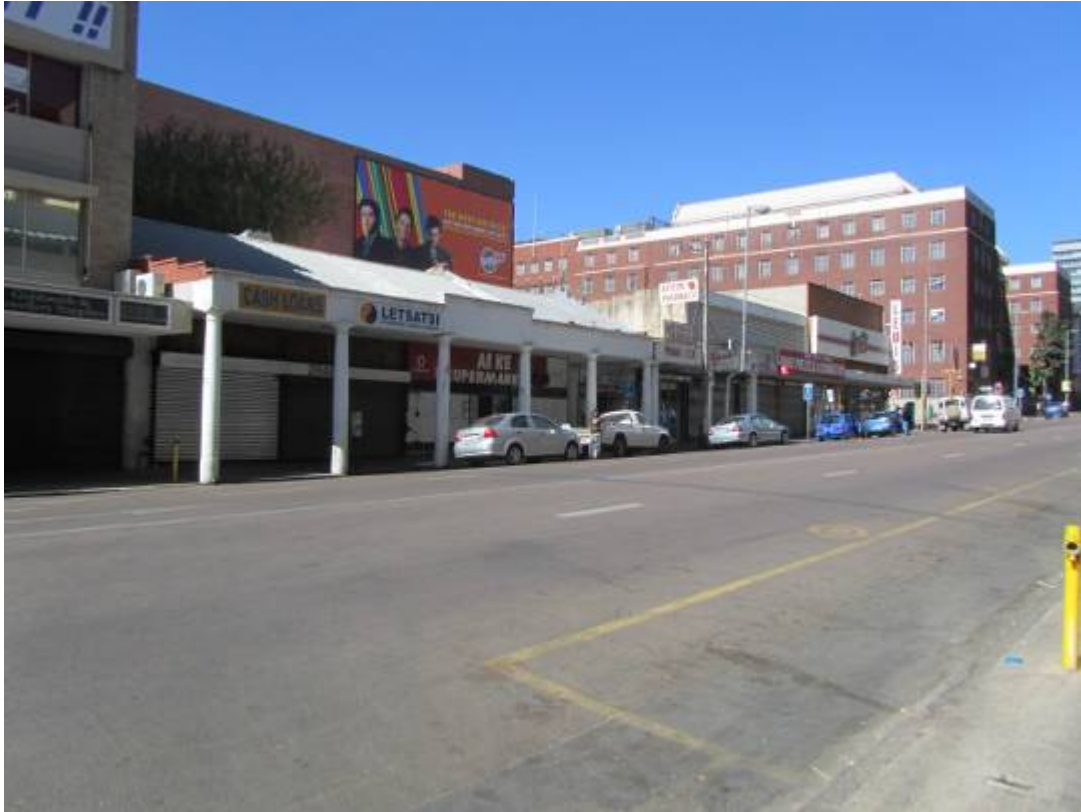
*Figure 220. Provisionally protected buildings. (P 1019)*

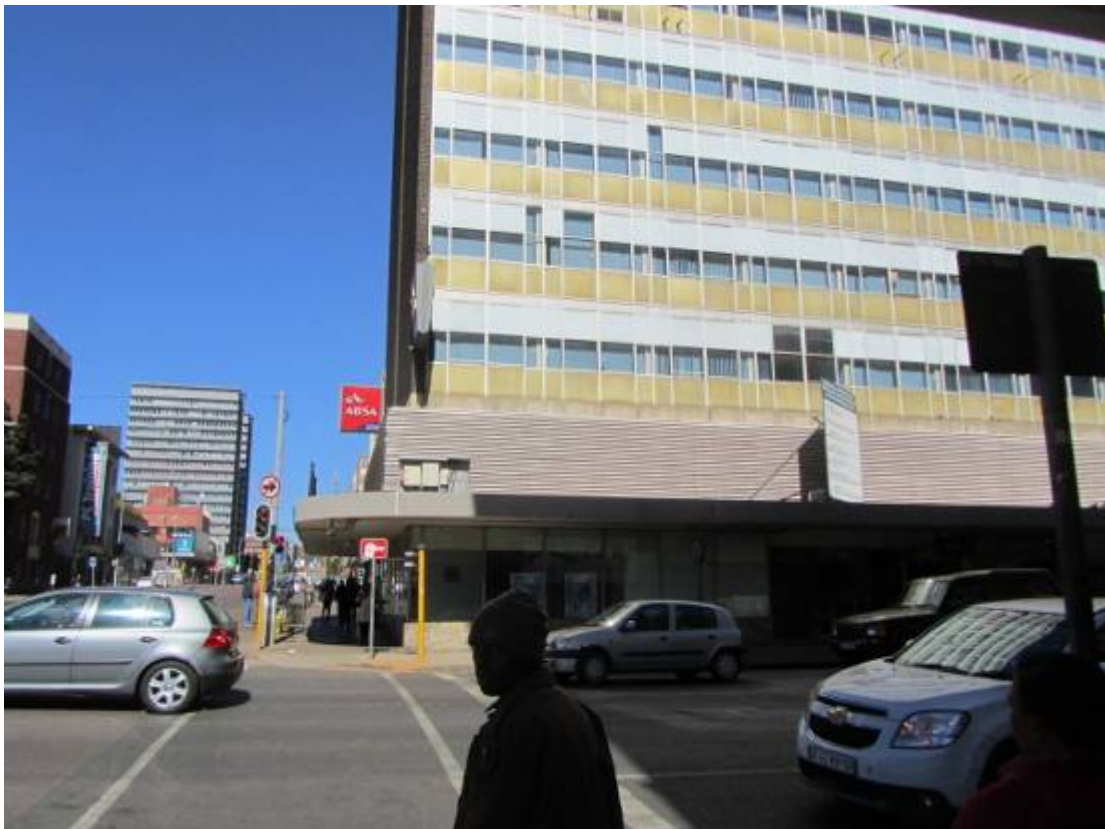
*Figure 224. Cement block paving, remnants of historical slate paving and granite curbing defining old roadway. (P 1024)*

13.3 All, or most of the historical curbing and paving, must be retained or replaced in-situ.

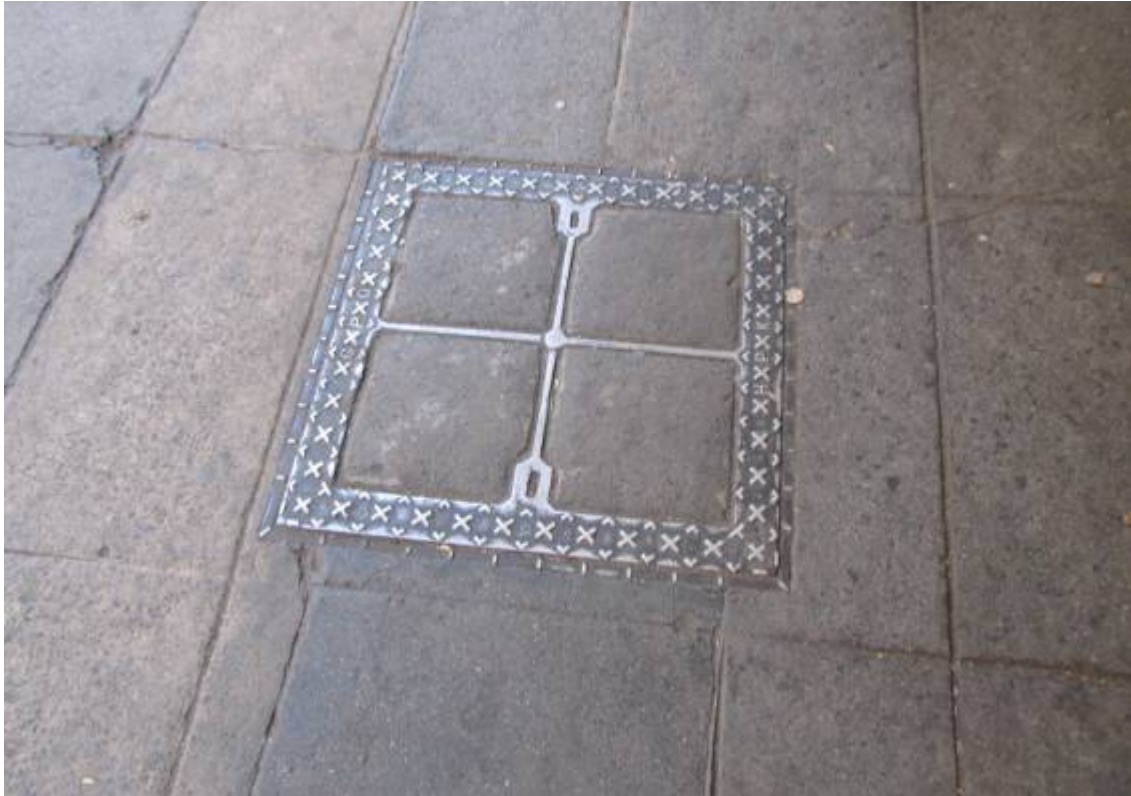
*Figure 234. Variety of paving material and historical pillar footprint. Note Granite curbing. (P 1034)*

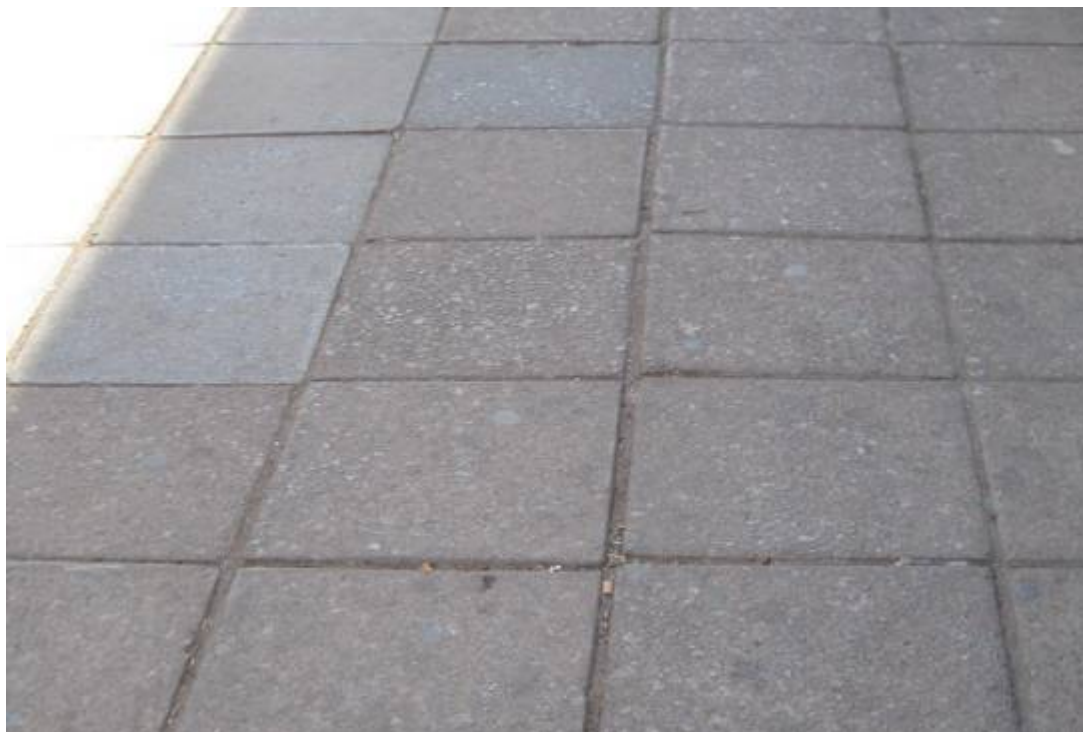
*Figure 239. Protected building. (P 1036)*

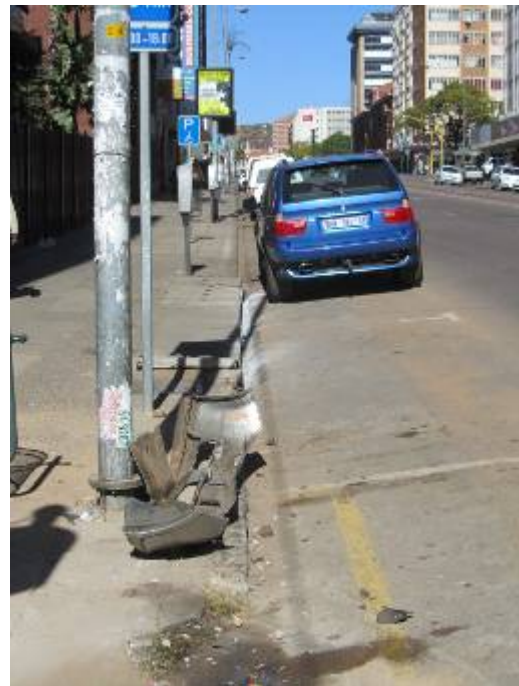
**Figures 242 and 243.** Provisionally protected building, and cement block paving and granite curbing defining old roadway. (P 1040 and P 1041).

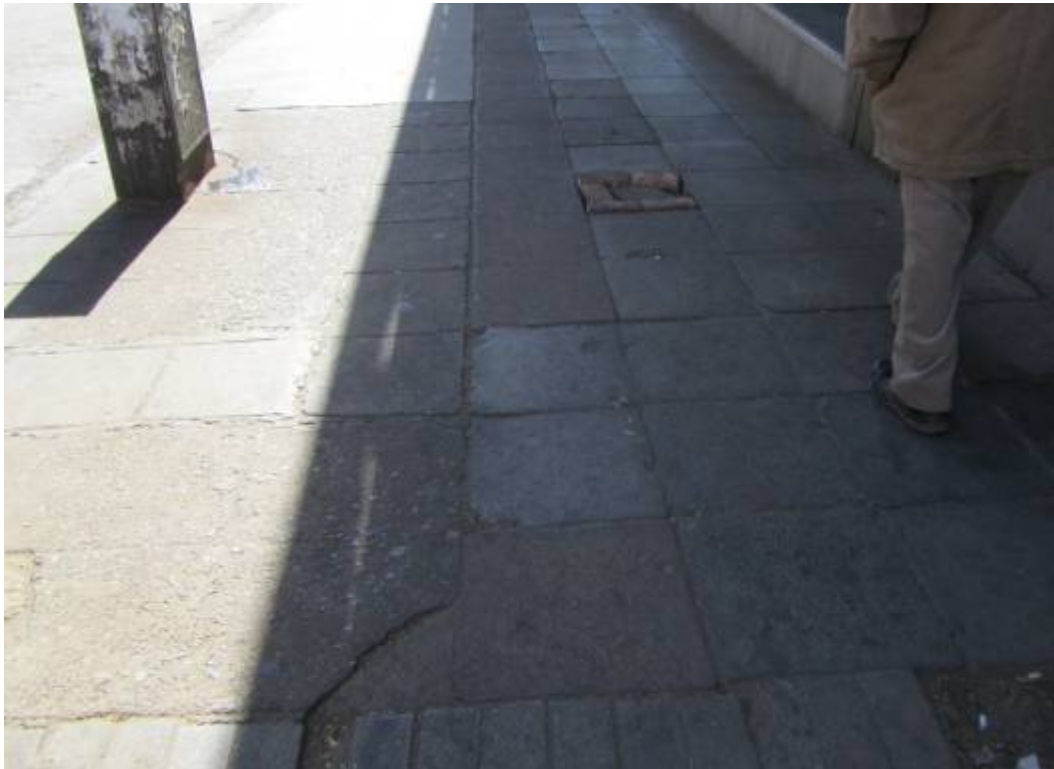
*Figure 255. Modern paving and curbing possibly associated with widening of Skinner Street. (P 1054)*

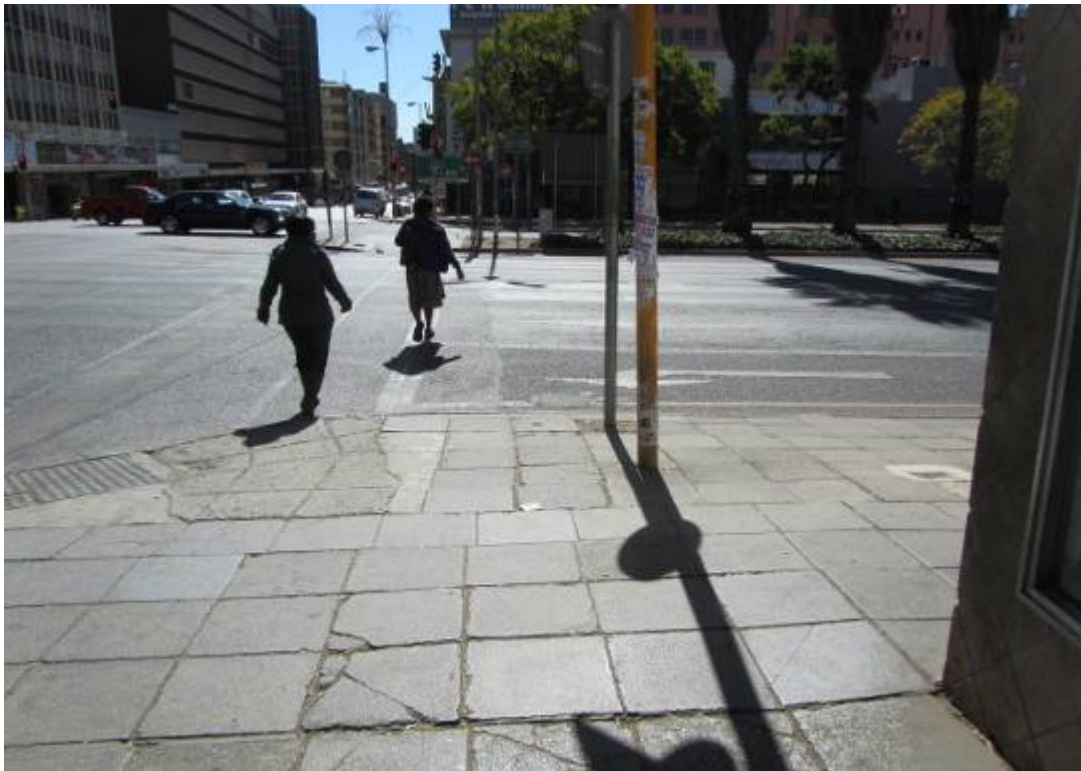
*Figure 265. Variety of paving materials. Note that some worker in the past tried to make the strip concrete match the paving blocks. (P 1062)*

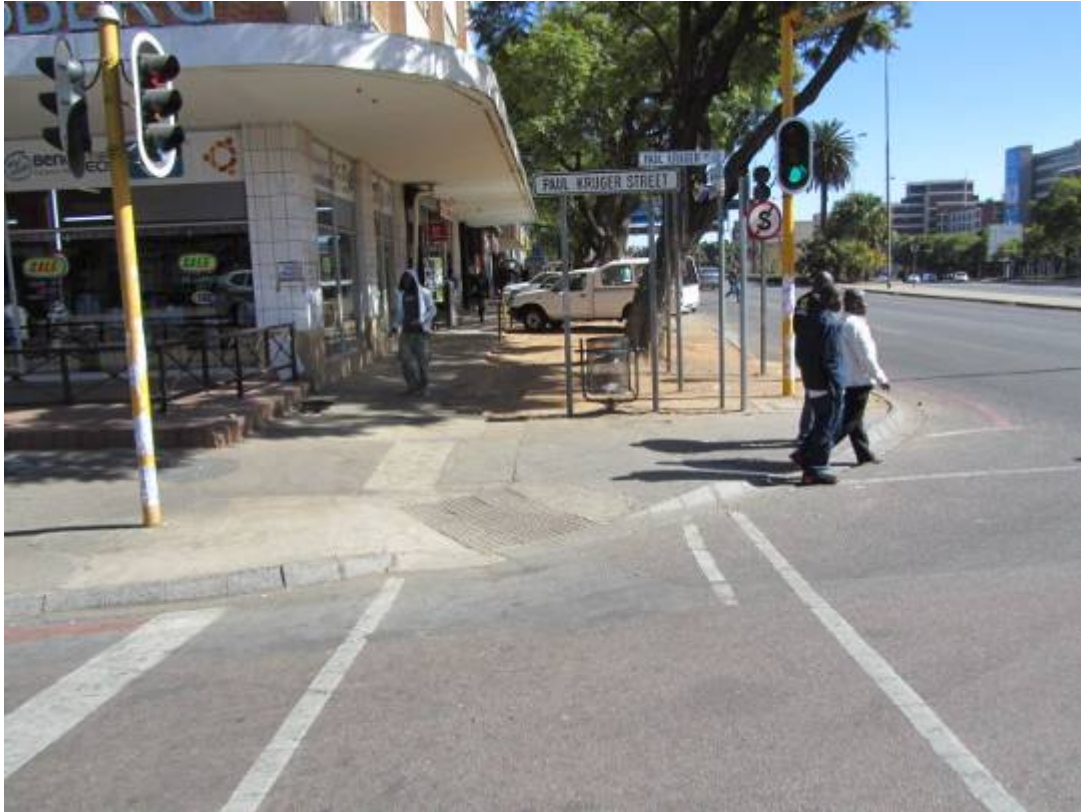
**Figure 268.** These trees will have to make way for the bus terminus. (P 1066)

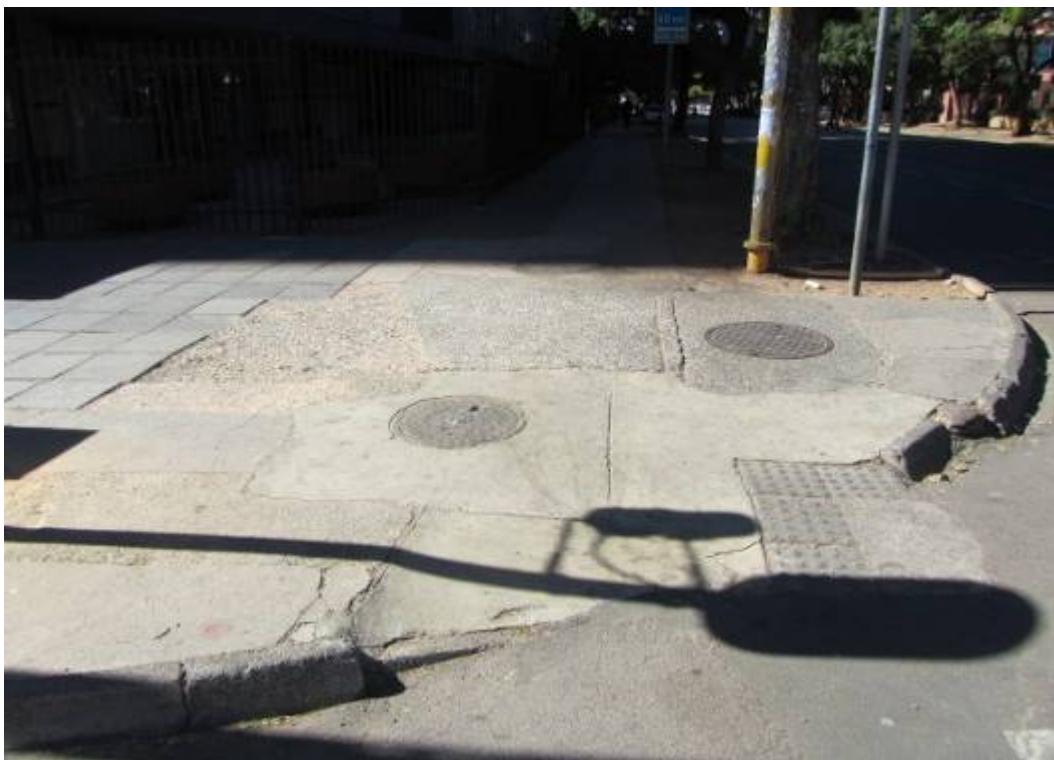
**Figure 277.** *It is important to design lateral termination of paving. (P 1075)*

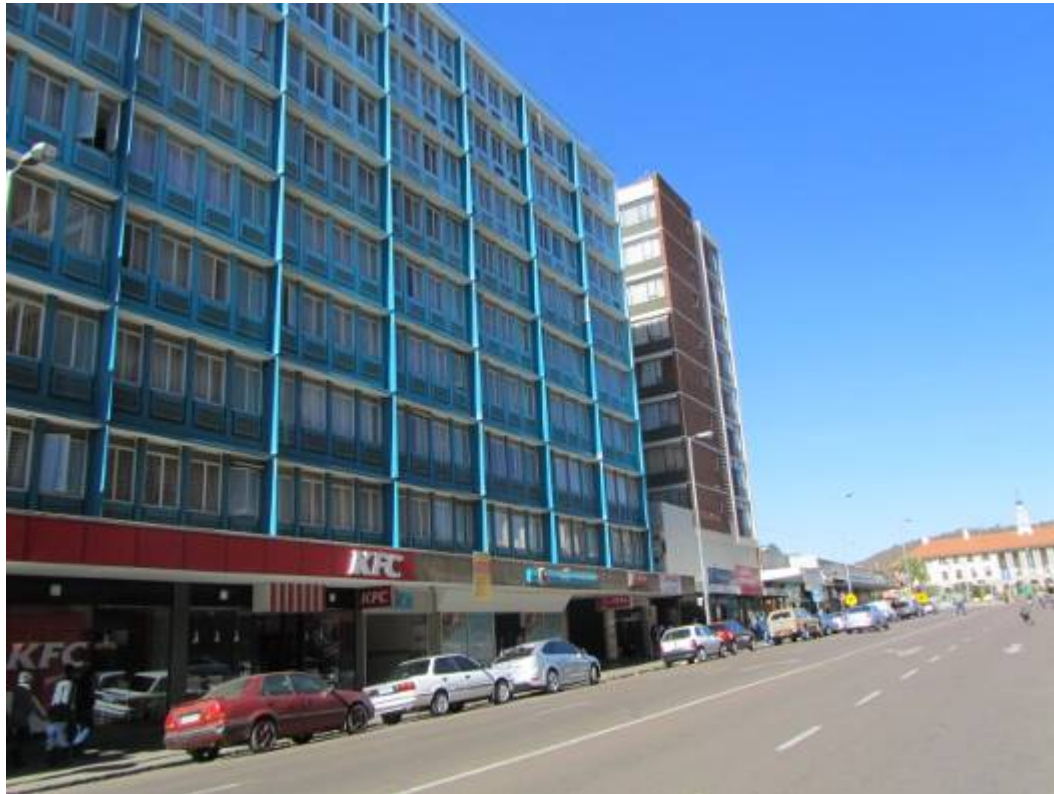
*Figure 315. Provisionally protected building. (P 1088)*

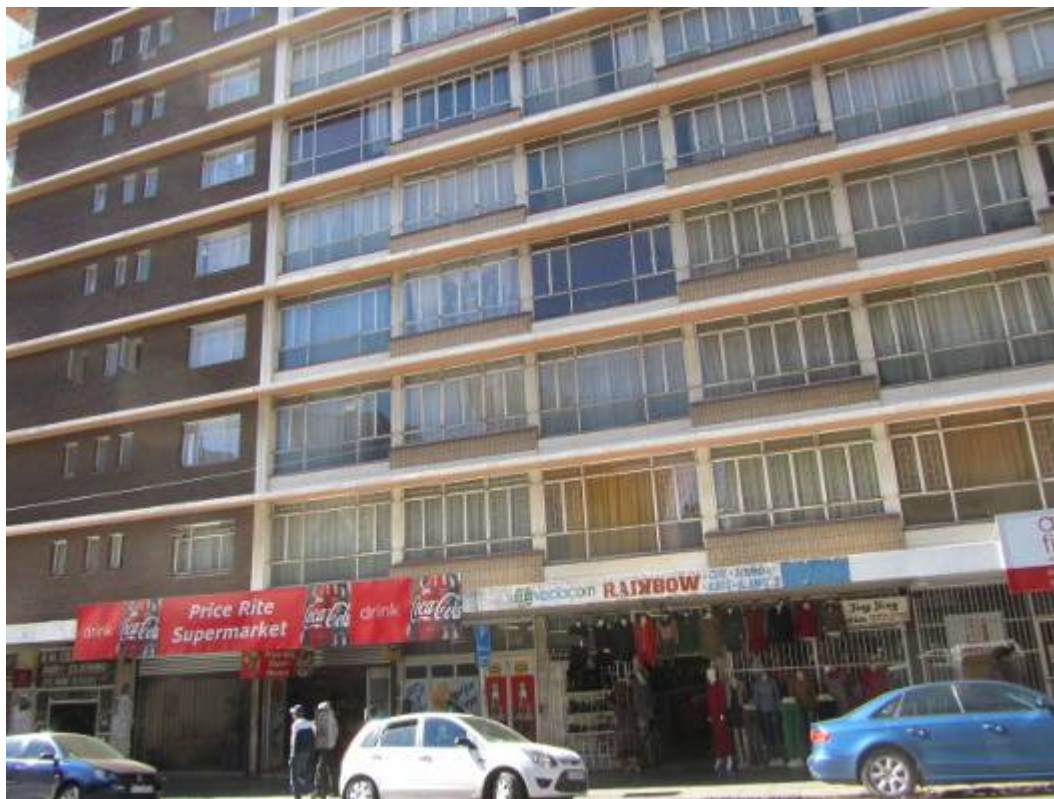
*Figure 316. Provisionally protected building. (P 1089)*

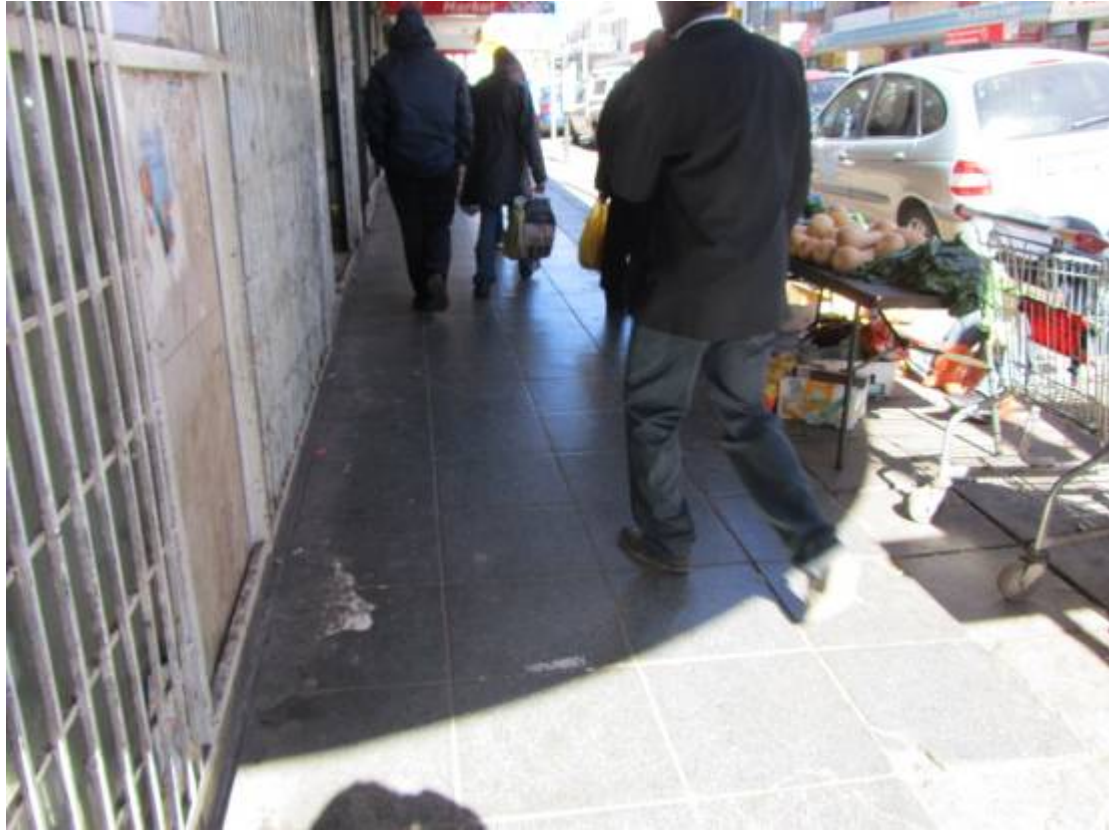
*Figure 317. Cement block paving. (P 1090)*

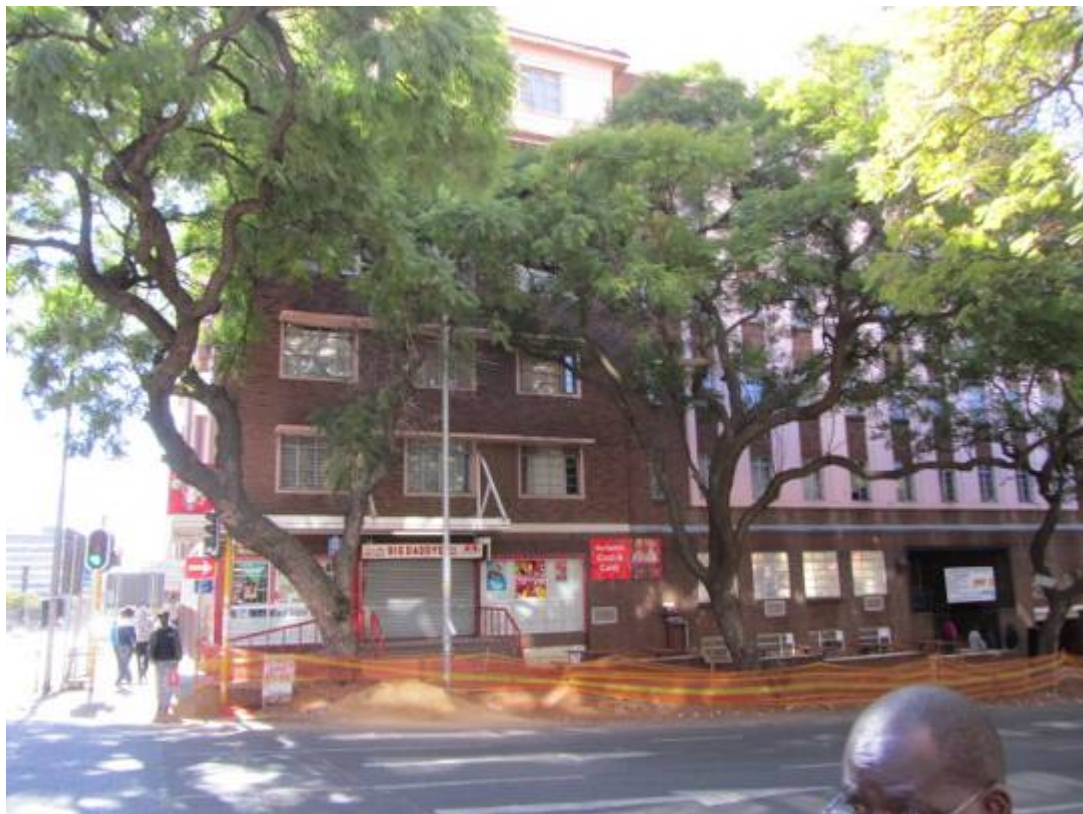
*Figure 318. Provisionally protected building. (P 1091)*

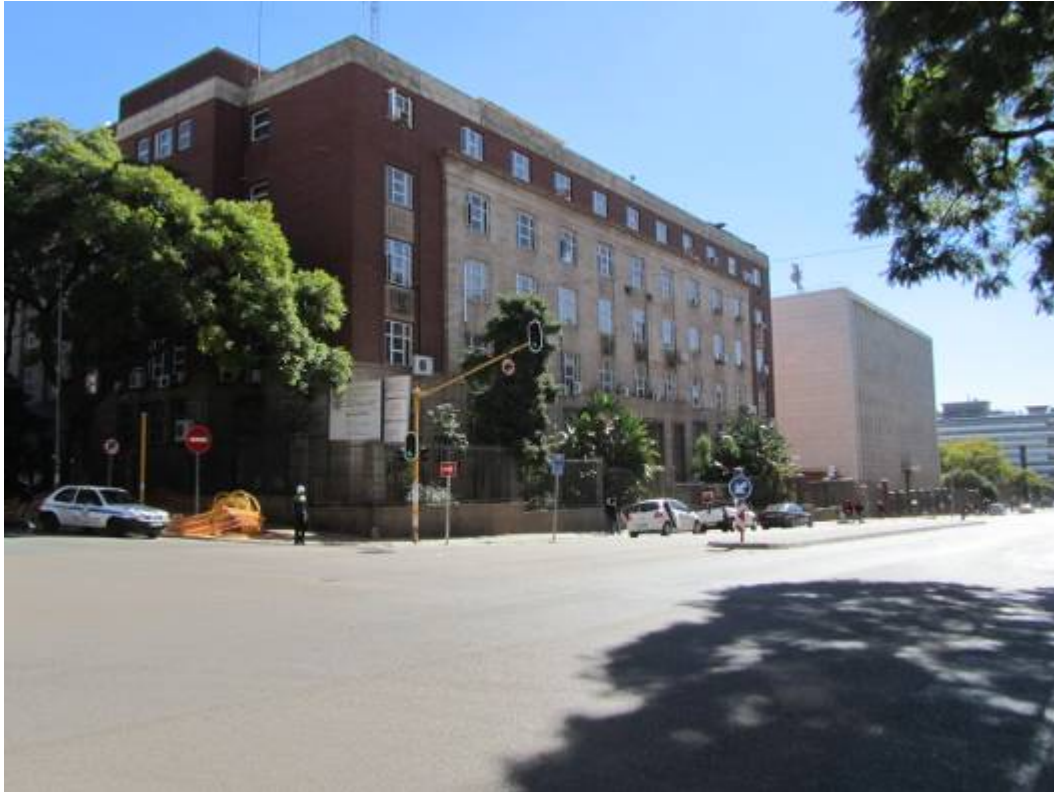
*Figure 319. Protected building. (P 1092)*

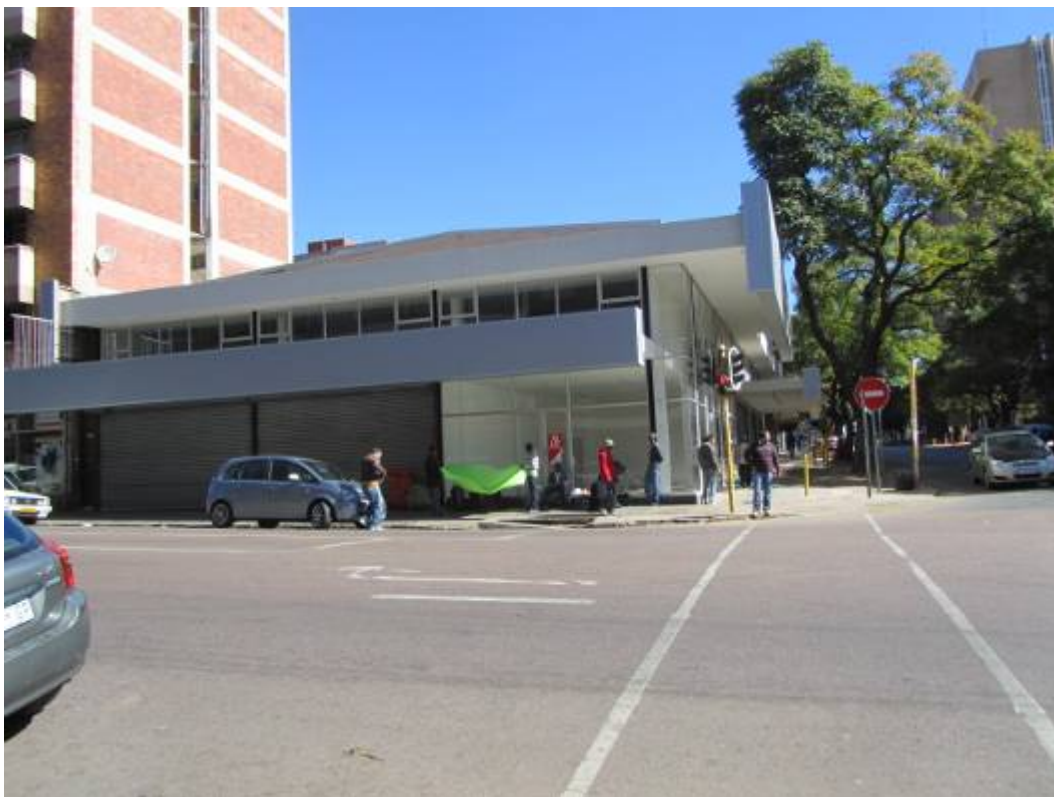
*Figure 320. Provisionally protected building. (P 1093)*

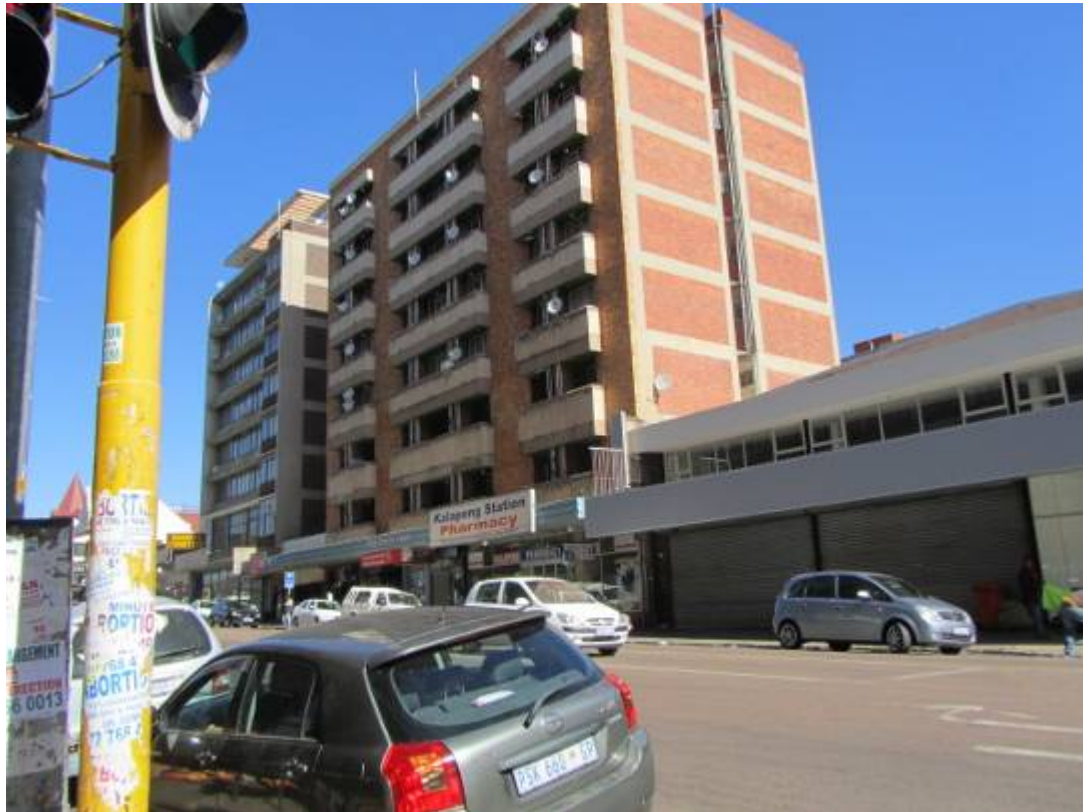
*Figure 321. Provisionally protected building. (P 1094)*

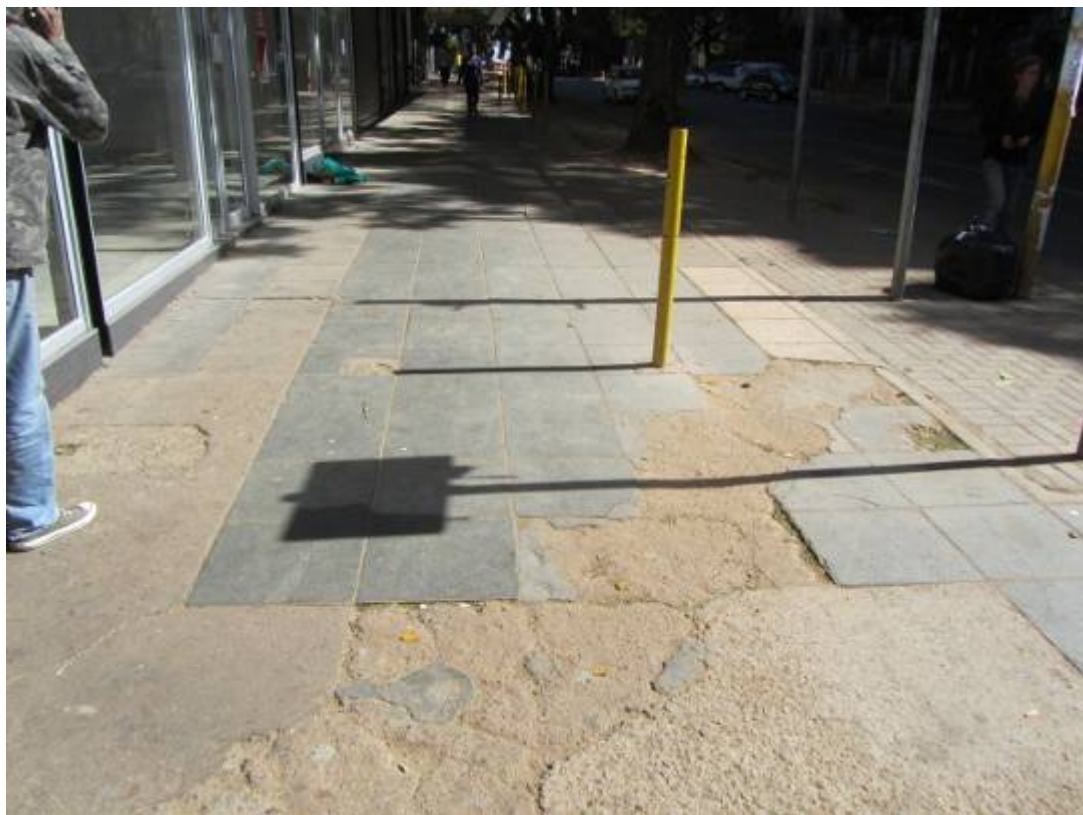
*Figure 322. Paving along Mare Street. Note trees. (P 1095)*

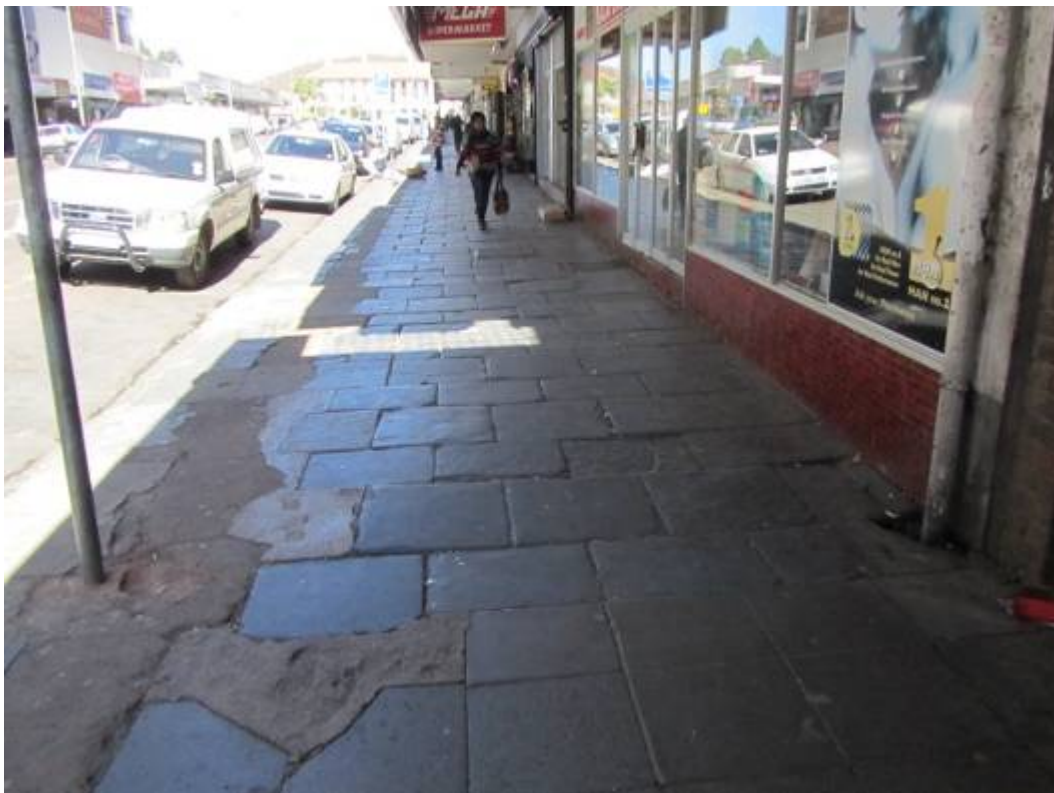
**Figure 324. Remnants of protected slate paving. (P 1097)**

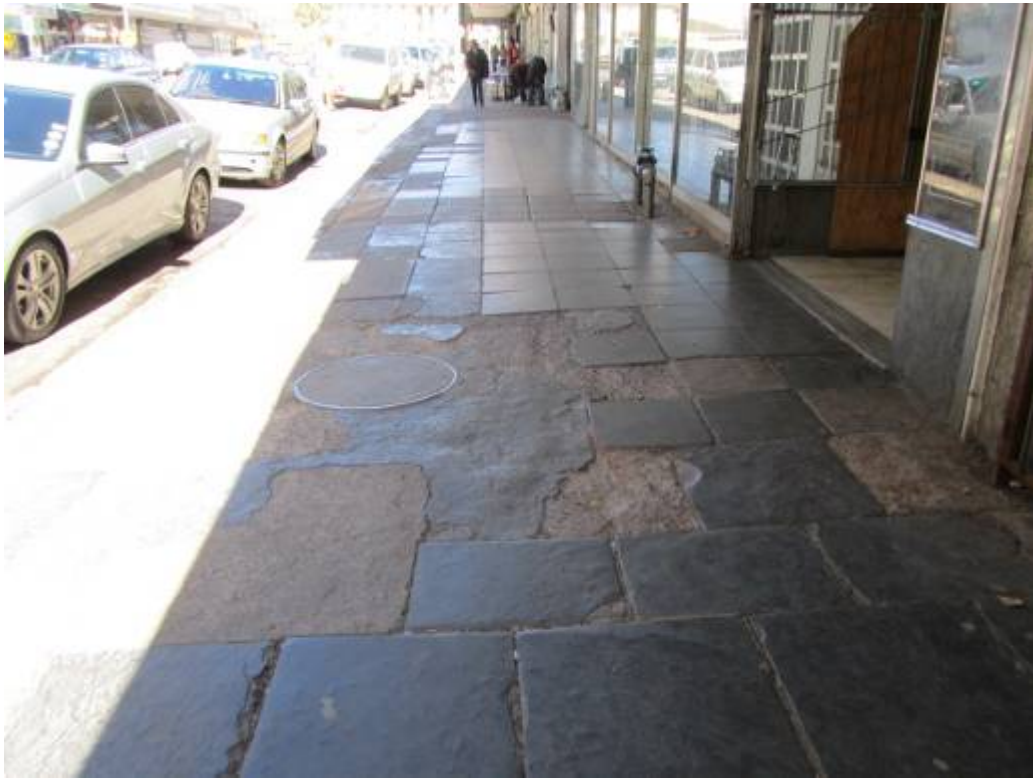
*Figure 325. Remnants of protected slate paving. (P 1098)*

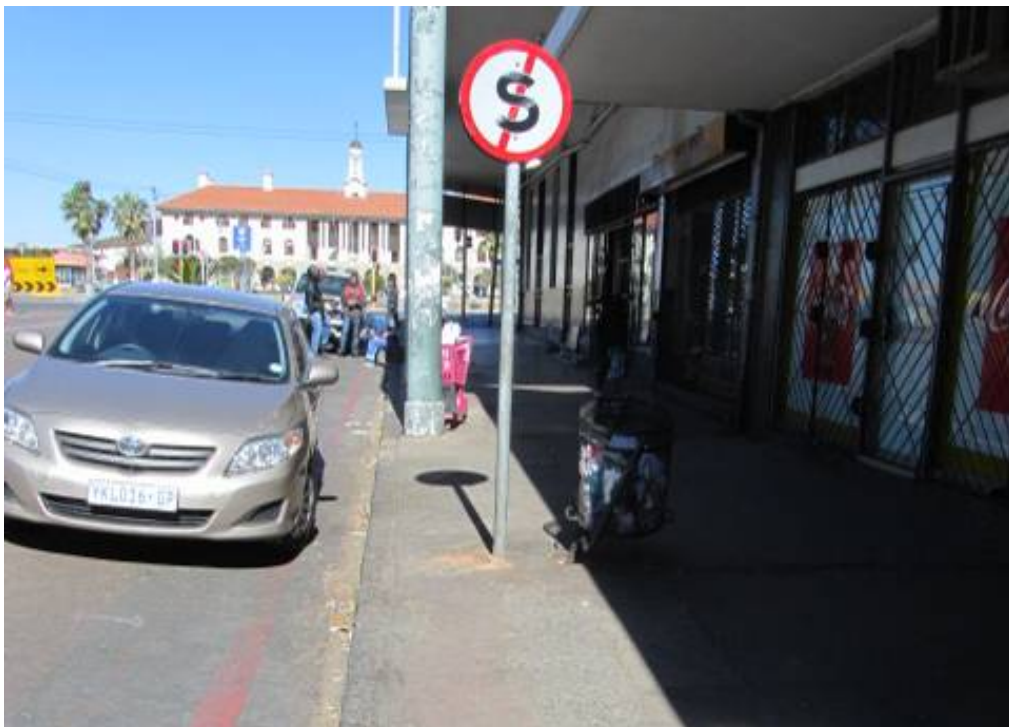
*Figure 326. Canopy support columns indicate definition of street and paving limits. (P 1099)*

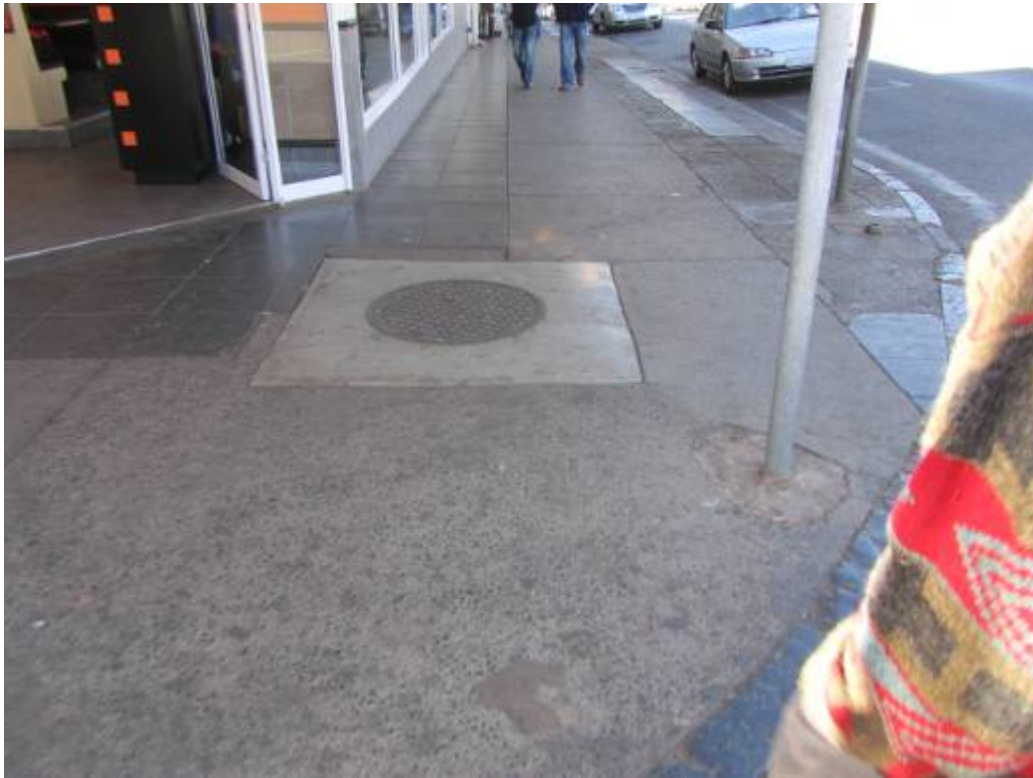
*Figure 332. Granite curbing and a variety of 'modern' paving. (P 1107)*

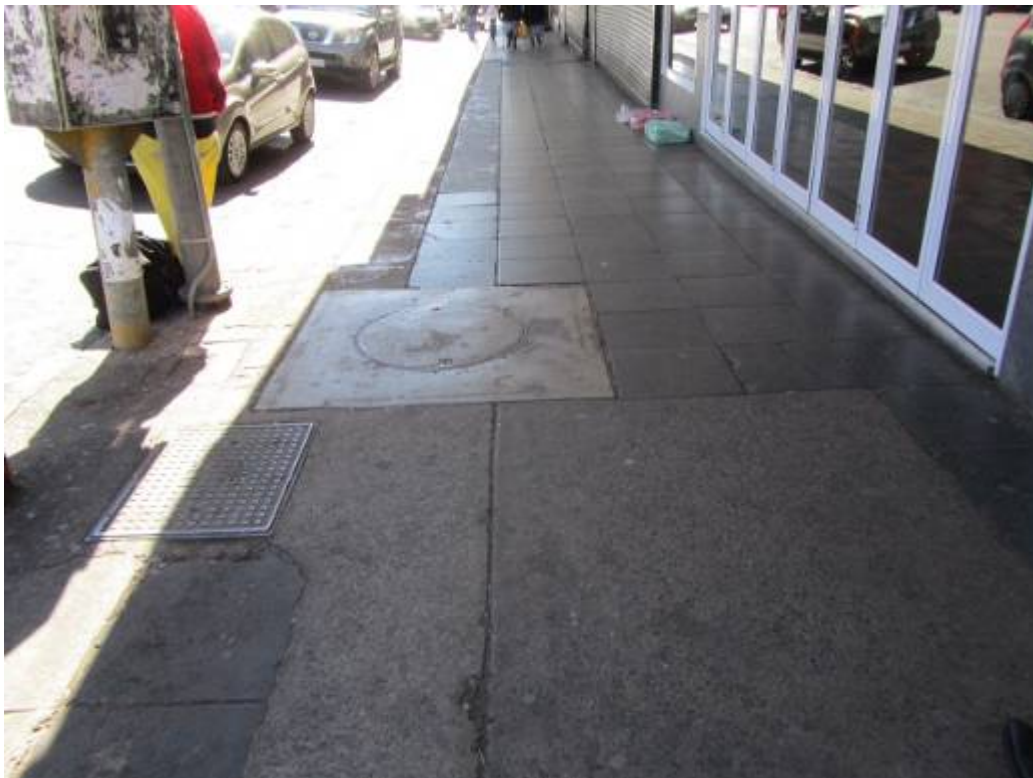
*Figure 333. 'Modern' paving and service hatches, one 'old'. (P 1108)*

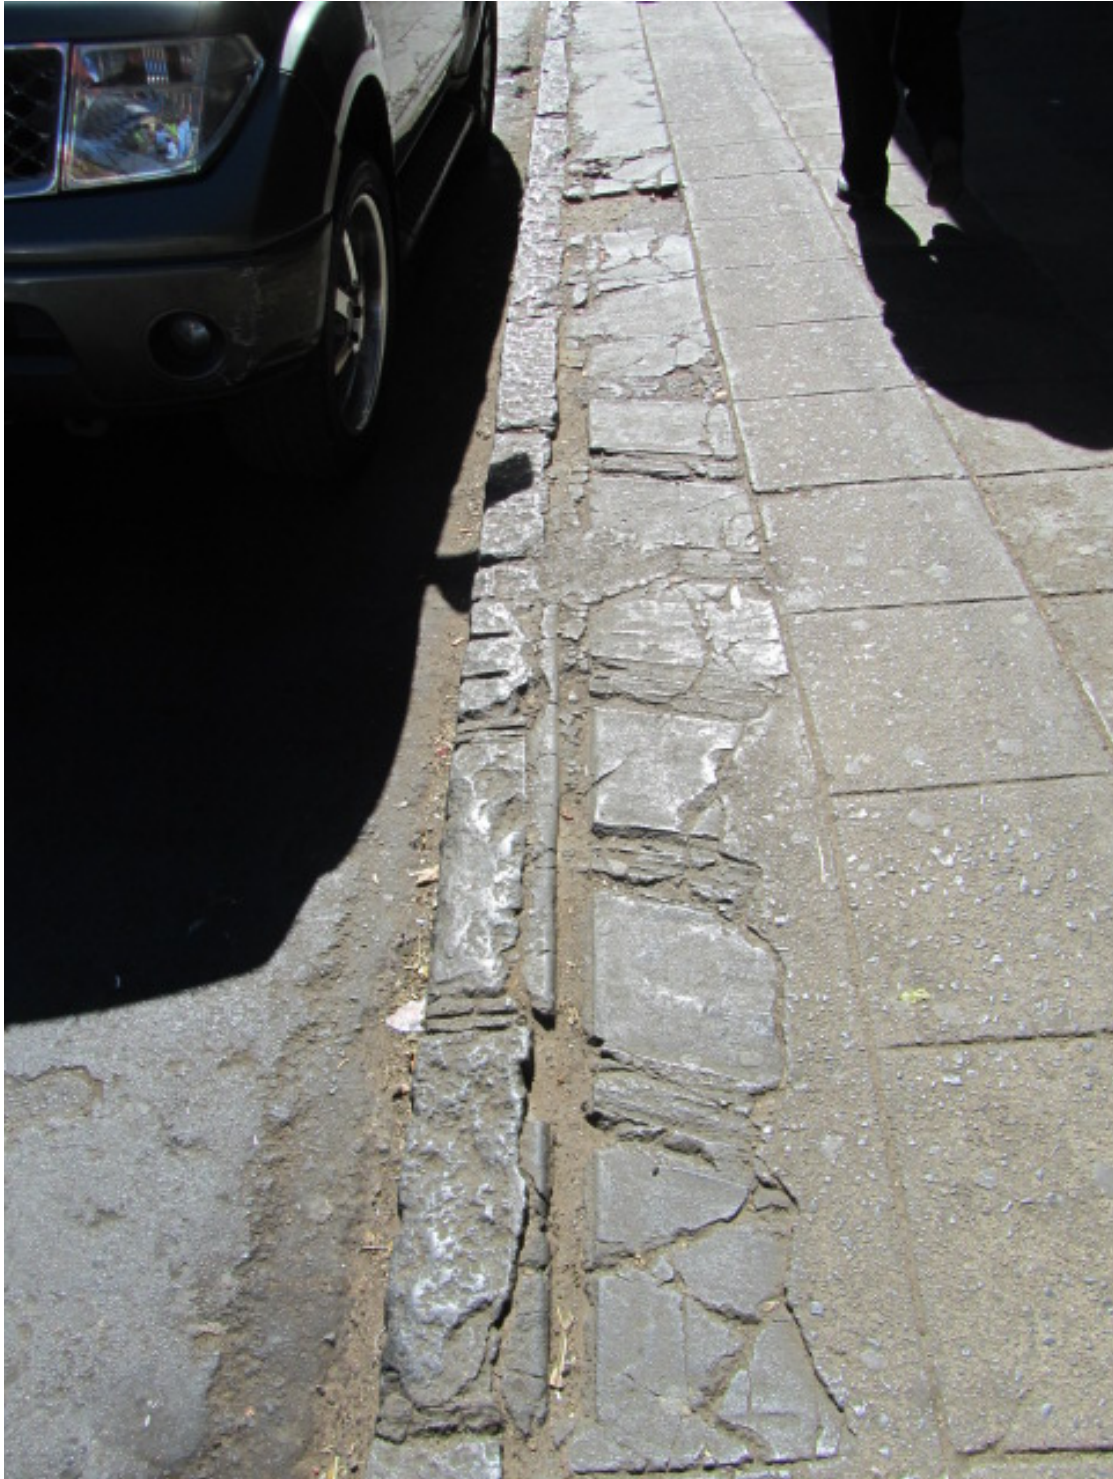
*Figure 336. This may be indicative of another older 'stone paving' that was used in the past. (P 1111)*

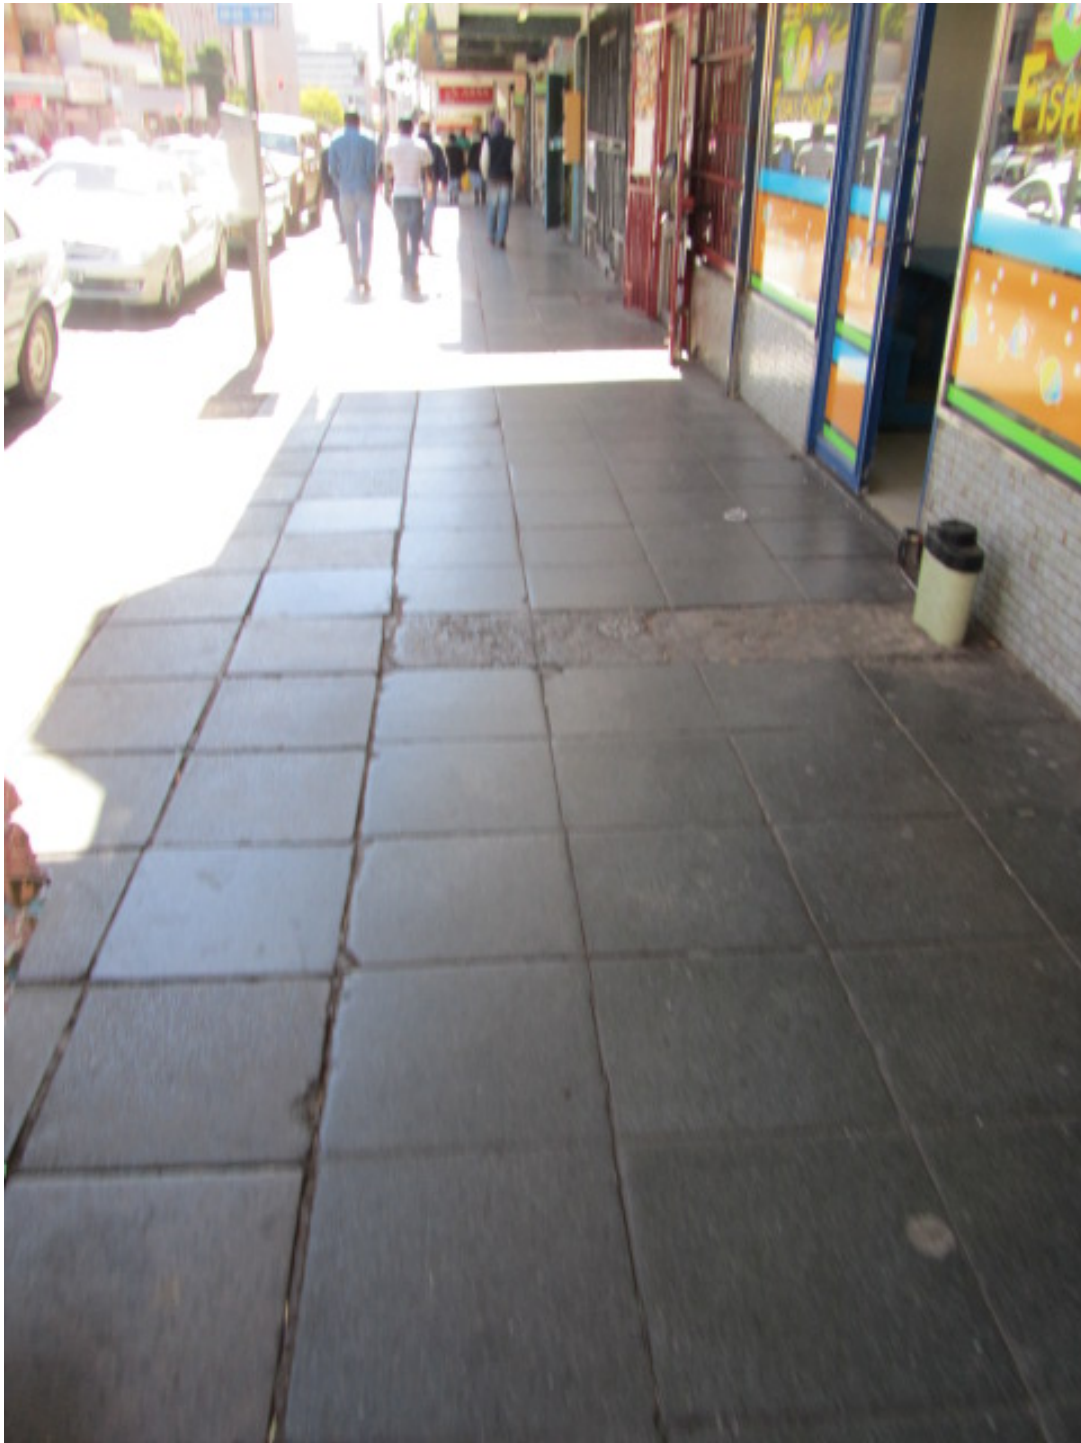
*Figure 337. Cement block paving. (P 1112)*
