## **1st Phase**

**Cultural Heritage Resources Impact Assessment for proposed rapid bus service, Paul Kruger Street, Pretoria, Tshwane.**

**June 2011**

**Report compiled by Sidney Miller and Dr. Udo S. Küsel.**

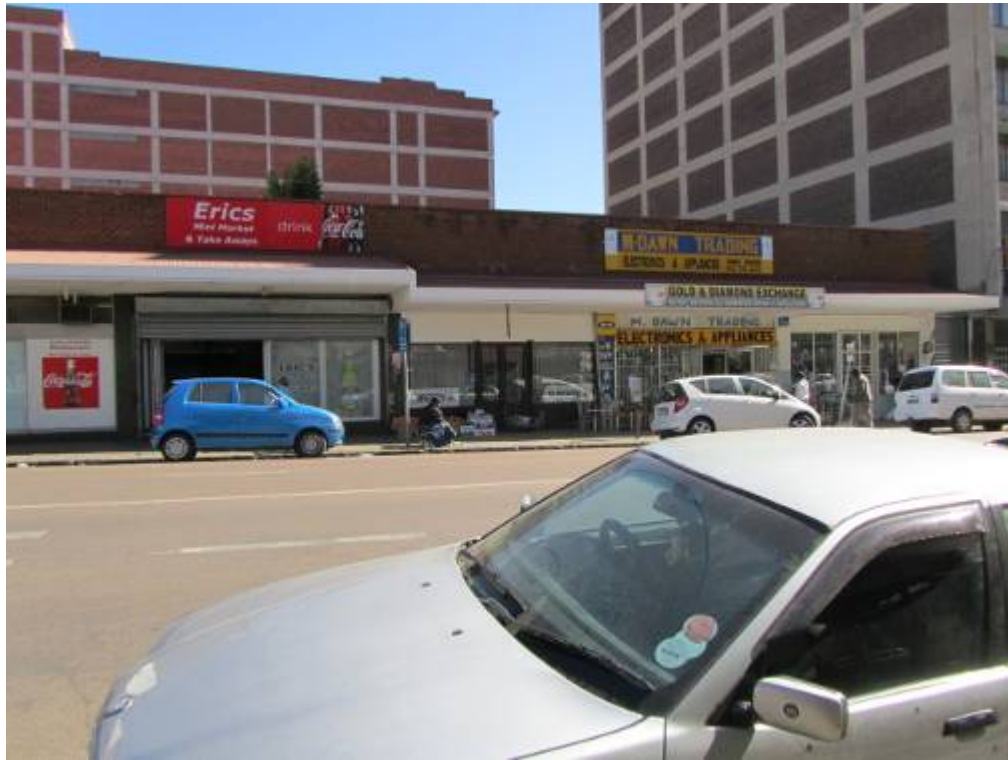
*Figure 338. Provisionally protected building (P 1114)*

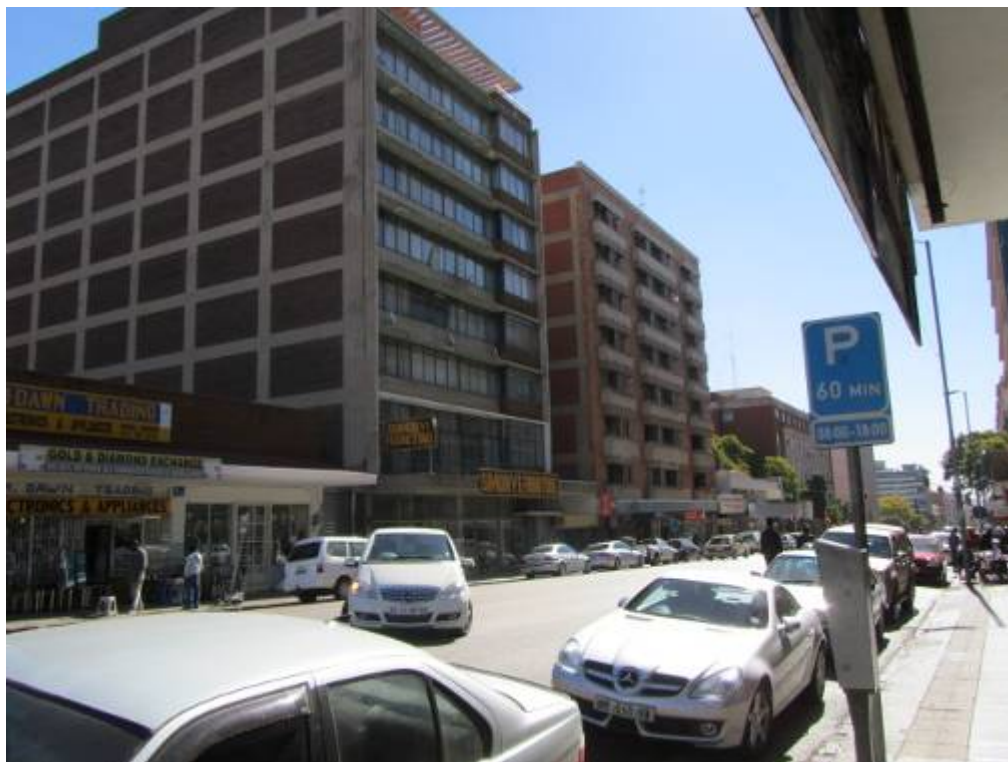
*Figure 339. Provisionally protected building. (P 1115)*

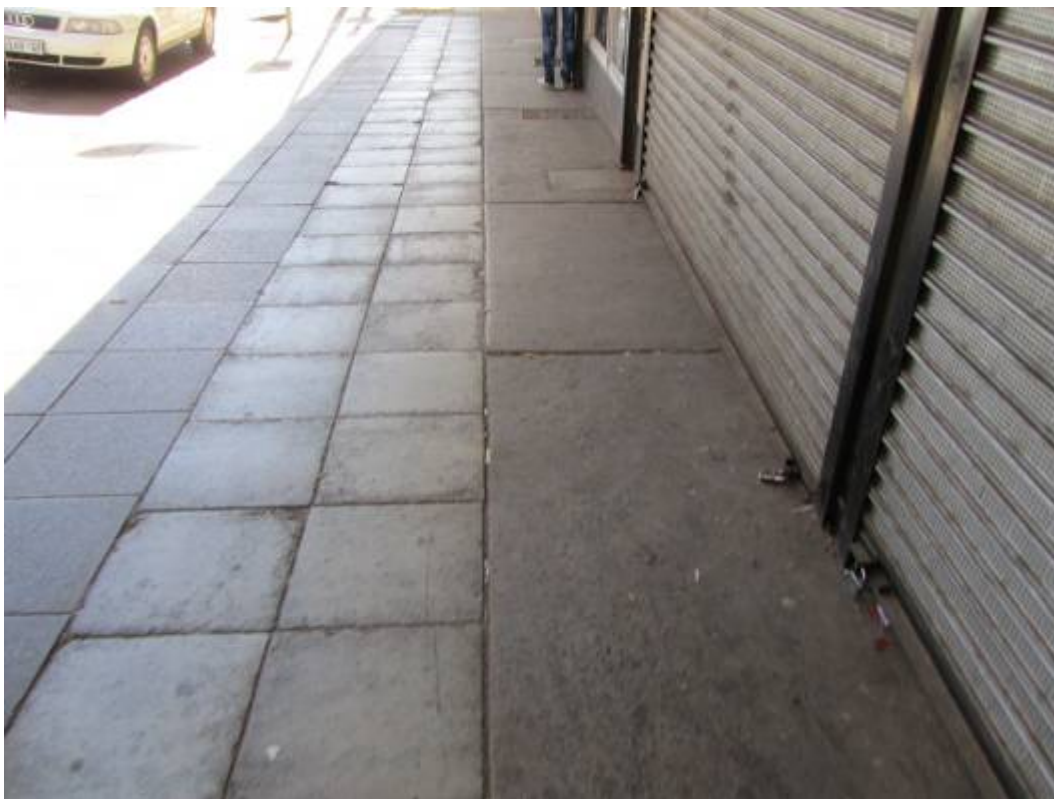
**Figure 341.** *Variety of cement paving. (P 1117)*
